BUCKLING OF PILES DUE TO LATERAL SOIL MOVEMENTS

Fellenius, B.H., 1972. Buckling of piles due to lateral soil movements. Proceedings of the 5th European Conference on Soil Mechanics and Foundation Engineering, Madrid, April 10-13, Vol. 2, pp. 282-284.

Bengt H. Fellenius, Swedish Geotechnical Institute
Bengt Johansson, Sven Tyren AB

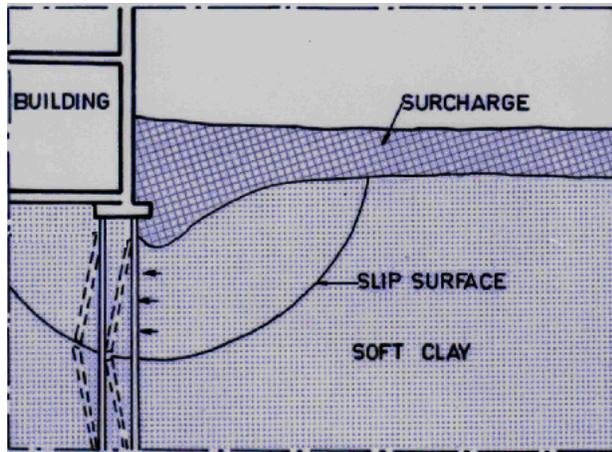
Fig. 2 Problem Illustration

The consequence of surcharging the ground outside a pile supported building is illustrated in Fig. 2. The surcharge has been increased continuously to compensate for settlements caused by a groundwater lowering in the area and by the previous surcharge.

Due to the combined effect of the sand surcharge and a lowering of the groundwater level by about 1 m, the ground surface settled. This settlement was continuously compensated, or reclaimed, by adding more surcharge to the ground outside the building, adding stress on the clay of about 2 tons/m^2 (20 KPa) to a combined stress imbalance of 5.6 tons/m^2 (56 KPa). Naturally, the settlements increased. Today (1972), the magnitude of settlement ranges from 1 m to 2 m. Moreover, as indicated by Eq. 1, this load is more than the soil can carry and troubles have appeared as illustrated in Fig. 2.

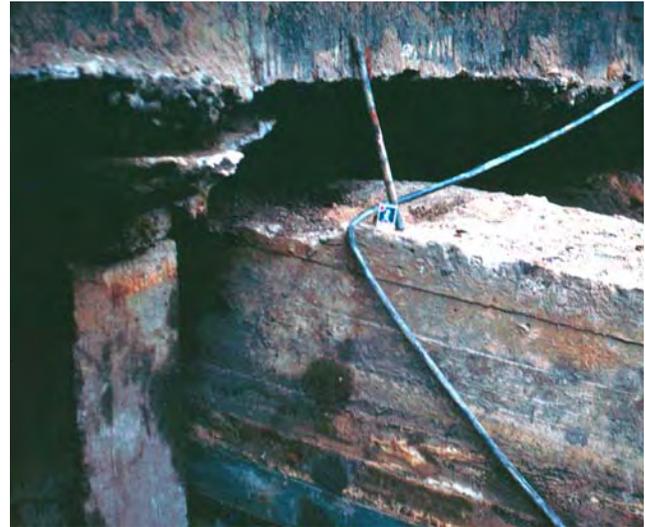
Fig. 3 The settled pile cap and Mega Pile

Cracks and settlement appeared about four years ago, and the building was underpinned by Mega-piles as it was falsely assumed that the original piles were badly installed and had

settled. However, the underpinning did not arrest the settlement. Fig. 3 shows a pile cap and one of the Mega-piles. Settlements and tilting are obvious. For further investigations, a few caps were removed and the piles underneath them were excavated inside large steel-tubes, enabling the piles to be studied in situ.

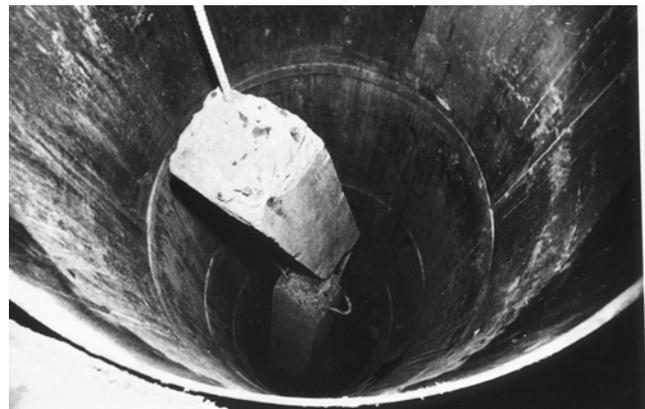
Fig. 4 A ruptured pile excavated in-situ

Fig. 4 shows a photo of a pile that was inclined toward the building. After exposing the pile, it was found broken some 4 m below the cap.

The remedy in this case has been to remove all the fill and to restore the ground floor by a deck supported on slender steel piles. Thereafter, the building will again be underpinned by Mega-piles.

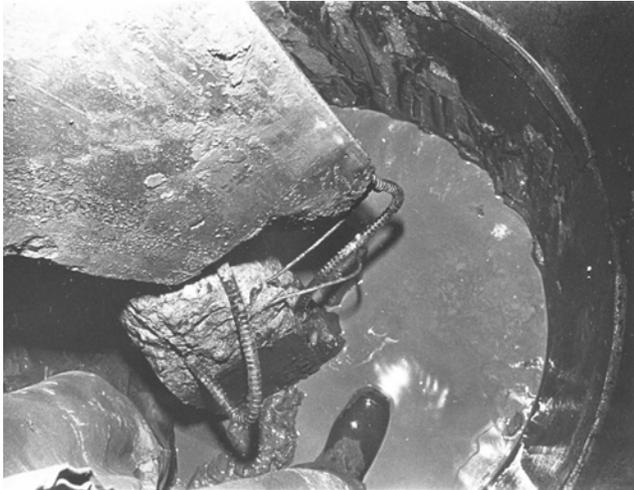
Fig. 5 Detail of the rupture

Fig. 5 indicates the mode of rupture: failure in a combination of bending and shearing due to the lateral thrust from the soil. After the rupture, the upper part of the pile was forced down by the weight of the cap causing the reinforcement bars to buckle.
