Nguyen M.H., and Fellenius, B.H. 2013. Analysis of a piled-raft foundation for Cai Mep Container Port, Vietnam. Proceedings of the Seventh International Conference on Case Histories in Geotechnical Engineering, Edited by S. Prakash, Wheeling, April 29-May 4, Paper No. 2.12, 6 p.

ANALYSIS OF PILED-RAFT FOUNDATION FOR CAI MEP CONTAINER PORT, VIETNAM

Nguyen Minh Hai

Bengt H. Fellenius

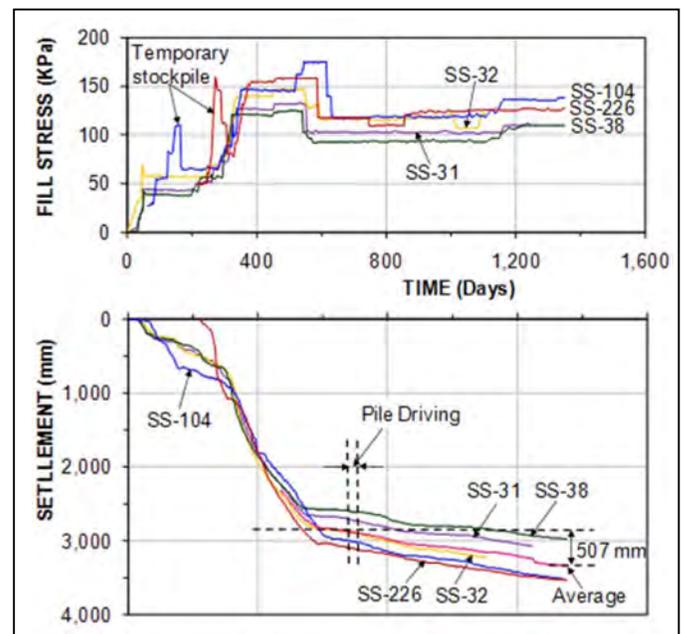
Fig. 4. Fill stress and settlement vs. days after start

Figure 4 shows the fill stresses and settlements measured at the five plates near the two buildings (benchmarks SS-31, SS-32, SS-38, SS-104, and SS-226) from the start of placing reclamation fill in early January 2009, placing of the surcharge in September through November 2009, removal of surcharge in May-June 2011, and until September 15, 2012; i.e., 0 to ≈ 300 days, ≈ 300 to ≈ 600 days, and 600 to $\approx 1,300$ days. The total average settlement before removal of the surcharge was about 3,000 mm. The average settlement during about 700 days after completion of the pile driving was about 500 mm.

The continued settling of the area was quite a surprise to the project. After the removal of the surcharge, it was expected that the consolidation would have been completed and settlement would have ceased. The reason for the ongoing settlements has been discussed by Fellenius and Nguyen (2013) and shown to be due to the fact that the wick drains used for the project were not stiff enough to resist the large soil stress at depth and did not function below about 20 m depth. That is, below about 20 m depth, the consolidation of the soft compressible soil was incomplete. Indeed, the consolidation continued even after the removal of the surcharge to finished ground elevation, Elev+.5.5 m. Above about 20 m depth, the consolidation was completed. Therefore the measured settlements are those continuing below 20 m depth.

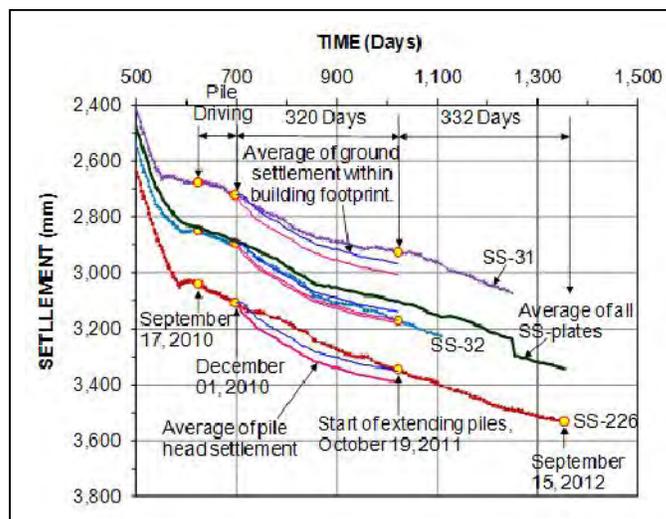
Fig. 5. Settlement of ground and piles at Maintenance Shop

Figures 5 and 6 show the average settlement from Day 500 (≈May 1, 2010) through Day 1,370 (September 15, 2012) of settlement plates SS-31, SS-32, and SS-226 near the Maintenance Shop and SS 38 and SS-104, respectively. Each figure also shows the average settlement of all five plates, and includes the average settlements of the monitored piles within the respective building. The pile head settlement has been connected to each SS-plate curve starting at the SS-plate settlement value measured at the end of the pile driving. At about one year after the end to the pile driving (December 1, 2010 through October 28, 2010), it was decided to extend the piles. (Coincidentally, the settlement of SS-32 on December 1, 2009 was the same as the average of all settlement plates).

The measurements show that the 18 m long piles settled along with the surrounding ground; actually slightly more than the ground outside for the first about three months after the end of driving. The difference is due to the fact that the total weight of the piles added stress to the ground, about 7 KPa for the Maintenance Shop and about 5 KPa for the Substation. It is likely that the ground surface inside the building footprints settled about as much and at about the same initial rate as the piles.

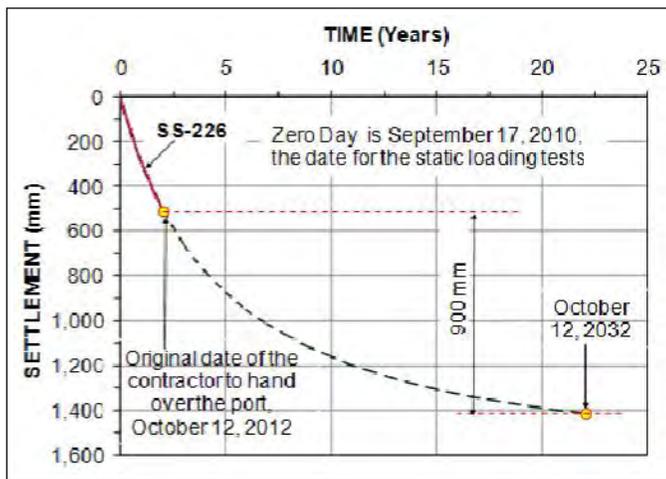
Fig. 7. Ground settlement vs. time at SS-226

Figure 7 shows a simple hyperbolic extrapolation of the settlement measured after the removal of the surcharge, which suggests that the twenty--year settlement would be more than twice the maximum allowed value of 400 mm. For settlement analysis and discussion of the consolidation at the site, see Fellenius and Nguyen (2013).

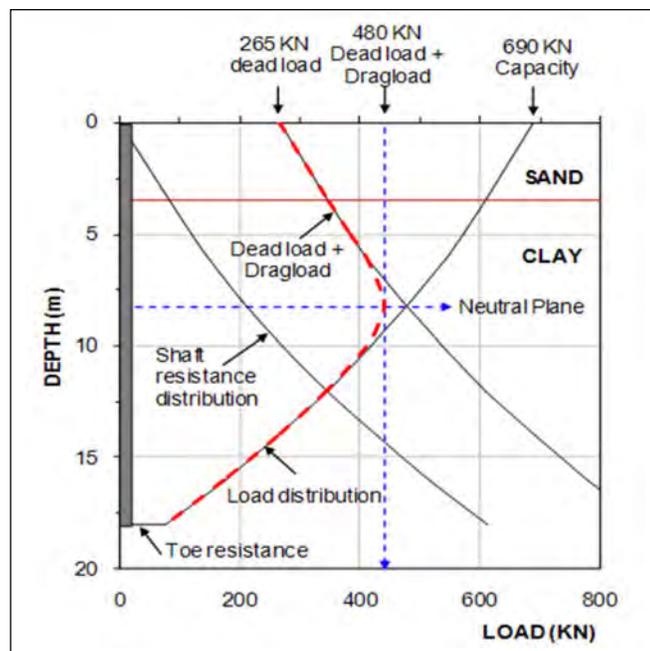
Fig. 8. Distribution of load and resistance of 18 m pile

Figure 8 shows the typical capacities, the load and resistance distributions, and the neutral plane location calculated by effective stress analysis using the UniPile program (Goudreault and Fellenius 2012) for the 18 m long piles. The calculations are based on back-calculation of the results of the static loading tests, using effective stress coefficient (beta) of 0.2 and a unit toe resistance of 470 KPa. The neutral plane location calculated for the 265 KN dead load is at about 8 m

depth. The drag load is of no concern for the piles. However, the downdrag (settlement) due to the ongoing settlements for the piles will be significant. Indeed, were the neutral plane even as low as at the pile toe, the downdrag would still be excessive for the foundation.

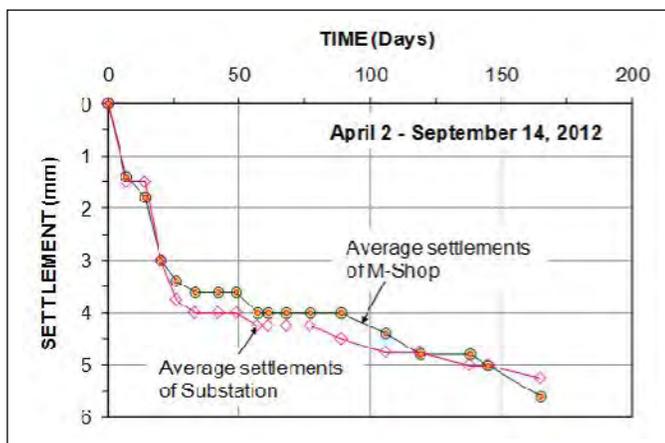
Fig. 11. Settlement of the two buildings after piles had been lengthened

The lengthening of the piles for the two buildings was completed on December 27, 2011. Figure 11 shows the building settlements from end of lengthening through September 14, 2012. The initial settlement is due to the 'elastic' shortening of the pile from the weight of the building being constructed during the first month. Thereafter, the building settlement has been small. However, it still amounts to about 3 mm in 5 months, i.e., 140 mm in 20 years, although the actual settlement would likely be smaller than that suggested by such linear extrapolation.
