Nguyen M.H., and Fellenius, B.H. 2013. Failure of embankment on soil-cement columns for Thi Vai Port, Vietnam. Proceedings of the Seventh International Conference on Case Histories in Geotechnical Engineering, Edited by S. Prakash, Wheeling, April 29-May 4, Paper No. 3.08, 11 p.

FAILURE OF EMBANKMENT ON SOIL-CEMENT COLUMNS FOR THI VAI PORT, VIETNAM

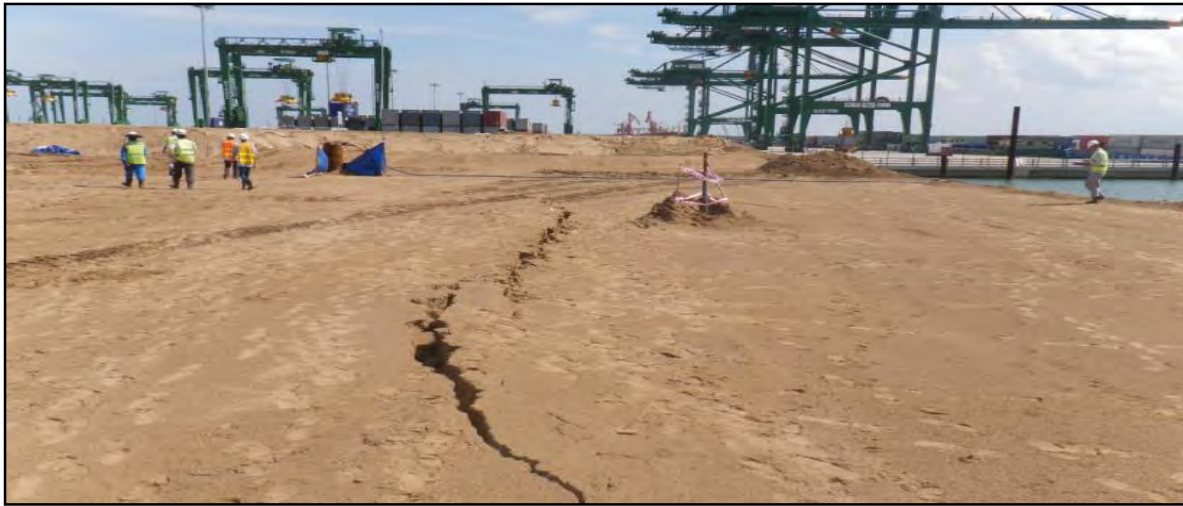
On March 29, 2010, when the final surcharge level was being approached, some lateral displacements were noticed to have occurred, and, on April 5, 2010, cracks appeared on the fill

surface about 30 m from the bank along about 100 m length. The cracks are shown on the photograph in Figure 1. In the morning of July 12, 2010, the width of the crack noticeably and progressively increased until, at 07:50h, the river bank failed along an about a 200 m long stretch. Figure 2 shows a photograph of the failure. A significant crack developed parallel to the river about 30 m inland, extending about 400 m along the river bank. All soil-cement columns along that length broke about 11 m below the fill surface. Figure 3 shows an artist's view of the future Port with the failed area marked out.

Fig. 1 Downstream view of the first cracks that appeared along the riverbank on April 5, 2010

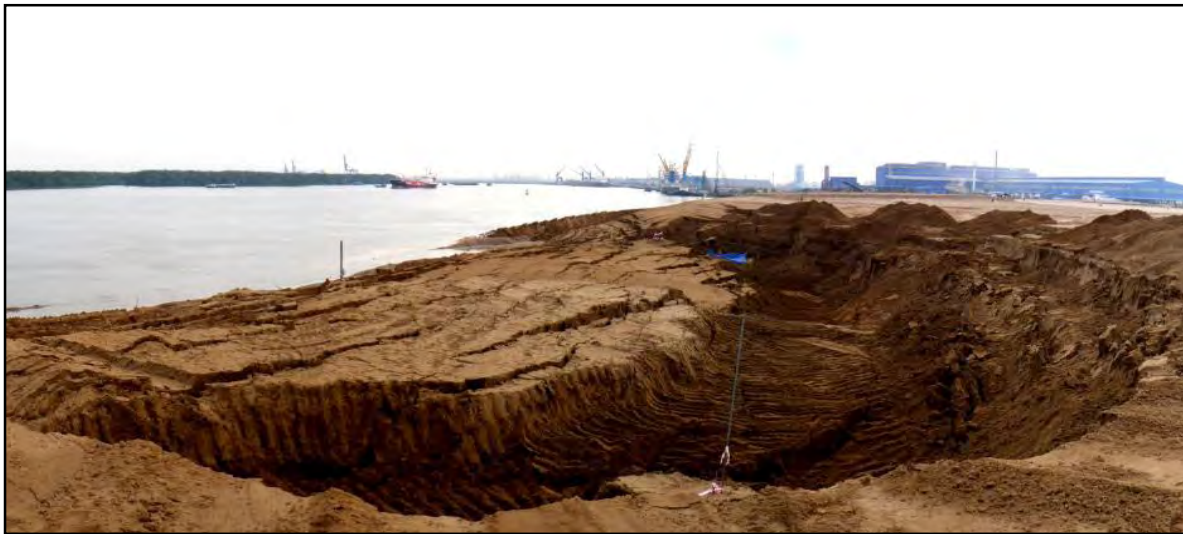
Fig. 2 Slope failure on July 12, 2010, viewed upstream

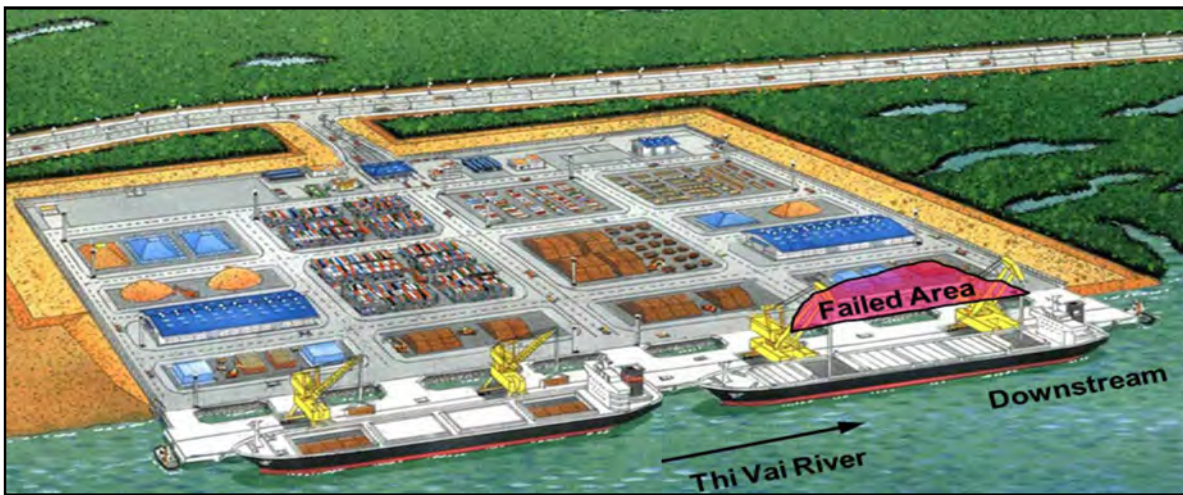
Fig. 3 Artist's view of completed Port with slope failure area overlaid (JICA 2006)

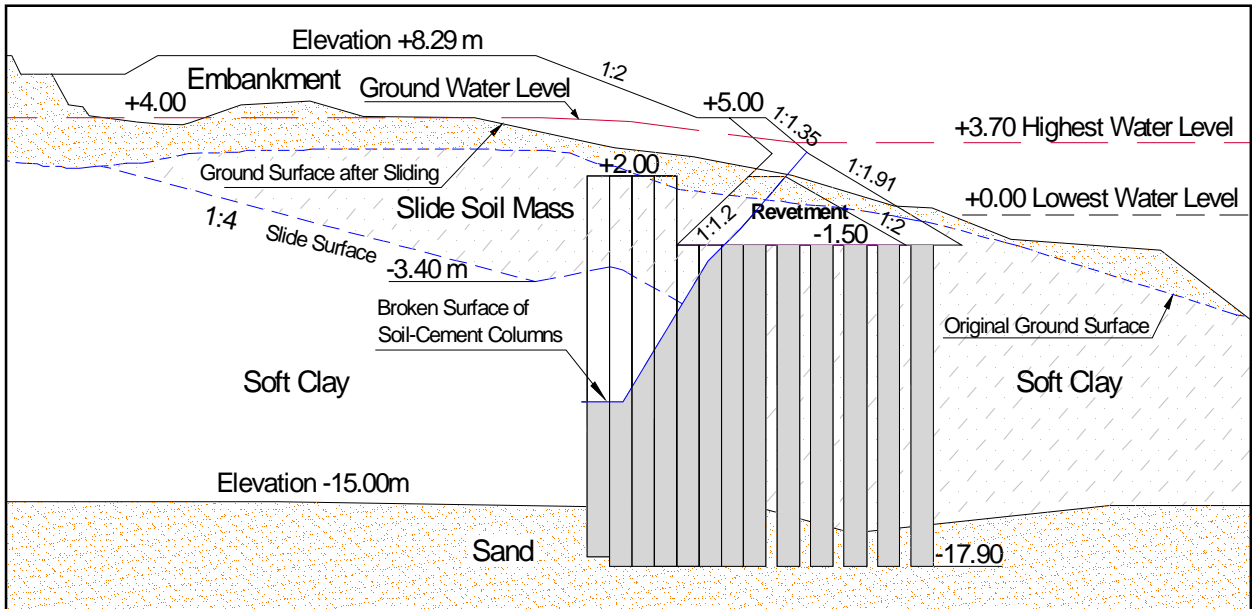
Figure 10 indicates the slide surface starting about 30 m from the river bank and sloping down at 1(V):4(H) toward the soil-cement columns at a depth of about 11 m below the original ground surface, breaking the columns. The lowest location of sliding surface was at Elev. 3.4 m, and the fill and ground surface after slope failure was lower than groundwater level (Elev. +4.0 m). The columns failed along an approximately horizontal plane, which suggests that the type of failure was by translational sliding and wedge.

Fig. 10 Cross section of failed embankment

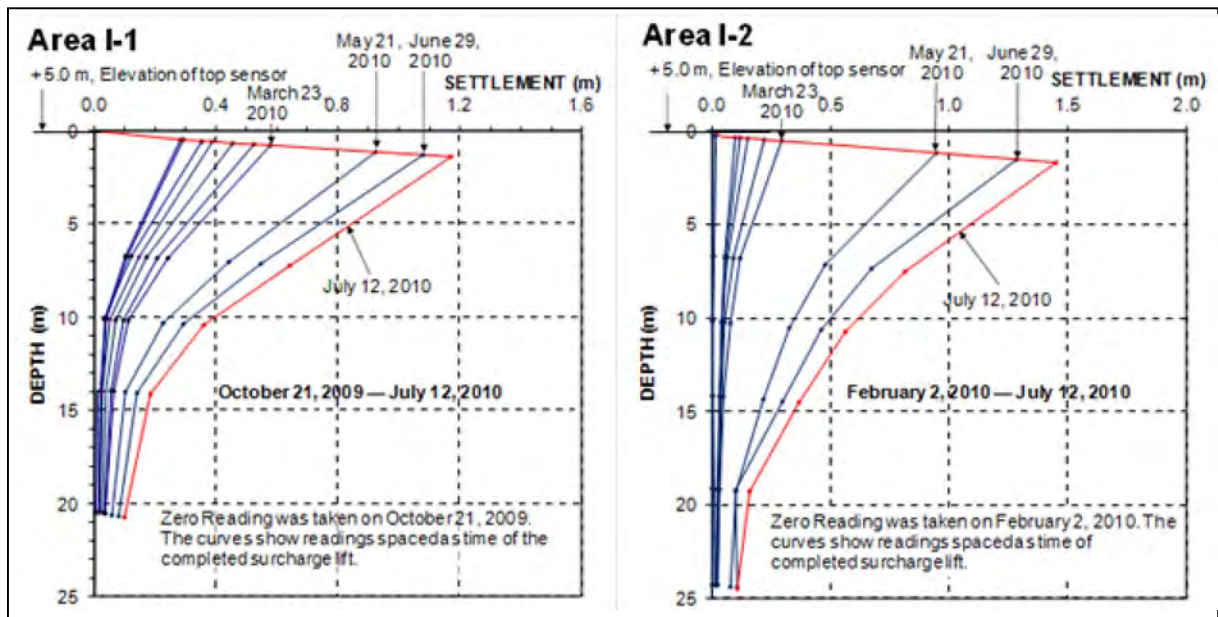
Figure 11 indicates the distribution of settlement versus depth at monitoring stations SS 1, P2 at Area I 1 and SS 3, P1 at Area I 2 just outside the failure area. The records were taken at the occasion of the completion of the placing of each, approximately equal, fill lift at the monitoring point. The recorded settlements are also indicated by the figure showing the records at the gradually increasing depth of each particular settlement anchor point. The settlement readings in extensometer stations E1 and E2 in Areas I-1 and I-2 started on October 21, 2009 and February 2, 2010, respectively.

The final set of readings (the red curve) is from July 12, 2010, the day of the slope failure. The records show increasing settlement between March 23 through May 21, 2010, in Area I-1, and March 30 through May 29, 2010, in Area I-2 respectively. This increase coincided with lateral displacements observed in inclinometer measurements taken during the surcharge lift to Elev.+8.1 m in Area I 1 and to Elev.+8.9 m in Area I 2.

Fig. 11 Distributions of settlement with depth below original ground surface at Areas I-1 and I-2

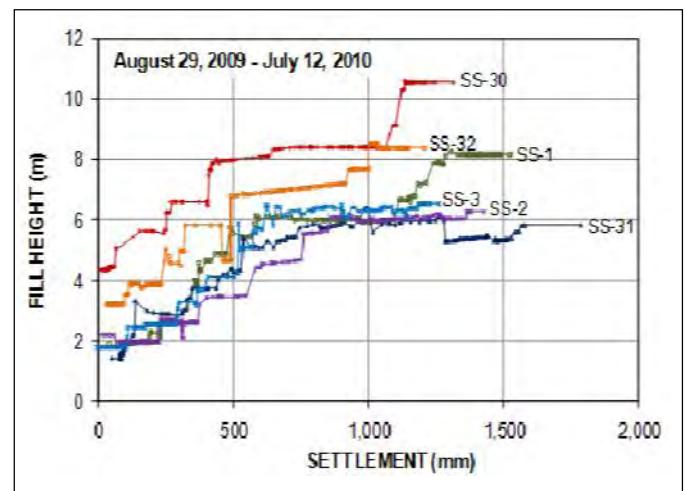
Figure 12 shows the measured settlement as a function of the fill height at the failure area, Areas I 1 and I 2. Stations SS-30 and SS-31 are inside the failure area. The settlements were monitored from August 29, 2009 through July 12, 2010, and October 28, 2009 through July 12, 2010, respectively. The graphs indicate that when the fill height of SS 30 in Area I 2 was increased to about 10.6 m (to Elev.+9.9 m), the settlement measured was smaller than that measured at SS 31, where the fill height was about 5.5 m (to Elev.+6.6 m).

The figure shows that at Station SS 31, where the about 1 m of fill was removed (May 7 through July 2), the settlements continued to increase, which is considered to be a consequence of the fact that the soil mass below SS-31 was moving laterally toward the river.

Fig. 12 Fill height vs. settlement

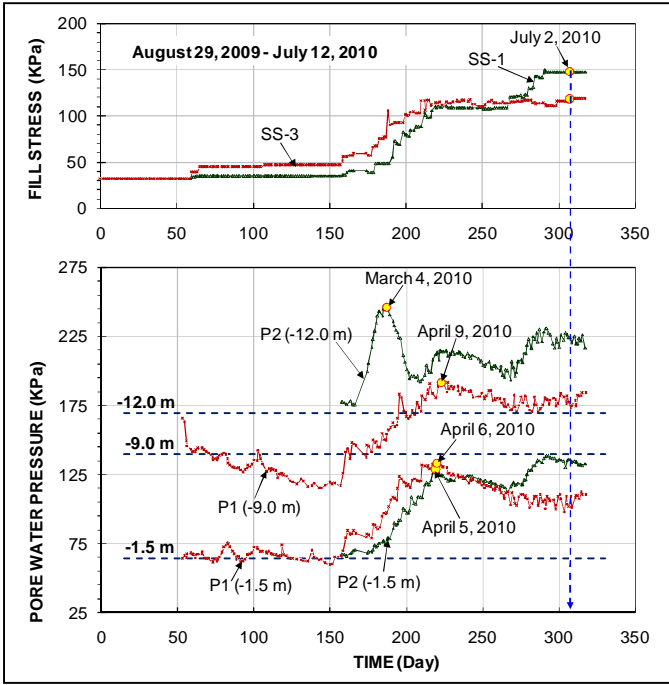
Figure 13 shows the measurements of pore water pressure at piezometers P1 (Area I 1) at Elevs. 1.5 m and -9.0 m, and at piezometer P2 (Area I 2) at Elev. 1.5 m and -12.0 m, both immediately outside the failure zone. The pore water pressures were monitored from October 21, 2009 through July 12, 2010, and February 2, 2010 through July 12, 2010, respectively (placing of fill started on January 30 and February 8, 2010, respectively). The dashed horizontal lines are the zero phreatic pore pressures at the indicated elevations.

The measurements show the pore pressures to rise as the placing of fill commenced. However, after about April 6, 2010, and March 4, 2010, in Areas I-1 and I-2, respectively, no further increase of pore pressure was measured. The measurements indicated excess pore pressures elevations at piezometer tip depth Elev.-1.5 m were at Elevs.+9 m to Elev.+13 m about 4 to 8 m above the original pore pressure phreatic height at that depth. The maximum phreatic elevations for the deeper down piezometers, P1 at Elev.-9 m

and P2 at Elev.-12 m, were Elev.+8 m and Elev.+11 m, respectively, about 3 to 6 m above the original pore pressure phreatic height at the piezometer tip depths. The excess phreatic heights correspond to a range of excess pore pressure of about 30 through 80 KPa. In comparison, the increase of total stress due the fill was about 150 KPa. It was expected that the wick drains and soil-cement columns would be effective in dissipating the increase of pore pressure due to the placing of the fill. However, it is likely that the horizontal shear movements developed pore pressures which counteracted the dissipation from the consolidation.

Fig. 13 Measured pore water pressure vs. applied stress

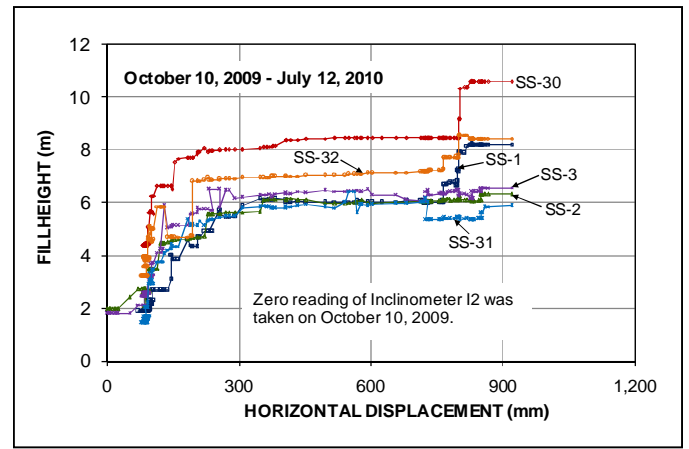
Figure 14 shows fill height versus horizontal displacement at all relevant monitoring stations. When the fill height at Area I-1 (SS-2, SS-3, SS-31, and SS-32) reached a height of about 5 m to about Elev.+7.30 m, corresponding to a stress increase of 100 KPa, the settlement increased significantly. In Area I-2 (SS 1 and SS 30), the similar increase occurred at a fill height of about 8 m (at about Elev.+8.0 m; stress increase of 150 KPa).

Fig. 14 Fill height vs. horizontal displacement

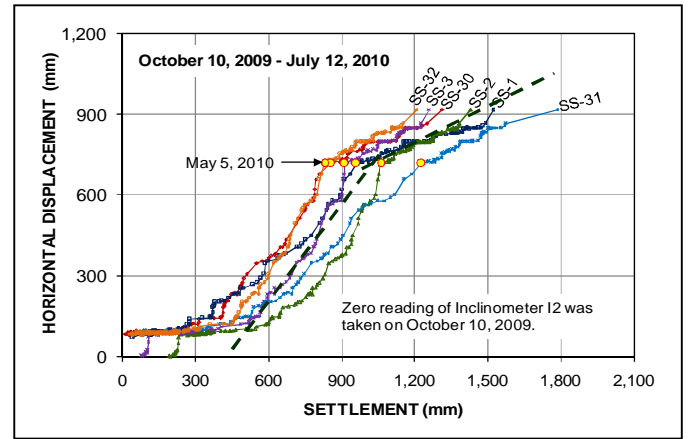
Fig. 15 Settlement vs. horizontal displacement

Figure 15 shows the horizontal displacement versus settlement obtained from inclinometer measurements. Until May 5, 2010, the horizontal displacements and settlements were about equal. However, thereafter, the horizontal displacement became about 2 to 3 times larger than the settlement. The dashed red lines in the figure show the average slopes of displacement to settlement of about 0.8 and 2.8, respectively.

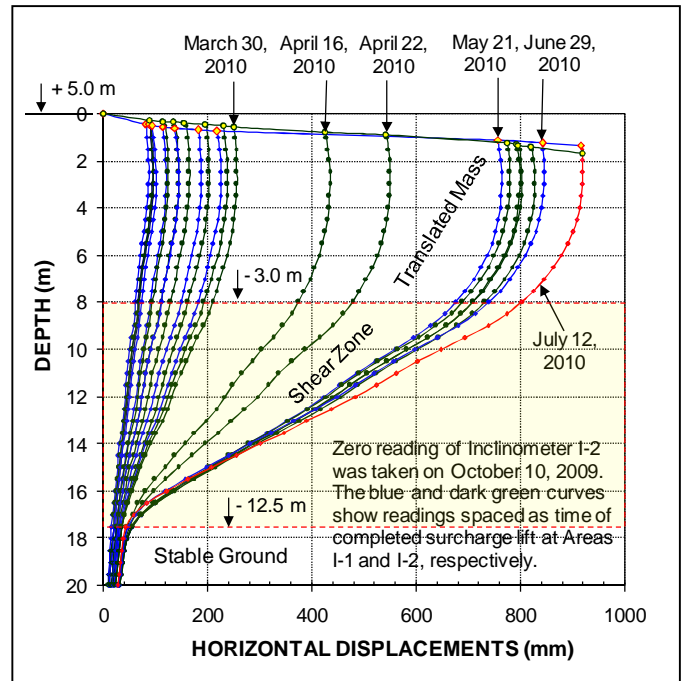
Figure 16 presents the measurements of horizontal displacement versus depth from October 10, 2009, through July 12, 2010, at the two inclinometer stations. The blue and dark green curves show the readings after completion of each surcharge lift at Areas I 1 and I-2. The lines connecting the top of each curve shows the fill surface level below the Elev.+5.0 m line on the date of the measurements. The measurements show that the onset of the sliding occurred after March 30, 2010, and that translation soil mass movement dominated down to Elev. 3.0 m, about 5 m below the original ground surface (Elevs.+2 to +3 m) and 8 m below the fill surface, with shear zone movements below and to Elev.-12.5 m, about 15 m below the original ground surface. The key zone for the analysis of the slope failure is at about Elev.-3 m, where soil shear can be assumed as fully mobilized by the slide.

Fig. 16 Horizontal displacement versus depth

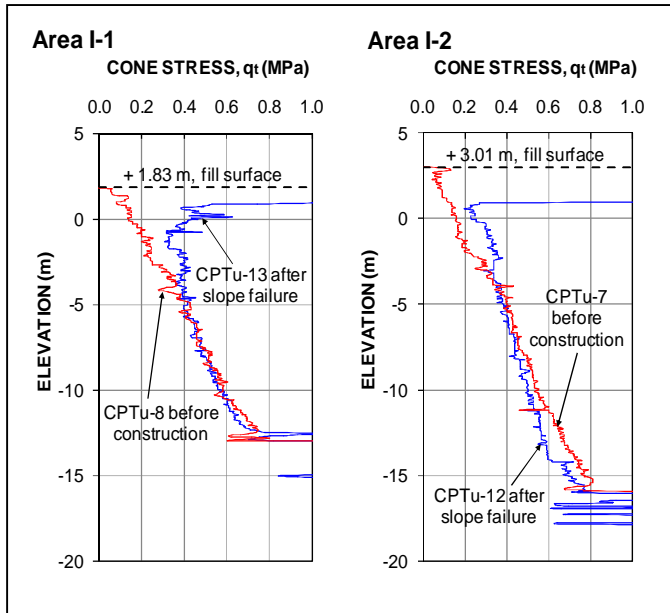
Figure 17 indicates a comparison between the distributions of cone stress from the CPTU soundings performed before and after the slope failure (correlated to elevation), suggesting little or no change between the cone stress for before and after the slide. An increase of shear strength would have resulted in an increase of cone stress. Instead, the cone stress from Area I-2 below Elev.-3 m even showed a decrease for the sounding after the failure.

Fig. 17 Cone stresses, q_t , versus depth in Area I-1 and I-2
