Tan, S.A., and Fellenius, B.H., 2012. Failure of a bidirectional-cell tested barrette. Full-Scale Testing in Foundation Design, M.H. Hussein, R.D. Holtz, K.R. Massarsch, and G.E. Likins, eds., Geotechnical Special Publication 227, pp. 307-321. ASCE Geo-Congress Oakland March 25-29, 2012, State of the Art and Practice in Geotechnical Engineering, ASCE, Reston, VA.

## **Failure of a Barrette As Revealed in a Bidirectional Test**

**ABSTRACT.** A 1.5 x 2.8 m, 44.5 m deep barrette was constructed in weathered sedimentary rock of the Jurong formation in Singapore with a bidirectional-cell assembly of two cells installed at 33.5 m depth, 11 m above the barrette toe, chosen presuming that resistance above and below the cell level would balance. When the test was performed, a proof test at the end of the construction work, the shaft resistance for the section above the cell level was surprisingly low; the shaft failed at a load of only about 3 MN. In a re-test, at the maximum cell load of 12.5 MN, the upward movement exceeded 100 mm. The barrette was then tested in a conventional head-down test, which first (second test stage) was with the cell vented to validate the results of the O-cell

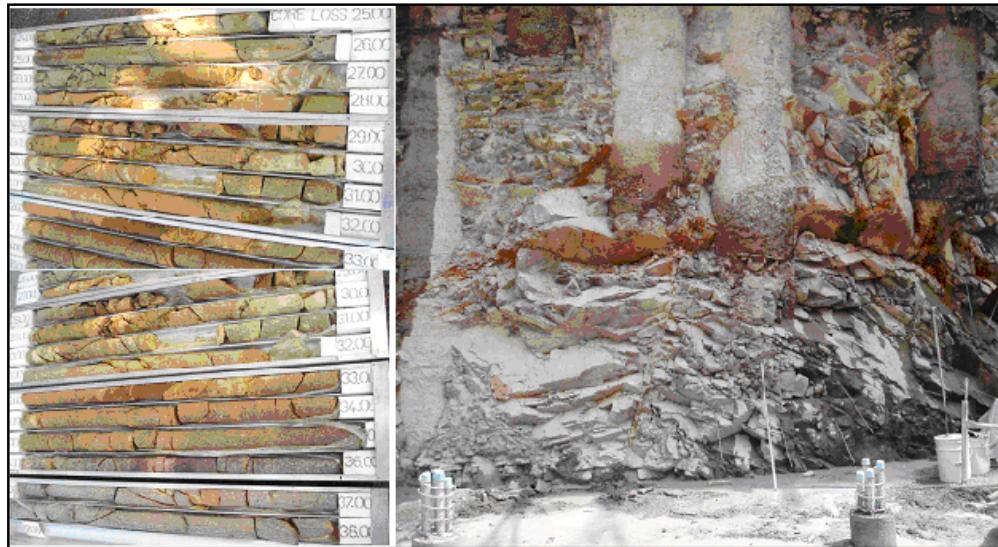
Field observations and geophysical surveys in several past projects show that due to the humid tropical condition in Singapore with high annual precipitation of more than 2 m per year, the thickness of the highly weathered soils typically ranges from 10 m to 30 m. For this particular site, the depth of soil weathered layers ranges from 20 m through 25 m (Figure 1). Figure 2 shows photos of a typical Jurong formation rock coring and the exposed face of a 30 m deep subway excavation about 5 km east of the test site.

**Fig. 2 Typical coring log and exposed excavation into Jurong Siltstone/Sandstone**
