Distribution of Residual Load and True Shaft Resistance for a Driven Instrumented Test Pile

Reply to Discussion

Sung-Ryul Kim¹, Sung-Gyo Chung¹, and Bengt H. Fellenius²,

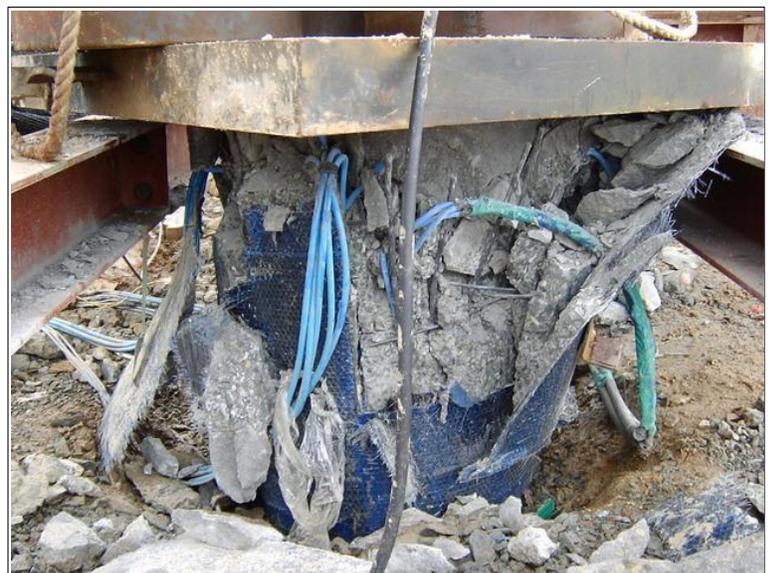
Fig. 1 The pile head immediately after the break

We are very pleased that the discussers have provided us with a reason to re-visit our paper. The back-calculated secant modulus relation of the Myeongji pile combined with the strain of $1,200 \mu\epsilon$ gives a calculated axial load of 5,700 kN for when the pile broke at a load of about 6,000+ kN. The 5,700 kN load corresponds to a stress of 32 MPa (over the $1,810 \text{ cm}^2$ cross section; the paper omitted to include the information that the wall of the Myeongji test pile was 30 mm thicker than that of the standard pile), well below the 80 MPa concrete cube strength and well below the axial strength of a standard pile. The primary reason for the break was the structural weakening of the concrete caused by the multitude of strain-gage cables in the pile wall, particularly where they were elbowed out of the pile shortly below the pile head. Figure 1 shows a photograph of the pile head after the collapse.
