338. Fellenius, B.H., 2014. Response to Load for Four Different Bored Piles. Proceedings of the DFI-EFFC International Conference on Piling and Deep Foundations, Stockholm, May 21-23, pp. 99 120.

RESPONSE TO LOAD FOR FOUR DIFFERENT BORED PILES

Bengt H. Fellenius¹⁾ and Mario Terceros H.²⁾

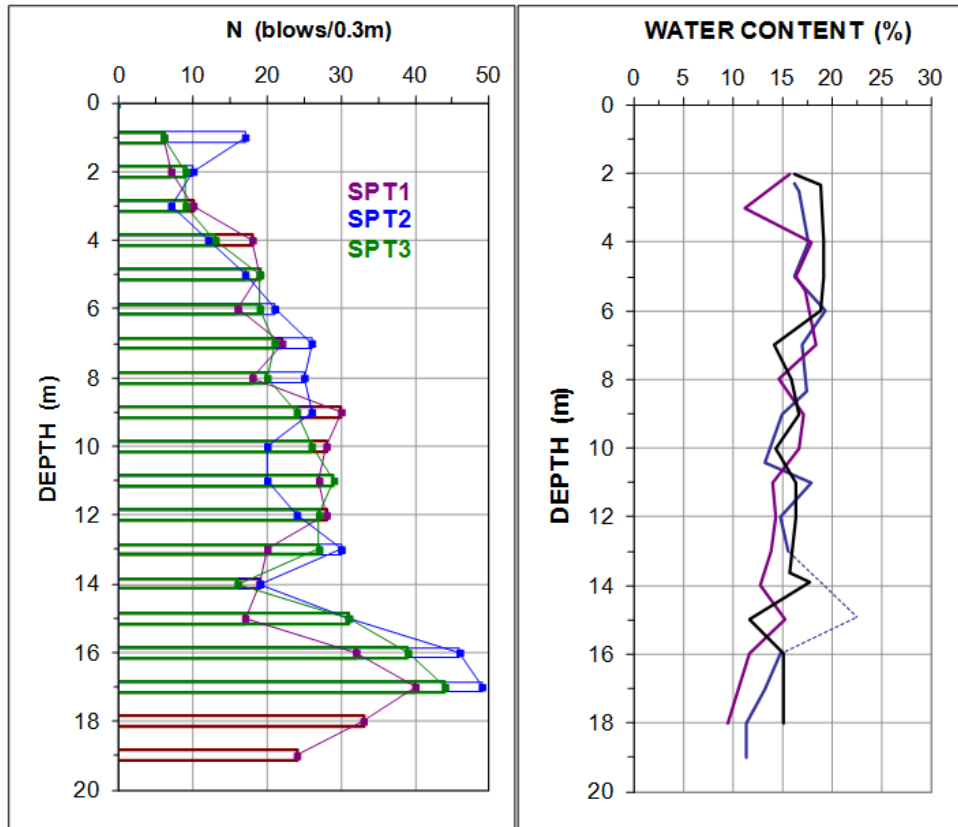
Figure 1 shows diagrams of the SPT N-indices and the distribution of water content in the three boreholes. The SPT-indices show the soil density to be compact. The average water content is about 15 %, plus-minus a few percent.

Fig. 1 SPT N-indices and Water Contents

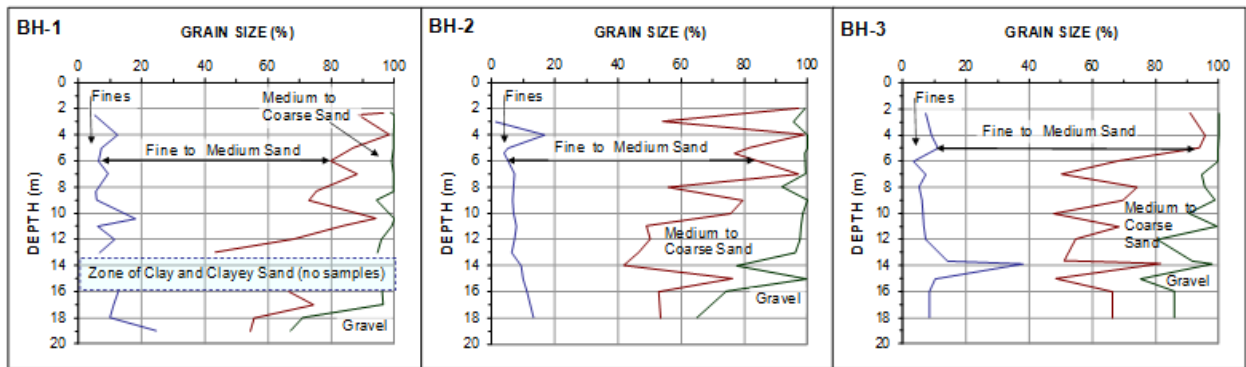
Figure 3 shows the grain size distributions obtained in the three boreholes, with the dominant fraction to be fine to medium sand with trace fines. Between 14 and 16 m depth, a zone of clay and clayey sand was encountered.

Fig. 3 Grain size distributions

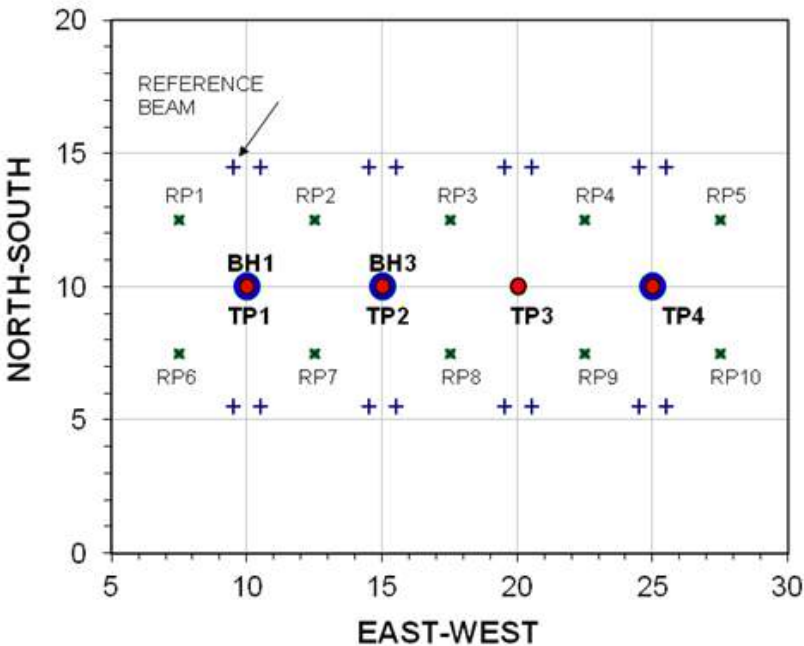
Boreholes and Test Piles in Plan

Figure 4 shows a plan of the borehole and test pile locations in plan and the locations of the reference beam supports and the reaction piles, RP1 through RP10.

Fig. 4 Plan view of the test site

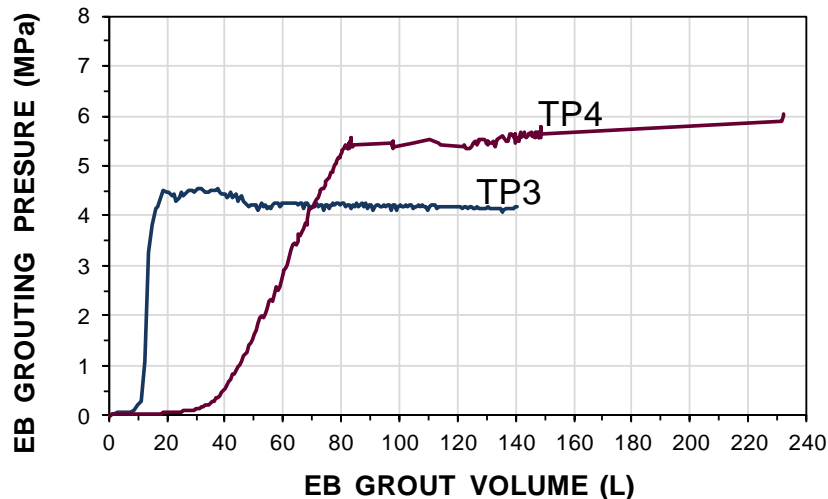
The EB units (Piles TP3 and TP4) were expanded using pressure grouting immediately after the pile had been concreted. To offset shortening of the height of the expander, which occurs during expansion, also the soil below the EB was pressure grouted. To further increase soil stiffness and strength, pressure grouting was implemented at the bottom of the EB. The expansion (inflation) significantly increases the earth stress against the EB. Figure 6 shows the EB grouting pressure and grout volume measured at the grouting pump during the expansion of the two EB units. The pressure-grouting curve of Pile TP3 shows a normal development for an EB in loose to compact soil. The EB in Pile TP4 required a slightly larger grouting pressure.

Fig. 6 Expander Body grout pressure and grout volume for Pile T3 and TP4

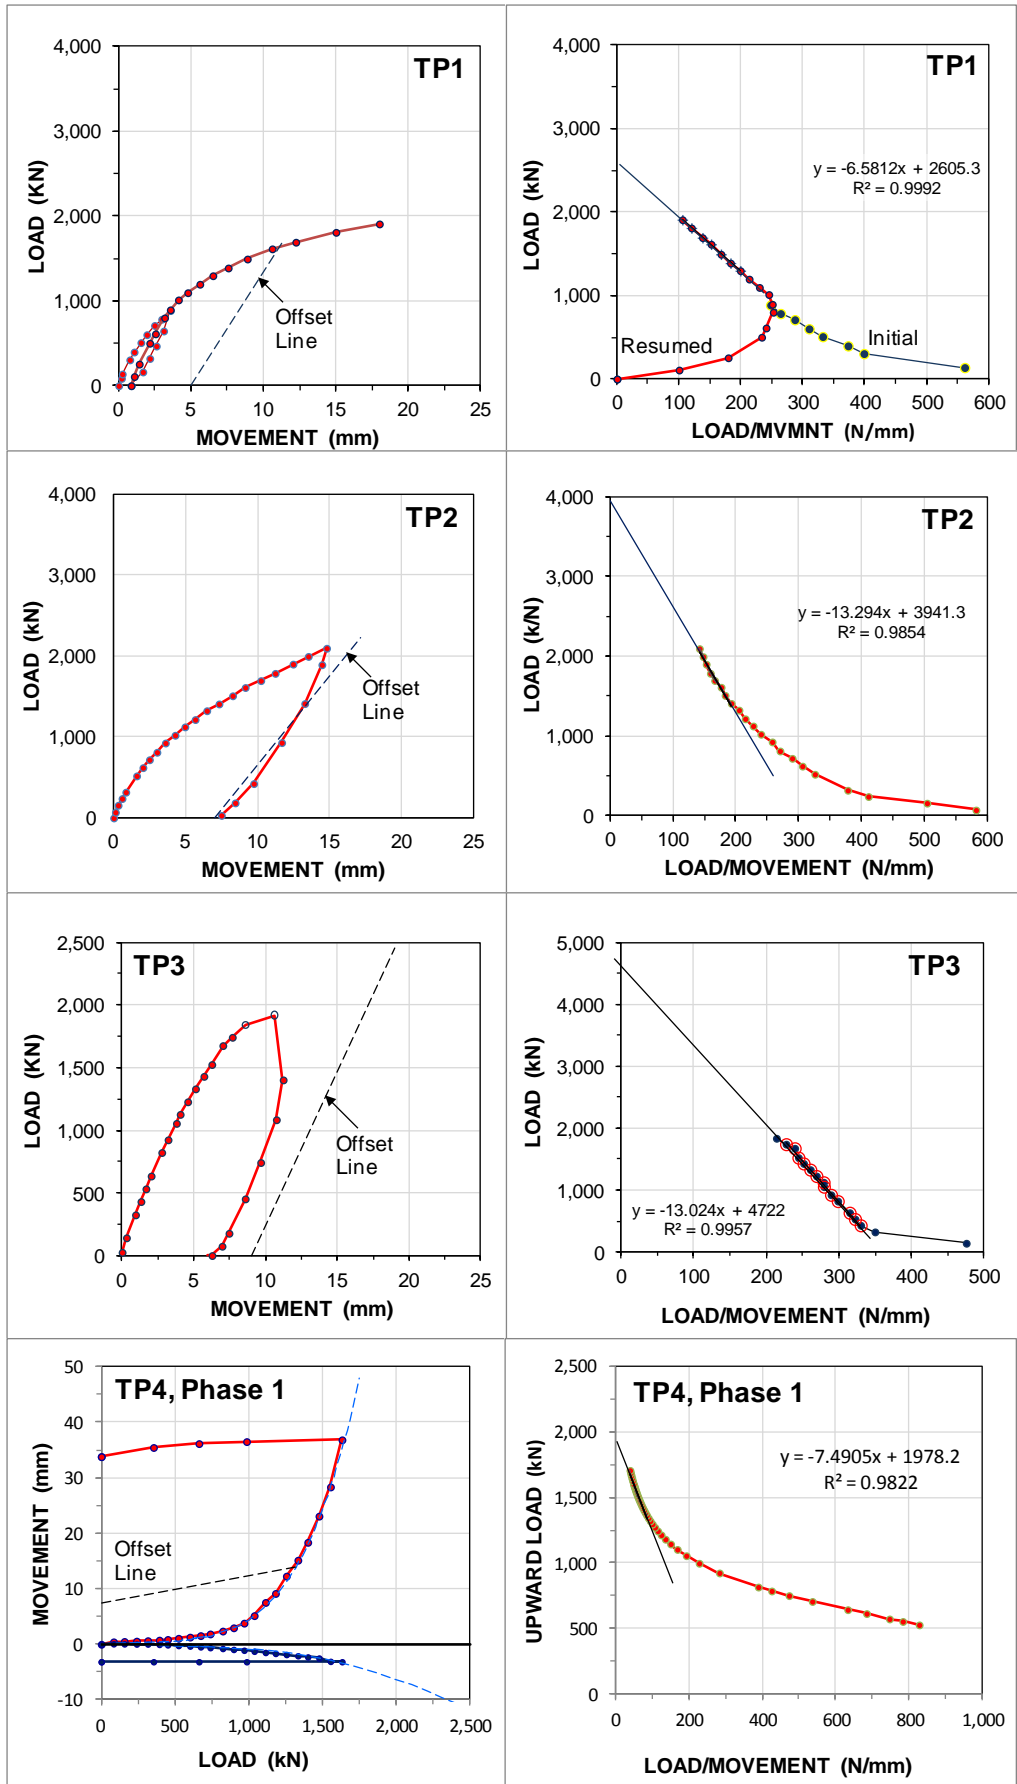
The static loading tests on Piles TP1 - TP3 were carried out as incremental maintained-load head-down tests with equal load increments of nominally 100 kN applied every 10 minutes. The loads were applied by means of a manometer-controlled hydraulic jack and the applied load to the pile was measured with a separate load cell. Pile TP4 was tested in three phases. Phase 1 was a bidirectional cell test with equal load increments of 75 kN applied every 9 minutes. Phase 2 was a subsequent head-down test with the cell open and draining and the test followed the same procedure as for Pile TP1 through TP4. Phase 3 was a repeat bidirectional cell test with equal load increments of 75 kN applied every 9 minutes. The load-movements recorded during the tests on Pile TP1 through TP3 and Pile TP4 Phase 1 are shown in Figure 8.

Fig. 8 TP1-TP4 Load-movement curves and Decourt constructions

Pile TP1. The TP1 test started on April 15, 2013, 38 days after construction. At the applied load of about 900 kN, a hydraulic hose between the pump and the jack sprung a leak and the pile had to be unloaded. After repair, the test was resumed. At the load of 1,908 kN, the pile broke at the ground surface and the test was terminated. The straight dashed line in Figure 9A is the offset limit line, which intersection with the pile head load-movement curve is generally considered to be a lower-bound value of the capacity of the pile, occurring for Pile TP1 at 1,700 kN. The Offset Limit Line was calculated using a pile modulus, E , of 25 GPa and the nominal cross section for the shaft and the pile toe—the pile toe diameter of the EB was used for Pile TP3. The diagram to the right of the load-movement diagram shows the construction of the pile capacity per the Decourt Extrapolation (Decourt 2008), which is the load that the load-movement curve, if continuing in a hyperbolic shape, would asymptotically approach at very large pile head movements. The Decourt extrapolated capacity for Pile TP1 is 2,600 kN). It is clear that the pile was approaching soil failure when it broke. The pile capacity can be considered to be about 2,000 kN.

It is interesting to see that, before the load applied in the resumed test had reached the previously applied load, the first part of the Decourt construction for the reloading records is very different from the construction using the initial loading records.

Pile TP2. The TP2 test started April 16, 36 days after construction. At the applied load of 2,100 kN, the hydraulic jack selected for the test reached its limit and the test had to be terminated. Extrapolation of the curve suggests that the curve would have intersected the Offset Limit Line at about 2,300 kN. The Decourt extrapolation indicates 3,900 kN. Had the test continued, it is probable that the capacity estimated from the load-movement curve would have been about 2,500 kN.

Pile TP3. The TP3 test started April 17, 34 days after construction. At the applied load of 1,800 kN, the pile head started showing cracks, the jack to tilt, and the pile head to deform. After two additional load increments, the pile broke right at the pile head. Extrapolation to an Offset Limit Load would be too uncertain to attempt. The Decourt construction indicates 4,700 kN.

Pile TP4 Phase 1. The TP4, Phase 1 test started April 17, 32 days after construction. When the cell load was 1,630 kN, the downward movement was 3 mm for the lower 2.5 m length of the pile (dominated by the 1.2 m long EB). The movement upward of the upper length was then 37 mm suggesting that the capacity of the upward length had been exceeded. The cell was then unloaded. There was no rebound of the lower length. After unloading, the opening between the cell plates was 37 mm. The upper cell plate rebounded (downward) 3.0 mm, which was twice the 1.3 mm maximum shortening of the pile. The offset limit construction for the upward length (shaft resistance only) intersected the curve at 1,300 kN. The Decourt extrapolation is 1,980 kN. The shaft capacity, is considered to be about 1,500 kN for the 15.0 mm long pile shaft above the cell. The response of the lower length with the EB is very stiff; the slope of the load-movement curve is 5 GN/m.

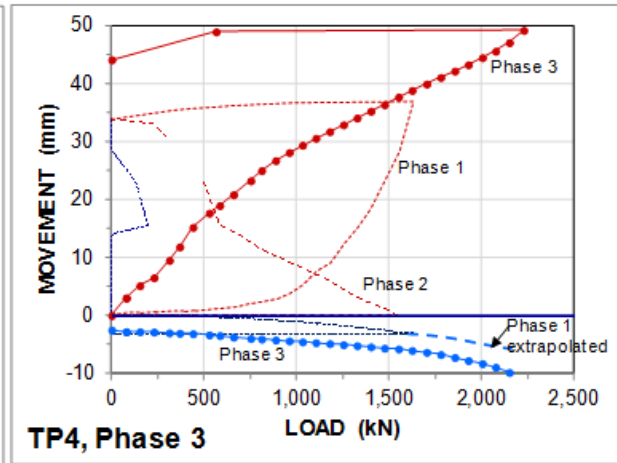
Pile TP4 Phase 3. Pile TP4 Phase 3 proceeded the day after Phase 2 and consisted of a resumed bidirectional cell test. Figure 9B shows the results. The upward load movement was similar to the Phase 2 response. At the movement equal to the maximum upward movement in Phase 1, the load applied in Phase 2 was the same as the maximum load applied in Phase 1, a repeat confirmation that direction of movement is of no consequence for the shaft shear resistance.

Fig. 9B Load-movement curve from Pile TP4 Phase 3

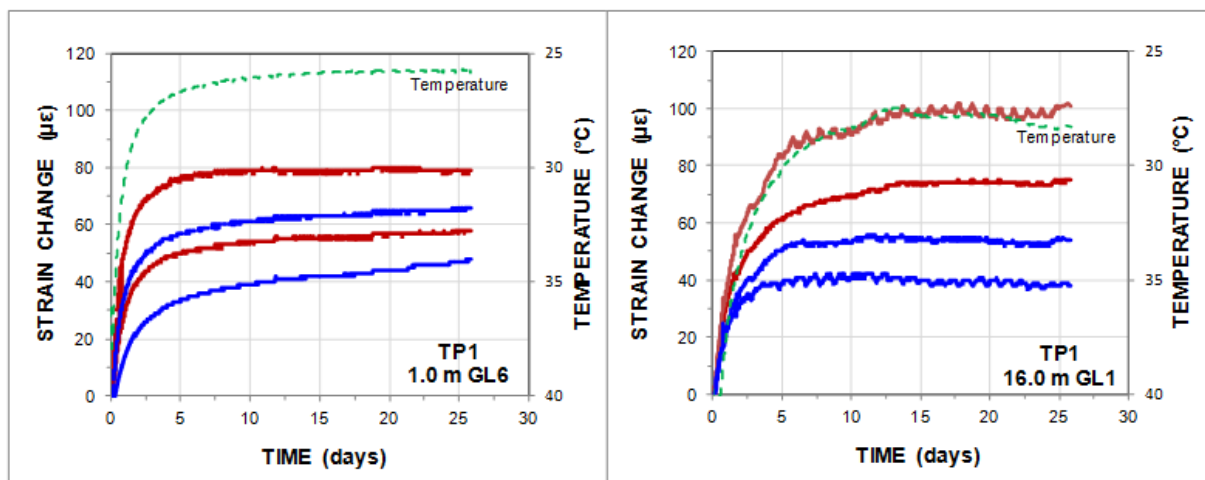
Fig. 11 Pile TP1 Change of strain in the two gage pairs at GL 6 and GL1 (1.0 m and 16.0 m depth) and temperature during the period between construction and start of the static loading test

The development of strain at the other gage levels in piles TP1 through TP3 was similar to that shown in Figure 11, that is, the strain in the pile increased proportionally to the temperature rise and ceased once the temperature had stabilized—within the first week after concrete was placed. The strain change is considered due to the difference in thermal response between the concrete and the steel. The thermal expansion of the concrete was smaller than that of the reinforcing steel, impeding its full expansion, which registered as an increase of compressive strain in the gages. (N.B., the gages themselves are insensitive to temperature changes). Such changes of strain are internal and do not affect forces between the pile and the soil. Therefore, it is concluded that the piles have only minimal residual load, if any. The strain gage readings at the start of the static loading tests were considered to be true zero values.

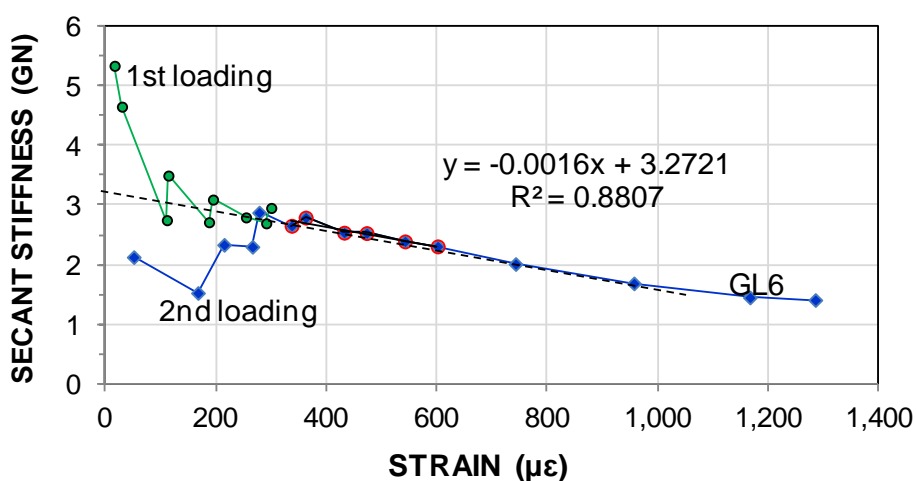
Figure 12 shows the secant stiffness versus strain in Pile TP1, a standard bored pile, for the uppermost gage level, GL6, located at 1.0 m depth. Linear regression of the secant stiffness vs. strain established the indicated secant stiffness of the pile. The correlation coefficient (0.8807) is somewhat low but acceptable. Figure 13 shows the incremental stiffness for the same gage level. The differentiation has accentuated the small errors and variations, the correlation is not good. The test was not carried far enough to make possible incremental stiffness evaluation for the other gage levels.

Fig. 12 Pile TP1 Secant stiffness for the uppermost gage level, GL6

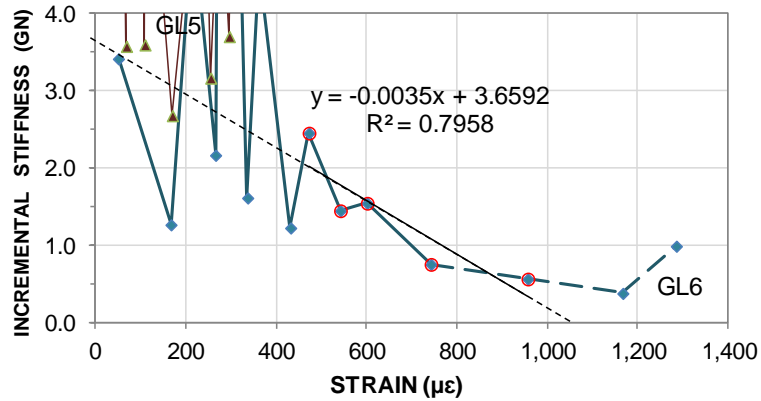
Fig. 13 Pile TP1 Incremental stiffness for the uppermost gage levels, GL6 and GL5

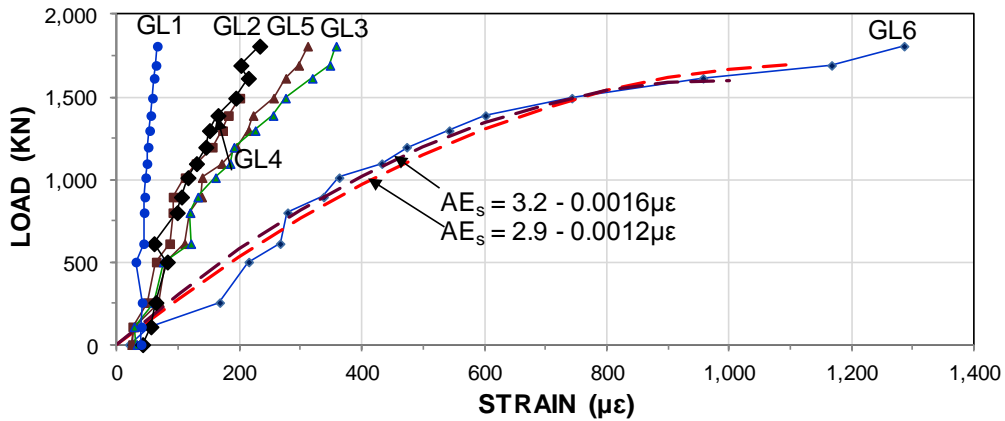
The relevance of the secant stiffness relation determined from the incremental stiffness method is shown in Figure 14 where the applied loads are plotted versus the measured strains for all six gage levels. There is a good agreement between the measured loads and the loads calculated from the strains using the secant stiffness relations.

Fig. 14 Pile TP1 Load-strain records

Figure 14 also indicates that Gage Level GL6 response was much softer (the slope is flatter) than the other gage levels. Moreover, the relation for Gage Level GL3 was a bit softer than that of Gage Levels GL5 and GL4. These difference in softness (slope) of the load-strain curve is a sign of differences in pile cross sectional areas between the gage levels.

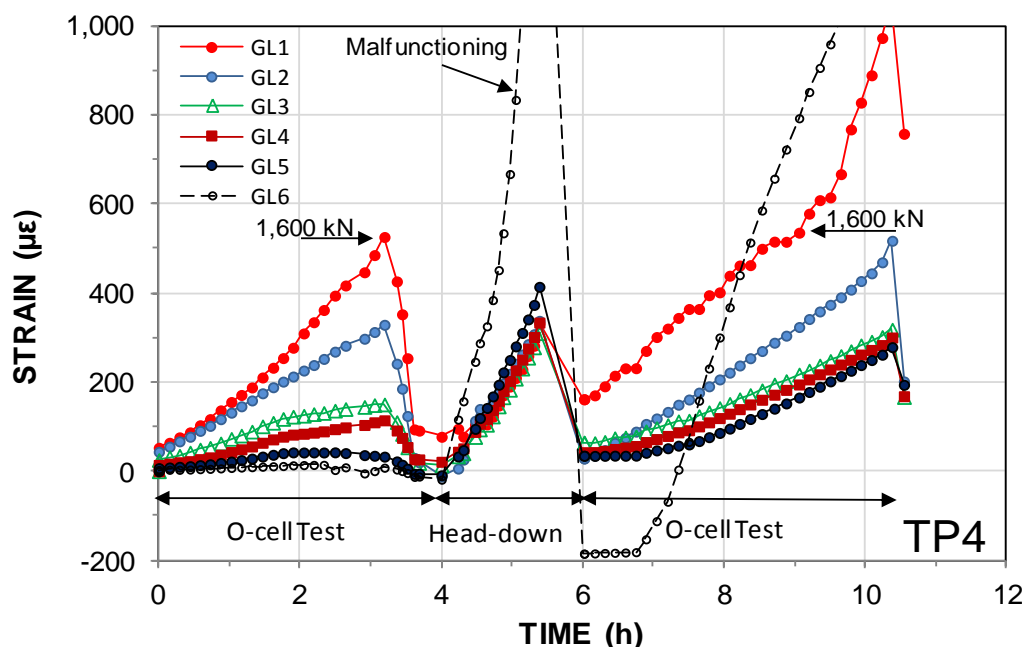
Figure 15 shows the strains measured in Pile TP4. Gage Level GL6 ceased to provide meaningful data at the end of Phase 1, but the other gage levels worked well throughout. At the end of the first bidirectional-cell test (Phase 1), no significant strain remained in gage levels GL2 through GL5 above the cell, as opposed to GL1, located below the cell and above the EB, where about 100 $\mu\epsilon$ of compression remained after the cell had been unloaded. During Phase 2, the head-down test, the cell was kept draining in the response to the downward movement of the shaft. That is, the cell recorded no load. It is therefore remarkable that gage level GL1 yet recorded strain. It would appear that the shaft resistance above the cell imposed loads and downward soil movement below the cell, conveying load onto the shaft between the cell and the EB. However, we believe that a more plausible reason is that during Phase 1 the surrounding sand and gravel entered the opening between the upward moving pile portion and the downward moving lower portion, due to it being drawn-in by the sucking action associated with the opening between the cell plates. This soil created an unknown amount of resistance to the Phase 2 closing of the opening, which resulted in the force measured in GL1 during Phase 2 test.

Fig. 15 Pile TP4 Strain versus time for Phases 1 through 3. GL6 malfunctions

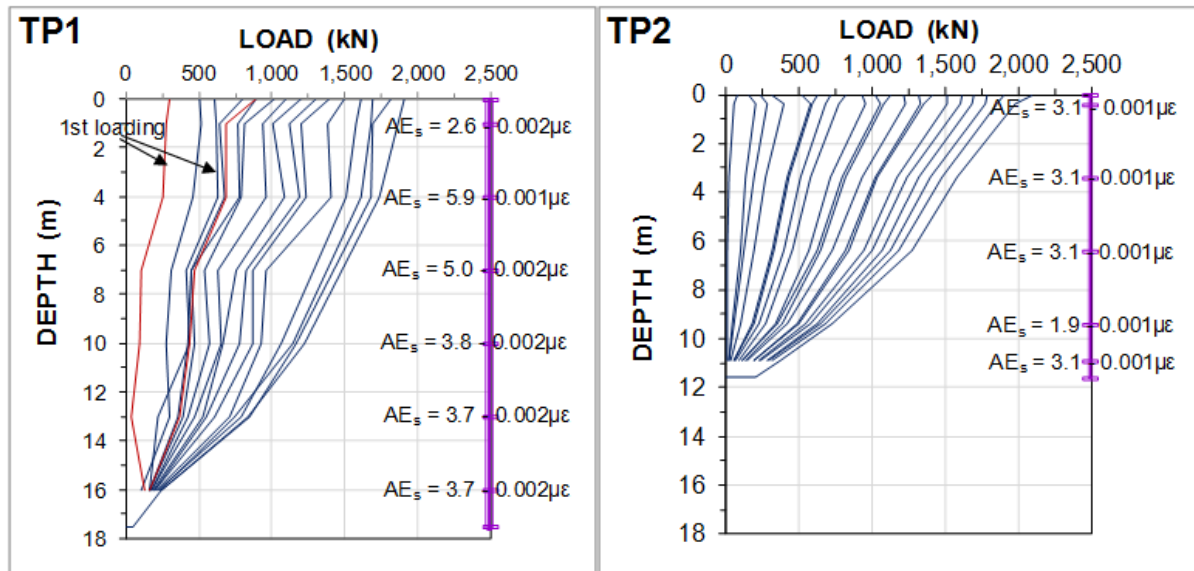
Test Piles TP1 - TP3. Figures 16 and 17 show the calculated load distributions for the head-down tests on Piles TP1 through TP3. The loads have been calculated using the secant stiffness relations indicated in the figures. The selection of stiffness relation for the gages that were not determined from the analyses were assumed to be the same as those that were found in the analysis of adjacent gage levels. However, when a calculated range of loads differed from what appeared to be reasonable

Fig. 16 Piles TP1 and TP2 Load distributions and applied stiffness relations

distribution, the value that gave a more reasonable distribution won out. It is obvious that for these test piles, the stiffness relations are very approximate. The main results was that they have provided a general even distribution from the pile head to the pile toe and assisted in determining the approximate toe response mobilized in the tests. The addition of the EB to Pile TP3 resulted in a significant increase of toe resistance.

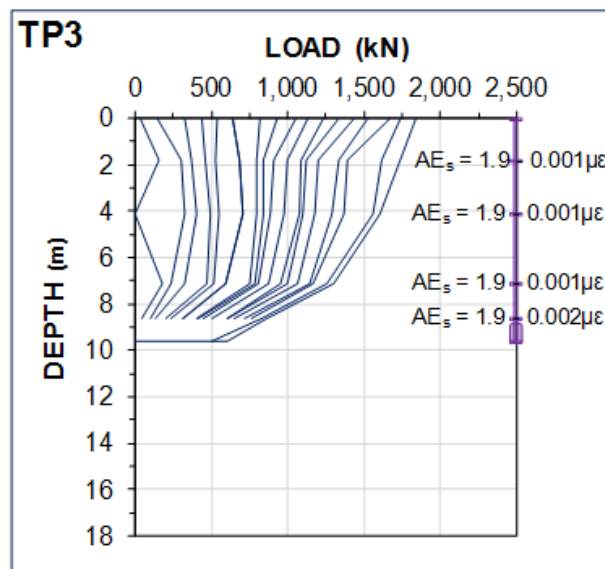
Fig. 17 Pile TP3 Load distribution and applied stiffness relations

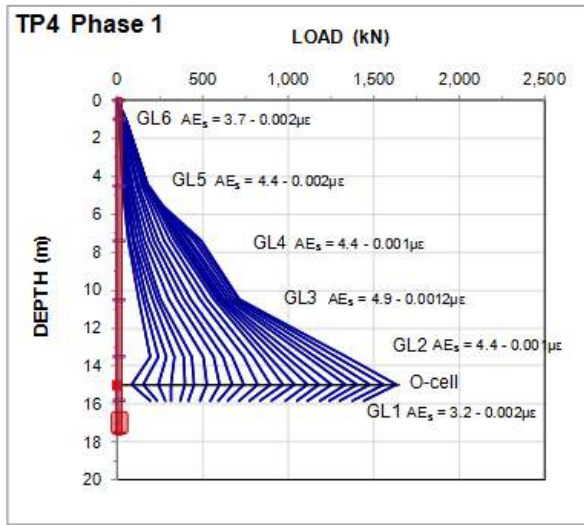
Test Pile TP4 Phase 1. Figure 18 shows the load distributions for the bidirectional-cell test, similarly calculated. Figure 19 shows the equivalent head-down load distributions which is constructed by "flipping" or mirroring the measured distributions to model the same loads and resistances for an equivalent head-down test. As indicated, the "flipped" distribution indicates a maximum load of about 3,300 kN for the same loads at the cell level and pile toe. Even if the pile had been constructed with a stronger material, it is not likely that a head-down test could have successfully loaded the pile to the large load indicated. N.B., the downward cell movement was a mere 3 mm in the test. Obviously, much additional resistance could have been mobilized by the EB.

Fig. 18 Pile TP4Phase 1 Load distribution and applied stiffness relations

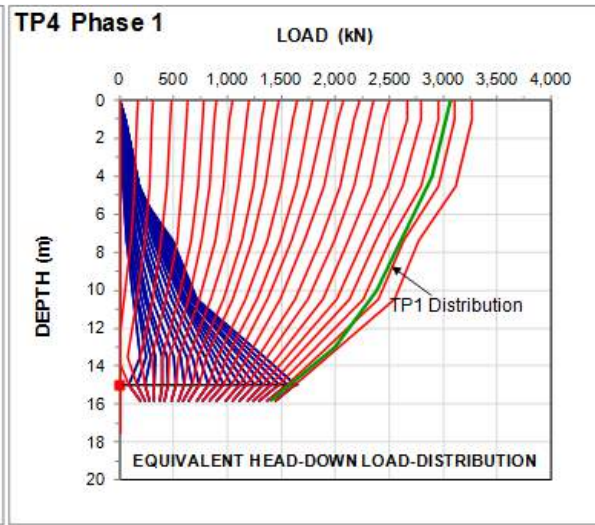
Fig. 19 Pile TP4 Phase 1 Equivalent head-down load distribution

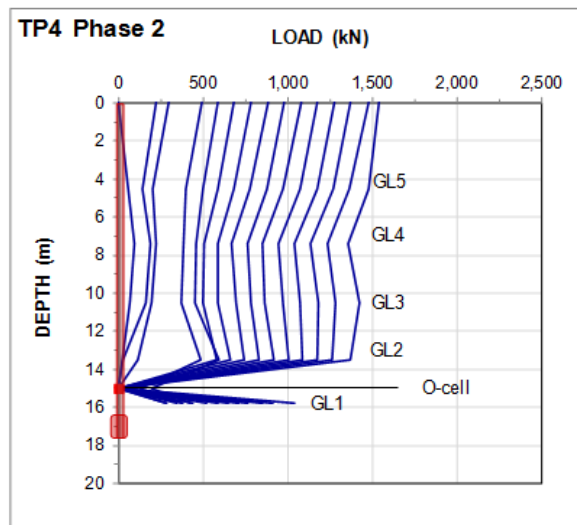
Test Pile TP4 Phase 2. Figure 20 shows the measured loads during Phase 2, the head-down test. As shown, Gage Level GL1, below the cell registered significant load, despite the fact that the cell was kept free-draining and unloaded. We believe that the surrounding soil (sand and gravel) was "sucked" into the opening between the cell plates in Phase 1. This soil then provided resistance to the Phase 2 closing of the opening. The load distribution data are not useful for soil analysis.

Fig. 20 Pile TP4 Phase 2 Load distribution

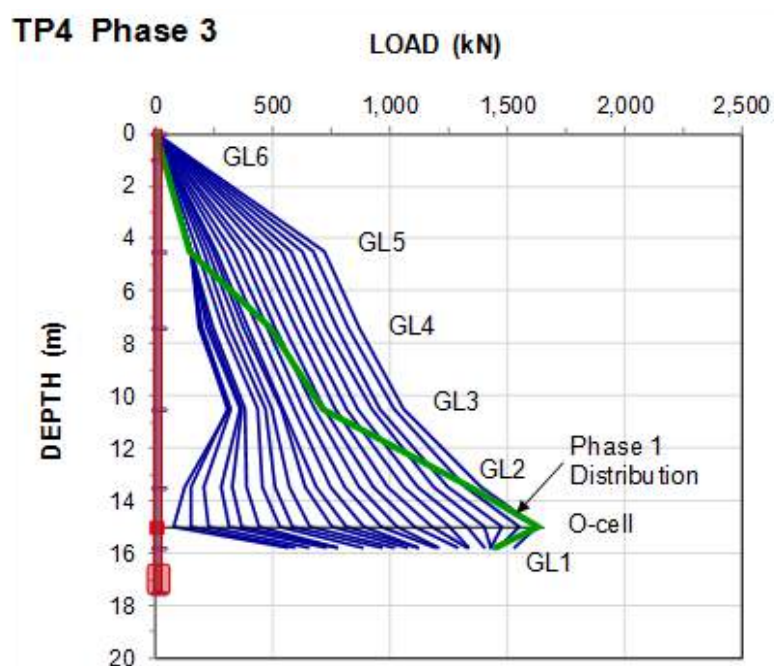
Test Pile TP4 Phase 3. Figure 21 shows the measured loads during Phase 3, the repeat bidirectional-cell test. The load distribution calculated for the maximum load in the Phase 1 test is added. The distributions for the maximum load above the cell in the two test phases are very different. The downward cell load and the EB response are quite similar, however. The soil response to the push-up, push-down, and push-up again appears to have resulted in a weakening of the soil layers above GL3 that was offset by a strengthening below GL3. At first glance, comparing the distributions at maximum load for Phases 1 and 2, it would seem as if Phase 1 would be affected by residual load that had been removed (released) from Phase 3. However, this begs the question, where are the strain changes that represent the removal? All load values are in reference to the same start ("zero") value. Possibly, the Phase 3 reloading caused a released of residual strain as the load was increased.

Fig. 21 Pile TP4 Phase 3 Load distribution

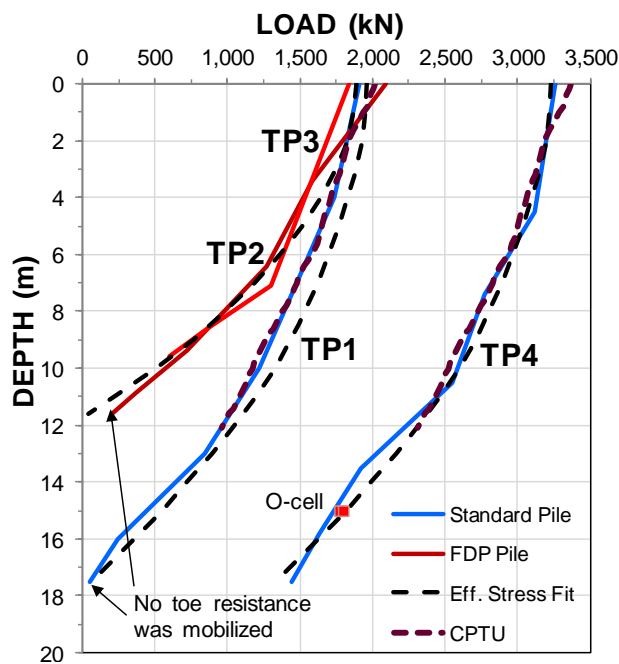
Figure 22 compiles the load distribution for the maximum applied load in the four tests showing that:

1. The standard piles, Piles TP1 and TP4, mobilized the shaft resistance equally.
2. The two FDP piles, Piles TP2 and TP3, showed very similar shaft response. Despite having a smaller diameter, the FDP piles mobilized more than twice as much shaft resistance (per unit length) as the standard pile.

3. The very similar measured shaft resistance distributions for Piles TP1 and TP4 and for Piles TP2 and TP3 were fitted to an effective stress analysis. The fitted distribution is shown by black dashed curves in the figure.

4. The CPTU records were used to calculate the shaft resistance distribution applying the Eslami-Fellenius CPTU-method (Eslami and Fellenius 1997) to the 12.5 m sounding depth. The CPTU-calculated distribution is shown by purple dashed curves in the figure. The agreement between the measured distributions and the CPTU-determined distribution is remarkable. However, it is probably also somewhat coincidental.

5. The addition of the EB to Pile TP4 added significant toe resistance to Pile TP4.
6. It is quite obvious from the overall test data that neither of tests on Piles TP1 through TP3 significantly engaged any toe resistance, EB or no EB.

Fig. 22 Compilations of the load distribution at maximum load

It is recognized that the loads obtained from the strain gage data and stiffness evaluations were approximate. However, the shaft resistance above 15.0 m depth was measured separately for Pile TP4 (Phase 1, the bidirectional-cell test). Therefore, the shaft resistance distribution of for Piles TP1 and TP4 is considered representative for the shaft response of the standard pile at the site.

The load distributions for Piles TP2 and TP3 also shown in the figure, are based on the same reasonable assumption that no appreciable load reached the pile toe in the tests in contrast to Pile TP4. For Pile TP4, the bidirectional cell provided a toe load of approximately 1,500 kN which resulted in only 3 mm of movement of the EB equipped pile toe.

The effective stress calculations for fitting a calculated load distribution (shaft resistance) to the measured distributions assumed one upper 10 m thick layer deposited on a lower, slightly denser layer. The input of soil density values and location of the groundwater table was taken from the soil profile of the site. For Piles TP1 and TP4, the fit was obtained with beta-coefficients of 0.5 and 0.6 for the upper layer and lower layers, respectively. For Piles TP2 and TP3, the fit was obtained applying a beta-coefficient of 0.5 at the upper boundary of the upper layer, increasing linearly to 1.4 at the lower boundary. In the lower layer, it was assumed to be 1.4.

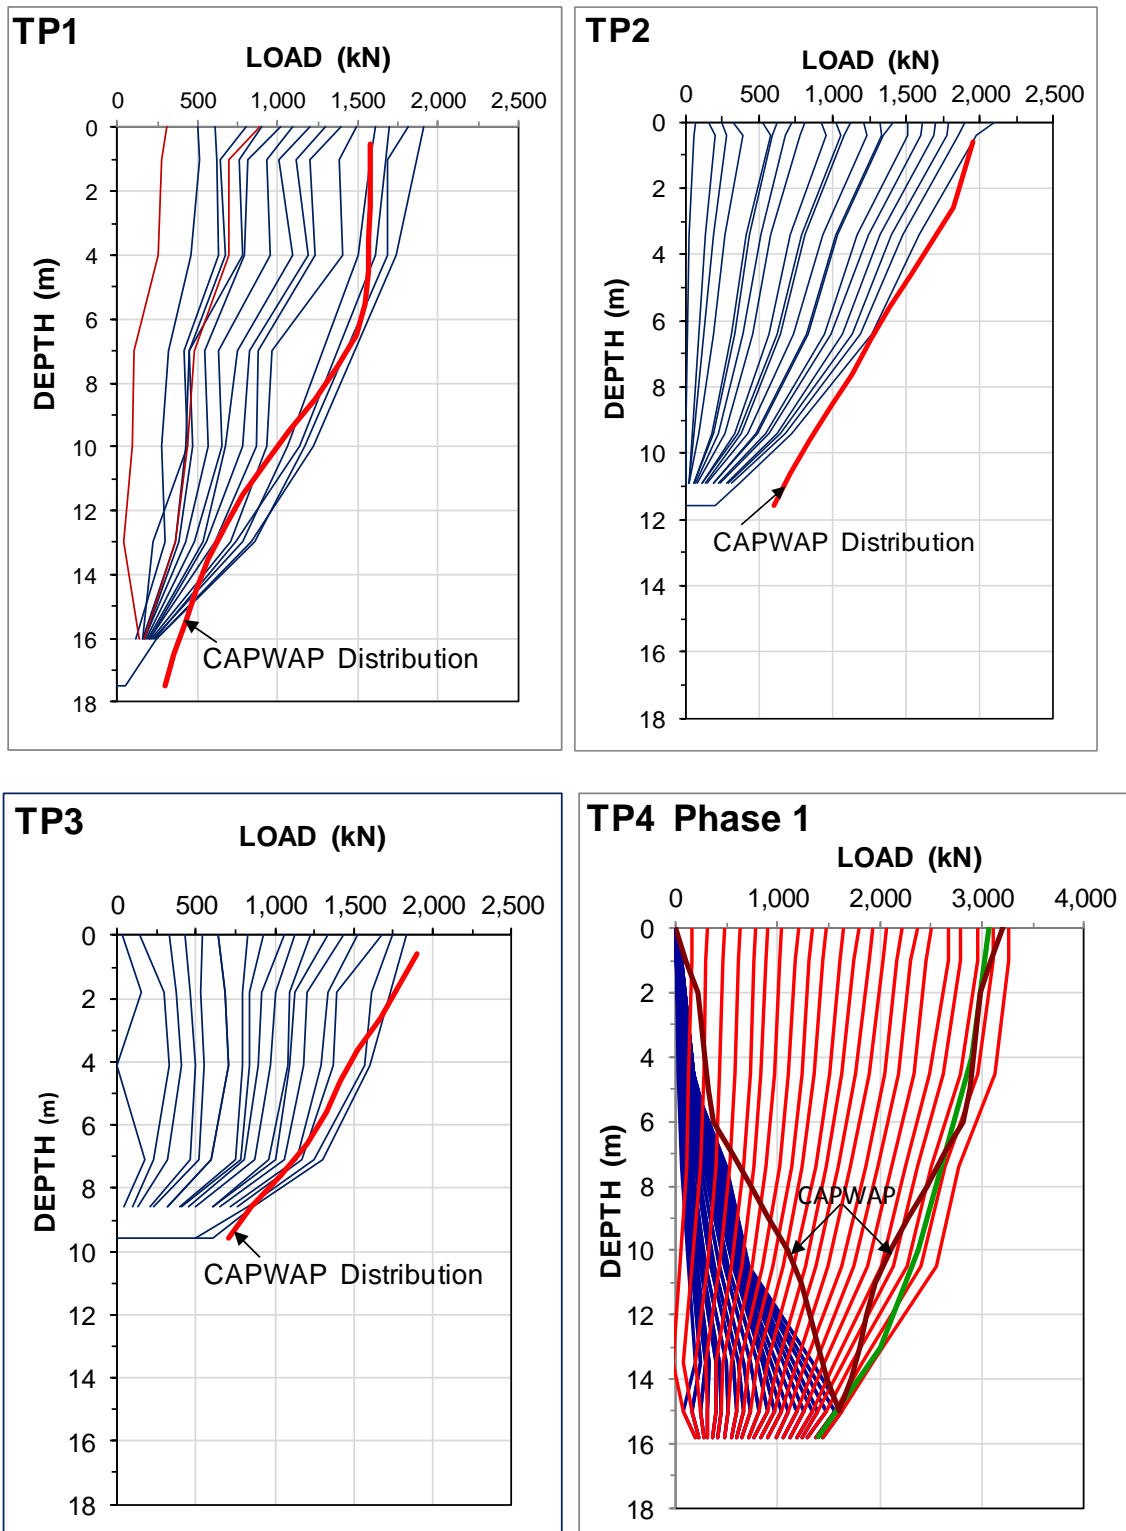
Three months after the static tests, all four piles were subjected to impacts from a 3,880-kg drop hammer. The driving was monitored with the Pile Driving Analyzer, PDA, and the records were analyzed using the CAPWAP software from GRL. The CAPWAP analysis produces, amongst other information, a static resistance and its distribution in the pile. Provided that the pile moves a sufficient distance for the blow and the net pile movement is at least about 3 mm/blow, then, the CAPWAP-determined resistance is considered similar to the pile capacity and used as such in design. If the net movement is smaller, the maximum resistance evaluated by the CAPWAP analysis is usually smaller than the pile capacity and the resistance distribution often less precise. Table 2 compiles the data for the four test piles. For all four piles, the net movement was smaller than the ideal value. Therefore, the calculated shaft resistance in the lower portion of the pile and the toe resistance was probably smaller than the actual resistance, i.e., the CAPWAP-determined capacity was smaller than the actual. Figure 23 shows the CAPWAP-determined load distributions.

Fig. 23 The CAPWAP-determined static load distributions compared to the distributions evaluated in the static loading tests. The TP4 diagram includes both the upward distributions and the equivalent head-down distributions.

The toe resistance showed for Pile TP4 originated from viscous resistance in the water in between the bidirectional-cell plates could not be squeezed out fast enough through 15 m long , 6-mm hose connecting the void inside the cell to the ground surface to the activating hydraulics (now removed).

Coincidentally, the maximum load applied to Pile TP1, TP2, and TP3 was about the same as the maximum CAPWAP-determined resistances in the dynamic tests. More important, the slope of the load distributions for the two types of tests was reasonably similar considering the uncertainties of the loads determined from the strain gage records and the fact that the resistances were not fully mobilized in the dynamic tests on Pile TP1, TP2, and TP3. The CAPWAP-determined load distribution for Pile TP4 is plotted shaft resistance and as resistance rising from the cell load. The TP4 maximum shaft resistance is considered to represent the ultimate resistance for both test types.

If the TP4 distributions are taken at face value, the static Phase 1 distribution suggests presence of residual load, which was more or less removed in the Phase 4 test, causing the CAPWAP-determined distribution to be closer to the actual shaft resistance. That is, the difference between the two distributions could be due to the residual load. However, this is hypothetical only and the difference could also be due to the uncertainties of both measurements.

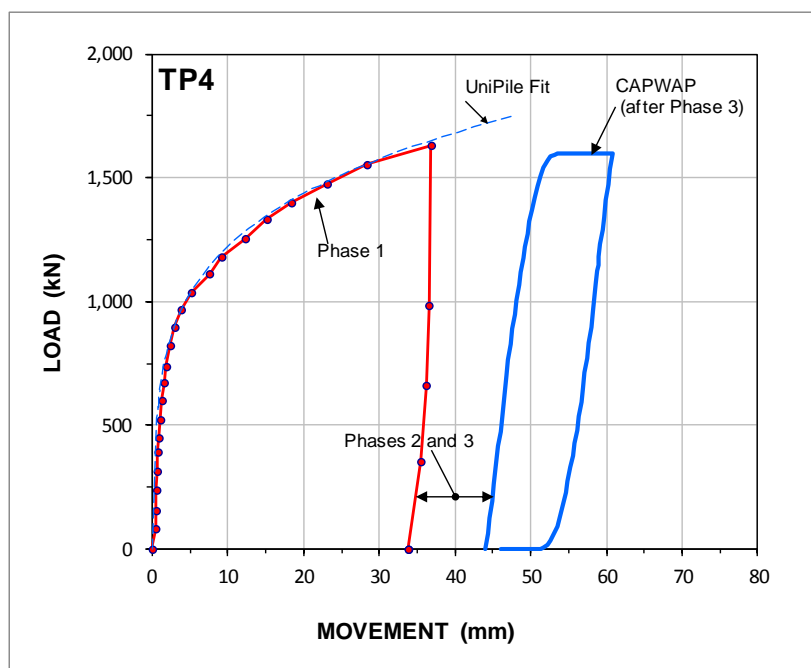
The static loading test on Pile TP4, mobilized the shaft resistance of the length above the bidirectional-cell test. Figure 24 shows the load-movement curve of the upward portion of the cell test plotted as load vs. movement. The CAPWAP-determined shaft resistance has been added to the diagram starting from the total movement at the end of Phase 3. The important point is that the CAPWAP-determined shaft capacity agrees with that found in the static loading test. The stiffer response of the CAPWAP curve for the latter half of the test, as opposed to the static test curve, could be an effect of the reloading condition.

Fig. 24 Shaft resistance load-movement curve from the static loading test on Pile TP4 and that determined in the CAPWAP analysis
