381. Amir, J.M. and Fellenius, B.H., 2017. Comments on the B.E.S.T. intentional defects and anomalies. Proceedings of the 3rd Bolivian International Conference on Deep Foundations, Santa Cruz de la Sierra, Bolivia, April 27-29, Vol. 3, pp. 39-43.

Comments on the B.E.S.T. intentional defects and anomalies

Amir, J.M.⁽¹⁾ and Fellenius, B.H.⁽²⁾

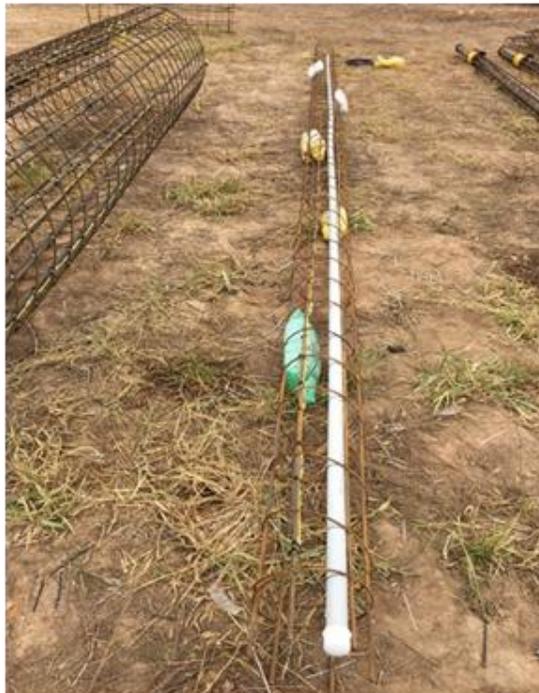
Fig. 1. Installed defects in Pile CFA450-1.

Figure 1 shows the location of the "flaw-bags" as placed in Pile CFA450-1, a 450-mm diameter CFA pile.

Nine piles were prepared with intentional flaws: Piles F3, DC1200-1, DC620-1, DC620-2, DC620-3, CFA450-1, CFA450-2, FDP450-1, and FDP360-1. Unfortunately, instructions to the field staff on how to prepare the flawed piles was let to the field staff's own devices. They elected to produce the intentional flaws by tying multiple sand-filled bags with dimensions of about 200 x 100 mm—about 12 % of the pile cross section—to each reinforcing cage at different depths before inserting it into the hole or casing. This, obviously, is an impossible testing situation. The cross section of the "flaw-bags " is notably smaller than the accepted detection threshold of the integrity testing equipment (notwithstanding that the uppermost bag was clearly detected as a flaw by the single-hole ultrasonic method—the rest were invisible). For a series of flaws down a pile, the deeper-located flaws can only be assuredly detected if they are larger than those above—all bags were about equal size, however—and limited in number. The intentional flaws, as prepared, had neither relevance to the testing methods nor to being representative for flaws in actual piles.
