Fellenius, B.H., Terceros, M.H., Terceros, M.A., Massarsch, K.R., and Mandolino, A., 2019. Static response of a simultaneous bidirectional test on a group of 13 piles Proceedings of the 16th Pan-American Conference on Soil Mechanics and Geotechnical Engineering, PCSMGE, November 17-19, Cancun, pp. 1214-1221.

# Static Response of a Group of 13 Piles Tested Simultaneously

**Keywords.** Pile group, static loading test, bidirectional test, expander body.

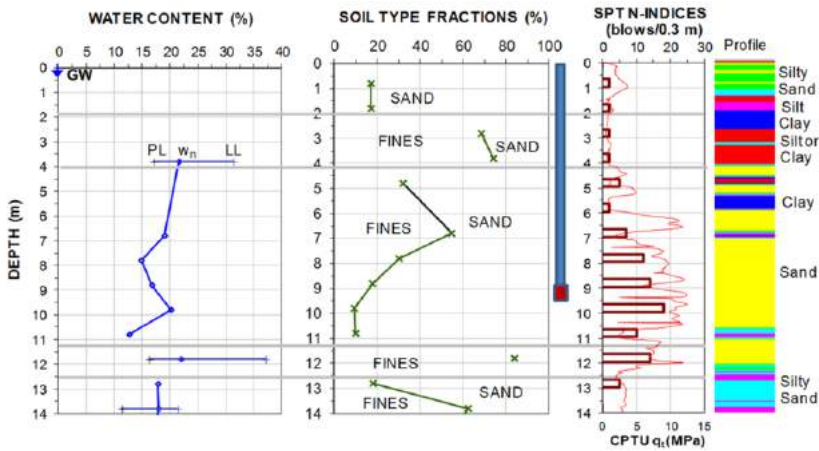
Figure 1. Soil profile from BH-E2.

pressure. Figure 1 shows a diagram compiling borehole information, SPT  $N$ -indices, and the CPTU cone stress,  $q_t$ , to 14 m depth. The CPTU was pushed to 22 m depth and Figure 2 shows all the results.

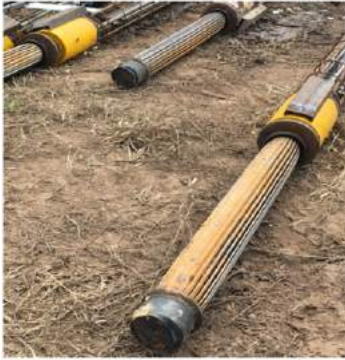
Figure 3. Photo of the EBs and BD before pile construction.

The Expander Body and its use is described by Terceros and Massarsch (2014). Figure 3 shows a photo of the Expander Body and BD (Yellow unit) before insertion into the pile shaft. The BD is connected to the pile reinforcement cage. The location of the separation of the BD and cage from the EBI was designed to occur at the bottom of the BD.

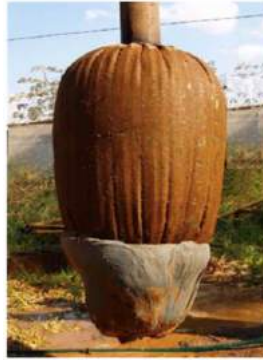
Figure 4. Exhumed EB.

Figures 4 and 5 show photos of an exhumed EBI and one expanded in air (model IDs EBI612 and EBI815, respectively, with the numbers indicating the diameter of a freely expanded unit. Figure 4 shows a photo of an exhumed EBI (EBI612) with post-expansion grout material and an in-air expanded EBI (EBI815). The grout volumes and injection pressures used for the expansion of the EBIs of the 14 test piles were very similar for the piles. The averages were 102 L and 4.0 MPa, respectively.

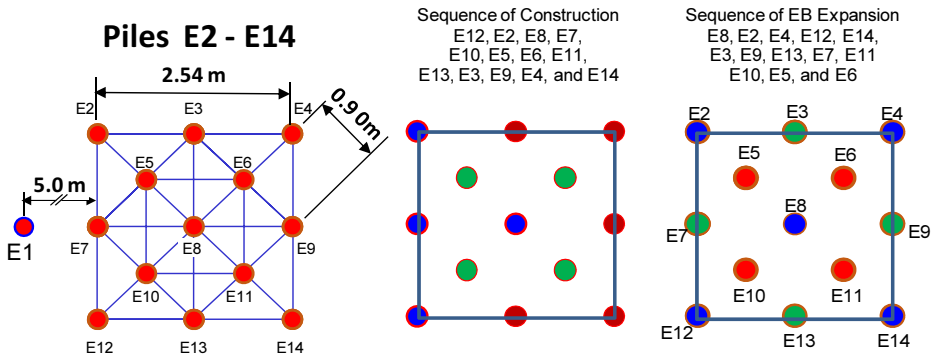
Figure 6. Pile locations and sequence of construction and EB expansion.

The piles were installed at a 3 pile-shaft diameter, center-to-center spacing, 0.90 m in the configuration shown in Figure 6. The spacing corresponds to an 11 % total footprint ratio (nominal total pile area over group footprint area excluding the EBI area).

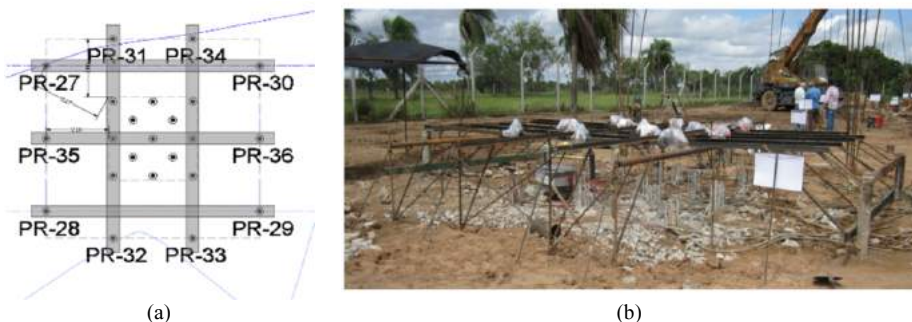
**Figure 7.** (a) General arrangement of at the test, showing reaction piles and beams; (b) Frame for recording pile movements Phase 1 test on Piles E2 - E14.

Static loading tests were performed on the piles—the single pile and group piles—by engaging the BD cell to push the pile shaft upward with the EB providing the necessary reaction force. The BD cells in the group piles were connected to the same pump to have all group piles, Piles E2 - E14, activated with equal load per pile. The pile heads were unrestrained and the pile head movements were measured individually. Figure 7.a shows the general arrangement with beams and reaction piles locations and Figure 7.b shows a photo of the arrangement for recording the individual movements of the piles. The measurements included monitoring the ground surface movements at 10 points along the perimeter and in the interior area of the group.

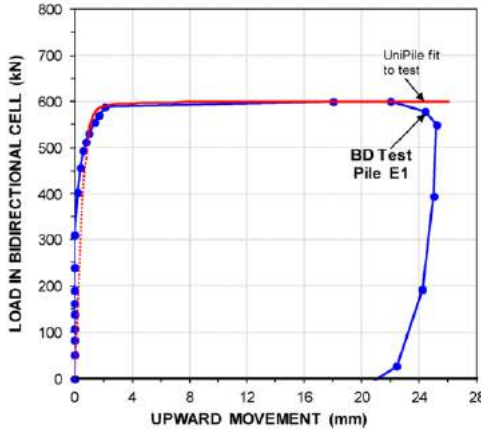
Figure 8. Pile E1 Upward load-movement of the pile length above the BD.

Figure 8 shows the measured load-movement of the upper pile length, plotted in accordance with the reporting convention of bidirectional testing as load vs. movement. The pile response to the applied BD load was quite stiff with very small movement up to 500 kN applied load at about 1 mm movement, which indicates the presence of residual compression force in the pile at the start of the test. Beyond 600 kN load and 2 mm movement, the response went into plunging. The figure also shows the result of a fit to the measured curve per an effective stress analysis and a hyperbolic t-z function with a function coefficient of 0.0099 (1/Q<sub>100%</sub>). The effective stress proportionality beta-coefficient, as applied to 1.0 m pile elements, ranged from  $\beta = 0.4$  at the ground surface to  $\beta = 2.0$  at 6 m depth, which value was then kept to the BD depth. The UniPile5 software (Goudreault and Fellenius 2014) was used to back-calculate the pile response.

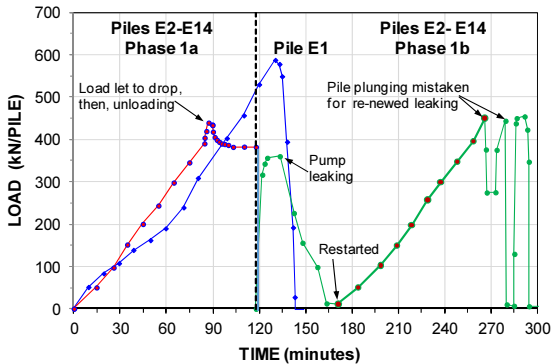
Figure 9. Loading sequence for Pile E1 and Piles E2 - E14.

**PILES E2 - E14.** The static loading test on the pile group, Piles E2 - E14 started on April 25, 2017, applying the same schedule of loading as used for the single pile test, Phase 1a. Nine load increments into the test, it was realized that the data collector was not recording properly and this triggered an unloading of the test to restart with a functioning collector. Unfortunately, on reaching zero BD load, the cells were let to drain further, which allowed the remaining force in the pile to move the upper BD plate against zero force. The test was then restarted three days later from zero BD load and with zeroing of all gages. Figure 9 shows the load/pile versus time applied. The load-movement measured for Pile E1 is included. Shortly after re-starting the test, it was found that the pump had sprung a leak preventing it from maintaining pressure. The BDs were then unloaded to almost zero pressure, whereupon they were locked from further release of hydraulic pressure and the pump was repaired. The re-loading was performed with the same reference of load and movements as at the start of Phase 1b.

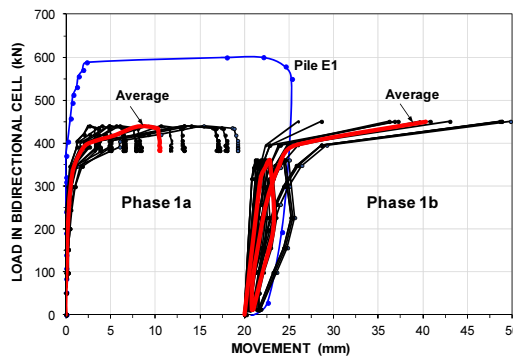
Figure 10. Pile E1 and Piles E2 - E14. Pile head upward load-movements.

Figure 10 shows the Piles E2 - E14 load-movements. The response of the 13 piles was very similar to that of the single pile: initially quite stiff and plunging after just a few millimetre of movement. However, the plunging load per pile was only about 70 % of the plunging load measured for Pile E1—430 kN versus 600 kN.

The test on the single pile, Pile E1, showed plunging response at 600 kN. If we assume that each of the eight perimeter piles provided the same plunging resistance (600 kN) as the single pile and that the total load consisted of the pile resistance and the weight of the soil in-between the piles ( $\approx 700$  kN), i.e.,  $13 \cdot 430 - 700 = 4,890$  kN, then, each of the eight would have carried  $4,890 \text{ kN} / 8 = 610$  kN and no contribution would have been needed from the interior piles. It would seem that the interior piles did not experience any soil resistance.

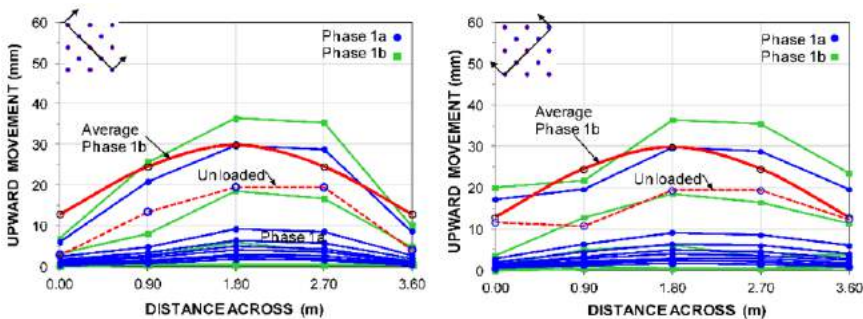
Figure 11. Upward movement of the pile heads along the diagonals, Phases 1a and 1b.

Figure 11 shows the upward movement of all pile heads across the two diagonals, including the net movements after Phase 1b unloading. Both graphs include the average of all pile head movements measured in Phase 1b for the maximum load, i.e., average of four piles, but for the center pile. The measurements showed that the center pile moved about three times more than the perimeter pile.

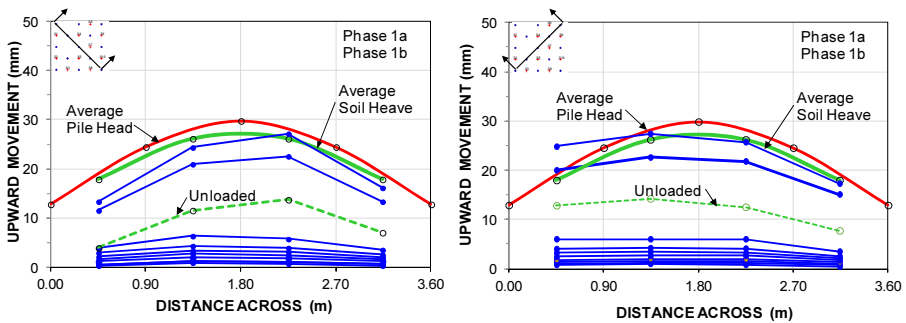
Figure 12. Upward movement of the ground surface within the pile group. Phase 1b.

Figure 12 shows the ground-surface upward movements across the diagonals (including net movements after Phase 1b unloading) and average (at maximum load) ground surface heave, as measured in ten anchors for Phase 1b. The figures repeat the average (at maximum load) upward movement of the pile heads (c.f., Figure 11). The "zero" measurement is the start of the Phase 1b, the net effect of Phase 1a is not known. It would seem that the pile heads moved a bit more than the soil surface. However, this is misleading because the pile head movements in Phase 1a in unloading were not recorded and, as mentioned, the Phase 1a ground surface measurements were not collected by the data collector. That is, the movements of the pile heads and the ground surface at the start of Phase 1b are unknown. The trend of the ground surface movements and that of the pile heads are the similar. In unloading after Phase 1b maximum load, the unloading movements were about the same for the pile head and the ground surface. It would seem that the pile head and ground surface moved more or less in unison.

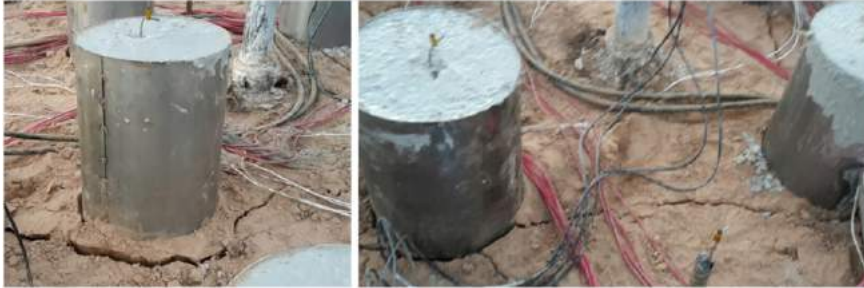
Figure 13 and 14 are photographs of piles and ground taken after Phase 1b unloading and show cracks in the ground surface around a corner pile and from pile to pile along the perimeter of the group. The observations suggest that the pile group moved in unison encompassing piles and in-between soil.

**Figure 13.** Photographs of cracks in ground surface at a corner pile and at two side piles.

loading. This was supported by the appearance of cracks around the pile group indicating that soil and piles had moved more or less in unison.

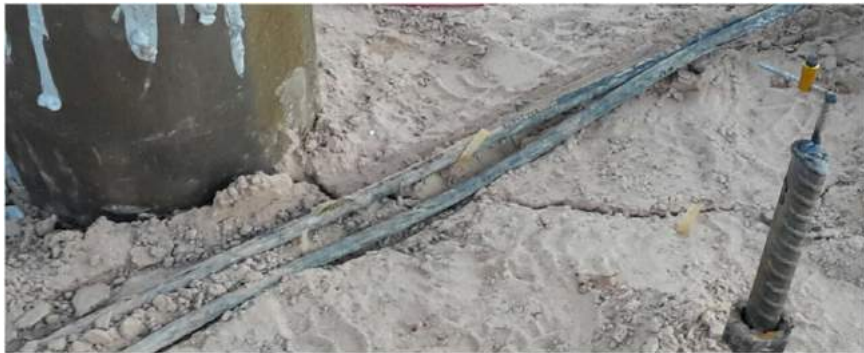
**Figure 14.** Photographs of cracks in ground surface stretching from one pile toward the next along the side of the group.
