Kania, J.K., Sorensen, K.K., and Fellenius, B.H., 2020. Driven piles installed in soft soils subjected to vertical and lateral soil movement. Canadian Geotechnical Society, Annual Geotechnical Conference, GeoVirtual2020, Calgary, September 14-16, 9 p.

Driven piles installed in soft soils subjected to vertical and lateral soil movement.

Jakub G. Kania
cp test a/s, Vejle, Denmark
Kenny Kataoka Sørensen
Department of Engineering - Aarhus University, Aarhus, Denmark
Bengt H. Fellenius
Consulting Engineer, Sidney, BC, Canada

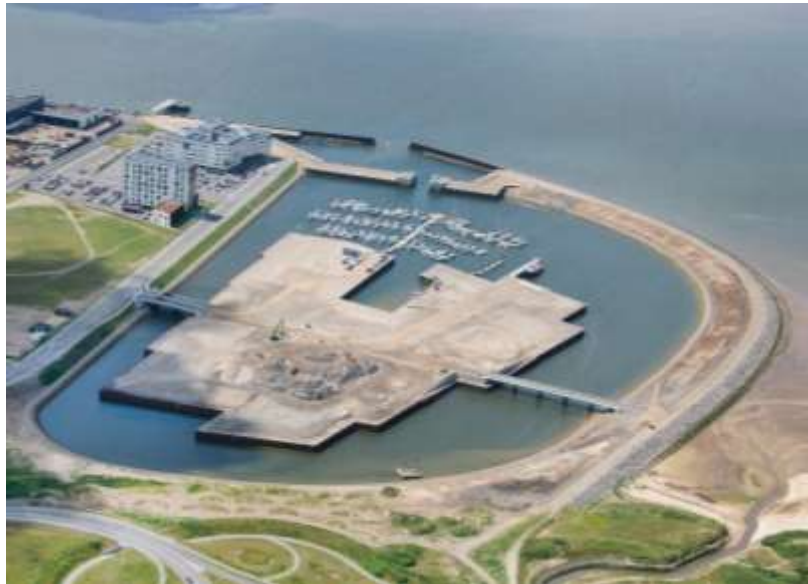
TEST SETUP

PHASE 2

Ground monitoring system:

- Piezometers
- Magnetic extensometers
- Standpipe

Pile instrumentation:

- DFOS (2 lines)
- VWSG (1 line)

Lateral soil movement

- Unplanned one-sided loading

Vertical soil movement

- 3m high fill

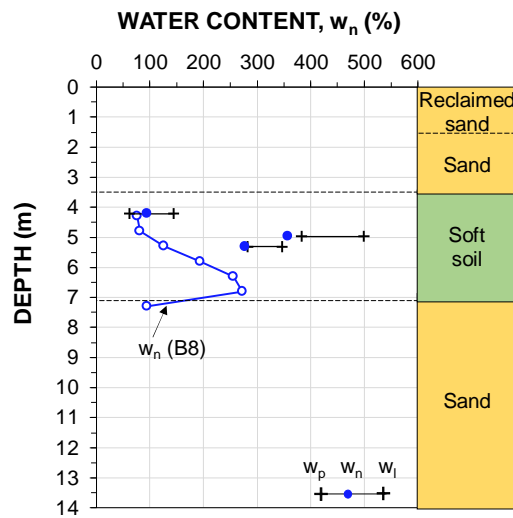
Figure 1. Soil profile, atterberg limits (soil samples collected in connection to the installation of in-situ monitoring equipment for the test setup on January 16-18, 2018) and distribution of water content (soil boring B8 performed on October 15, 2008)

The soil profile, distribution of water content in the soft soil layer, and Atterberg limits are presented in Figure 1. The water content of the soft soil layer ranged from about 77 % to about 273 % with an average of 158 %. The plastic limit, w_p , ranged from 63 % to 383 % and the liquid limit, w_l , ranged from 145 % to 499 %. An average measured unit density of the soft soil layer was about 1,200 kg/m³.

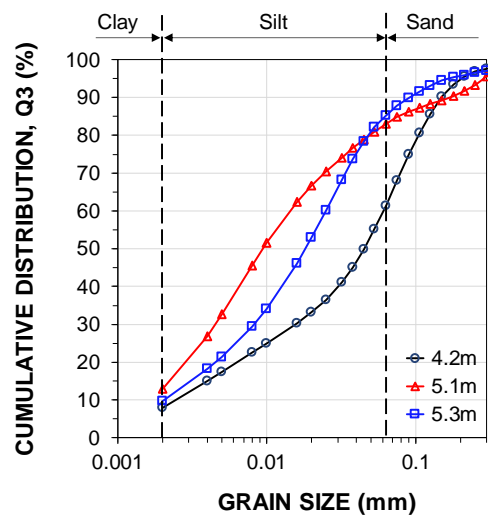
Figure 2. Grain size distribution by laser diffraction performed on soil samples collected in connection to the installation of in-situ monitoring equipment (data from Savery 2019).

The grain size distribution, presented in Figure 2, shows the dominant particle size, on average, to be 69 % silt size, 11 % clay size, and 20 % sand size. The organic content in the soft soil layer ranged from 12.9 to 91.4 % with an average of 56 %.

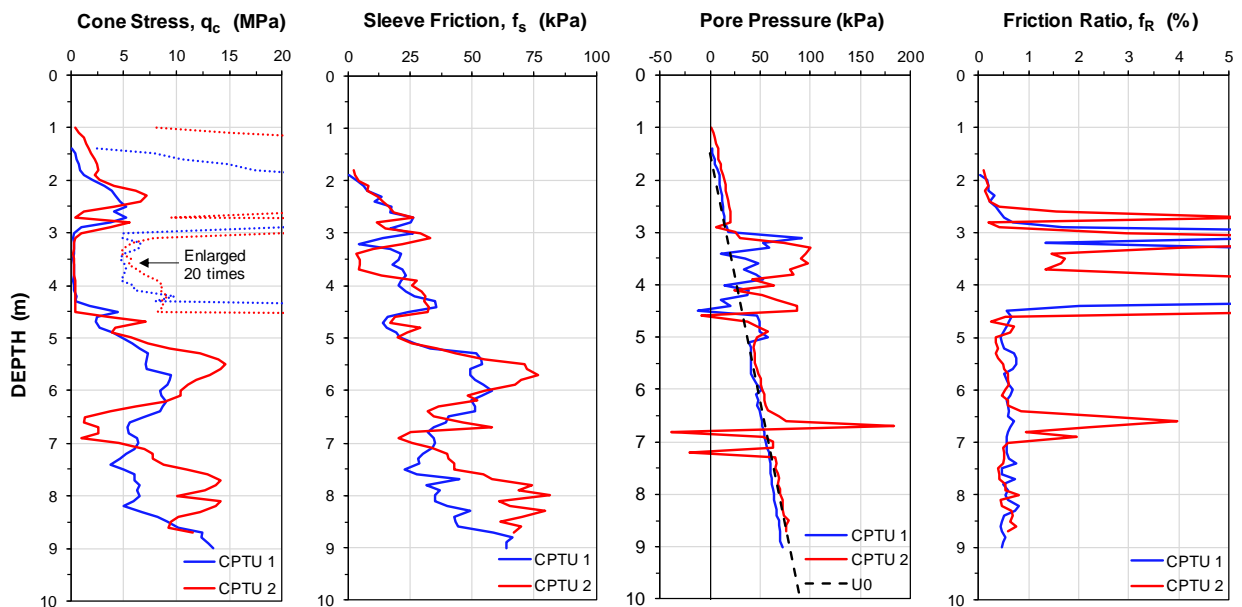
Figure 3. CPTU diagrams (CPTU 1 and CPTU 2 from soundings pushed about 55 m and 70 m from the test piles on February 17-20, 2017).

The results of two CPTU soundings pushed on February 17-20, 2017 are presented in Figure 3. The CPTU 1 and CPTU 2 sounding was pushed about 55 and 70 m from the test piles, respectively. As indicated in the enlarged portion of the qc-diagram, both results showed the existence of the soft soil layer between about 3.0 to 4.5 m depth.

Undrained shear strength of 16 kPa of the soft soil layer was determined based on the CPTU soundings applying a cone factor, N_k , of 15.

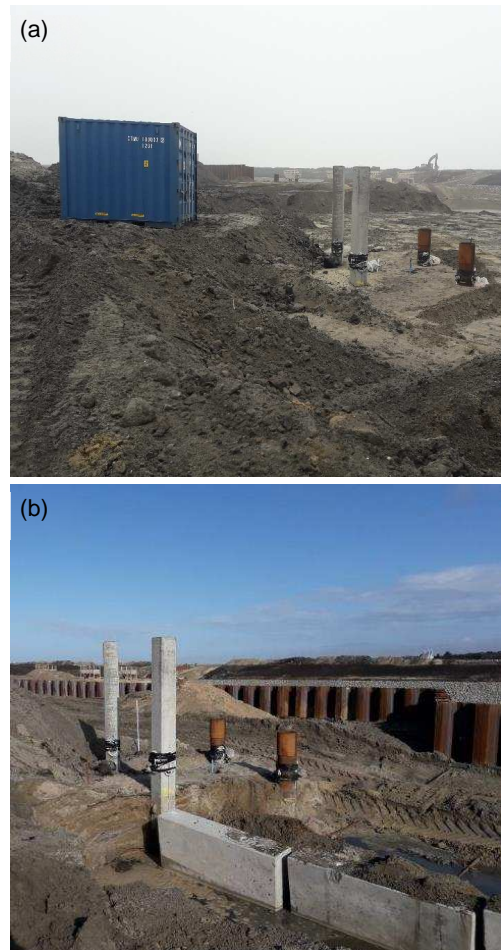
Figure 6. Test site at (a) Day 78 and (b) Day 126 (before placing the 3.0 m fill). The concrete slabs in (b) are anchor plates for the sheet pile wall seen in the background.

Construction activities, including installation of a sheet pile wall, anchor plates and filling the area in-between the sheet pile wall up to the final level of +4.5 m ASL, in the close proximity to the test piles continued during Phase 1 and 2 until about Day 200. As shown in Figure 6 (a), an unplanned one-sided loading occurred during Phase 1. The sheet pile wall was installed at Day 91. Further details on the construction activities around the test piles during Phase 1 are provided in Kania and Sørensen (2019). The concrete anchor plates were installed in the proximity to the test piles (about 3 m away from the bitumen coated steel pile) between Days 123-125 as presented in Figure 6 (b).

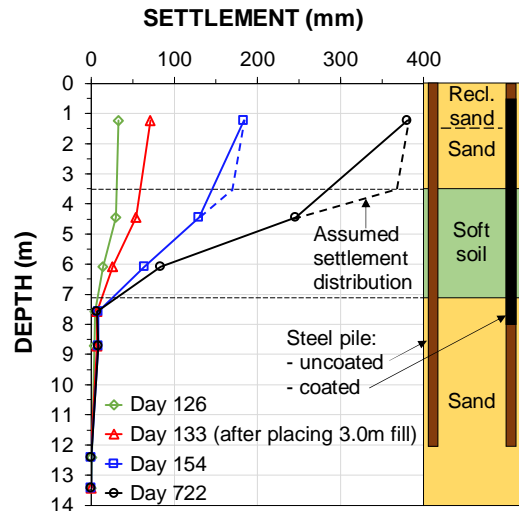
Figure 7. Soil settlement profiles at selected days after pile driving.

Figure 7 shows the soil settlement at selected days after pile driving. It can be seen from the graph, that the settlement occurred mainly due to the compression of the soft soil layer. The maximum settlement of 33 mm before placing the fill (Day 126) was recorded from the settlement gage located at 1.2 m depth. The settlement during Phase 1 is thought due to consolidation of the soft soil layer due to the placing a 1.5 m thick layer of reclaimed sand to form a working platform. Placing the additional 3 m high fill layer significantly increased the compression of the soft soil layer. The maximum settlement at Day 722 was recorded to be 381 mm as recorded at 1.2 m depth.

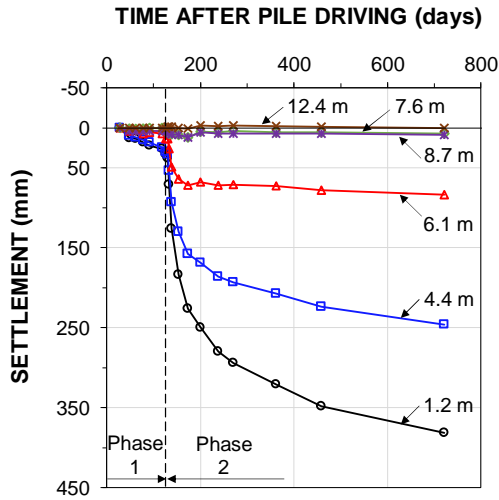
Figure 8. Settlement of individual gages with time after pile driving.

As shown in Figure 8, the individual settlement gages installed above 6.1 m depth are still settling albeit at a decreasing rate. The settlement after full consolidation is expected to amount to 436 mm. The settlement of the gage located at 1.2 m depth is mainly due to compression of the soft soil layer. Placing of the fill is seen to cause only small settlement of the gages located in the sand below 7.6 m depth.

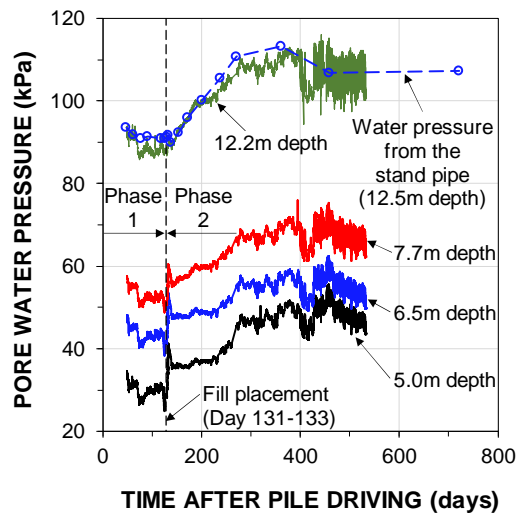
Figure 9. Pore water pressure recorded from individual piezometers located at different depths and the water pressure calculated from the standpipe water level records.

Figure 9 presents the measured pore water pressures with time. Immediately after placing the fill the piezometer located at 5.0, 6.5, and 7.7 m depth recorded an increase of 12.4, 11.5 and 8.9 kPa, respectively. The piezometer installed at 12.2 m depth (sand layer) did not record any increase of pore water pressure immediately after placing the fill. Between Day 133 and Day 141 the pore water pressure decreased by 4.9, 5.2, and 4.2 kPa from the piezometer installed at 5.0, 6.5, and 7.7 m depth, respectively. After Day 141, all the piezometers recorded an increase of pore water pressure. As can be seen from the graph the ground water table level in the bottom sand layer was increasing after placing the fill. It is therefore likely that the reduction in the pore water pressure due to consolidation is cancelled out by the increase due to rise in the water table. The piezometer installed at 12.2 m depth was following the increase of ground water table level.

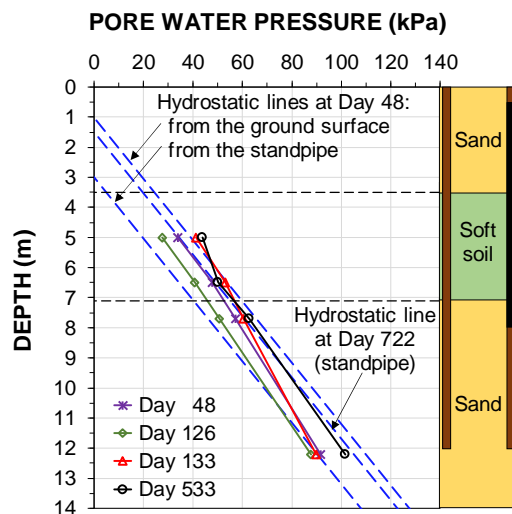
Figure 10. Pore water pressure profiles at selected days after pile driving.

Figure 10 shows the hydrostatic and measured pore water pressure profiles at selected days after pile installation. At Day 48, the piezometer in the sand layer (12.2 m depth) showed a hydrostatic pore water pressure corresponding to a ground water level at 3 m depth (1.5 m below mean sea level), while the water level measured from the ground surface corresponded to 1 m depth (0.5 m above mean sea level). The other piezometers confirmed the non-hydrostatic pore water pressure distribution. At Day 533, the piezometer installed at 5.0 m depth showed about 10 kPa excess pore water pressure, while the piezometers located at 6.5, 7.7, and 12.2 m depth showed hydrostatic distribution.

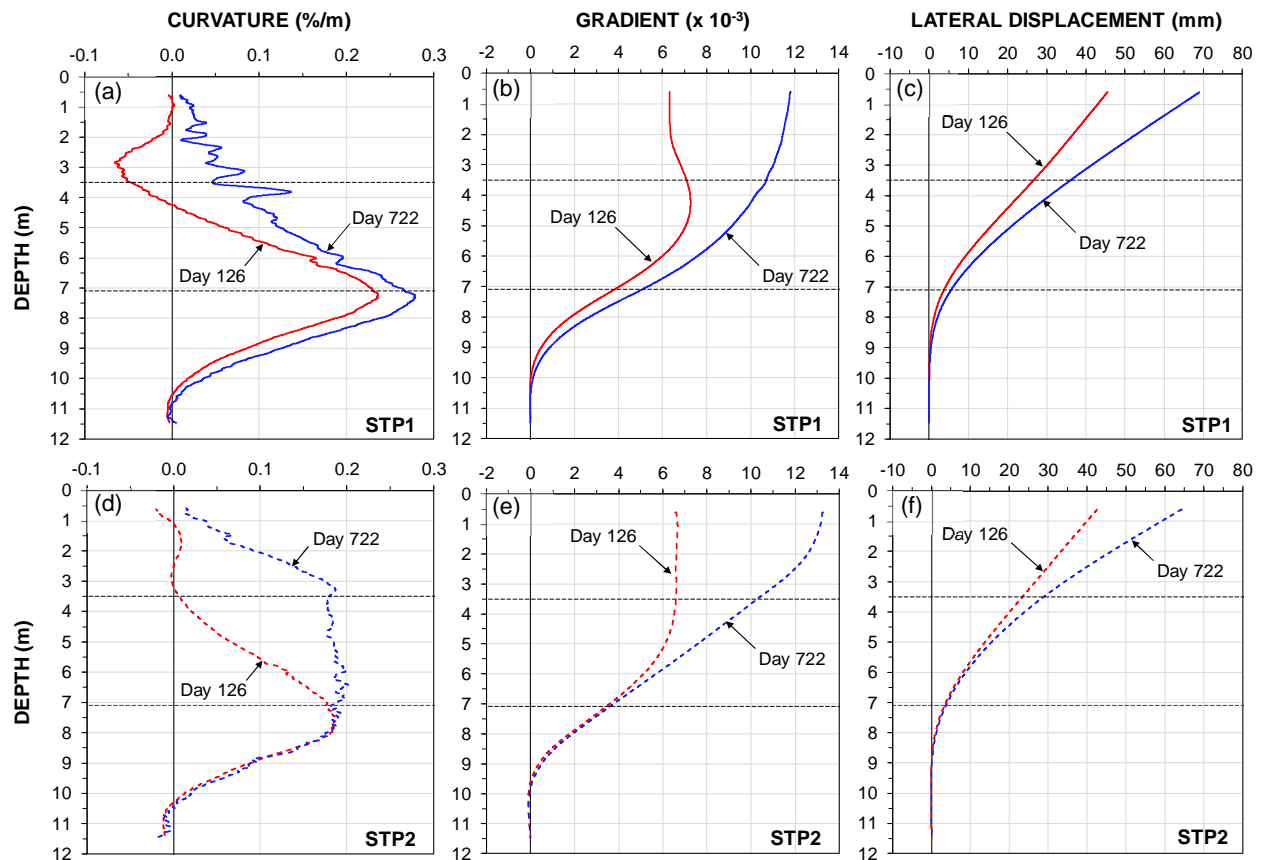
Figure 11. Curvature ((a) and (d)), gradient ((b) and (e)) and lateral displacement ((c) and (f)) of the uncoated (STP1) and bitumen coated (STP2) steel test pile recorded at Day 126 (before placing the fill) and Day 722 (589 days after the end of placing the fill). Data for STP1 at Day 126 from Kania et al. 2020.

In order to investigate the deformation of the test piles, it was assumed that the piles worked as cantilever beam fixed at the pile toe after driving. The reference readings were those recorded immediately after driving. This allowed to determine the integration coefficients (cf. Eqs. 6 and 7). Figure 11 shows the curvature (a) and (d), gradient (b) and (e), and the lateral displacement (c) and (f) of the uncoated and bitumen coated steel pile, respectively. It can be seen from the graphs that both piles experienced similar deformation before placing the fill (Day 126). Afterwards (Day 722), the curvature, gradient, and lateral displacement of the uncoated steel pile (STP1) increased above 10.5 m depth. In contrast, the lateral deformation of the bitumen coated steel pile (STP2) was unchanged below 7.5 m depth.

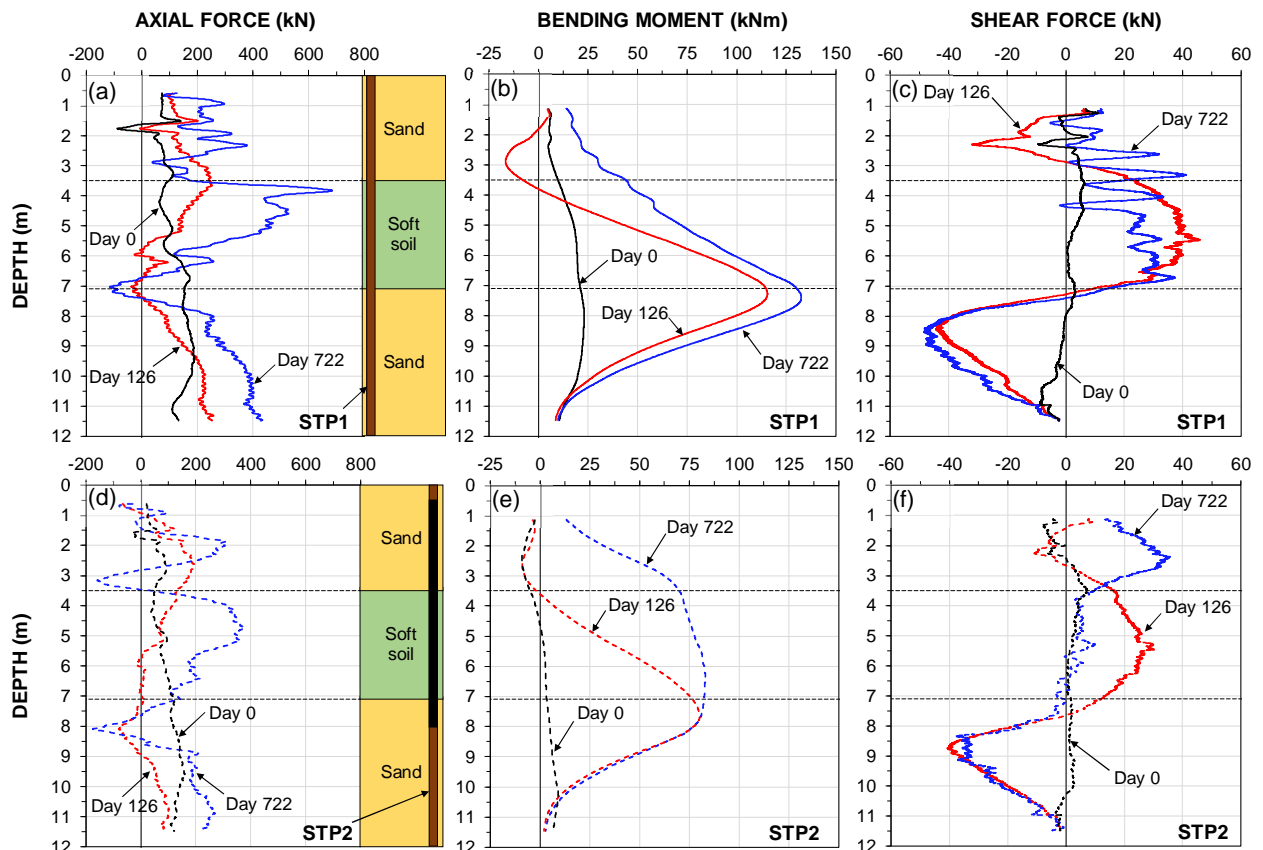
Figure 12. Axial force ((a) and (d)), bending moment ((b) and (e)) and shear force ((c) and (f)) along the uncoated (STP1) and bitumen coated (STP2) steel test pile recorded at Day 0 (immediately after driving), Day 126 (before placing the fill) and Day 722 (589 days after the end of placing the fill).

Figure 12 shows the distribution of axial force (a) and (d), the bending moment (b) and (e), and the shear force (c) and (f) along the uncoated (STP1) and bitumen coated

(STP2) steel pile respectively. These features were determined directly from the strain data with reference readings before pile driving. Positive values of axial force denote compression. In order to obtain an appropriate shear force distribution, the bending moment was smoothed (using a moving average) before differentiation. Even though, the shear force diagram above 4.5 m depth along the STP1 was scattered (Figure 12 (c)). Smoothing the data should be used with caution, since it can easily alter or disguise the meaningful data points.

It can be seen from the graphs in Figure 12 that the development of internal forces immediately after driving (Day 0) and during the Phase 1 (Day 126) was similar in both test piles. Placing of the fill (Day 722) changed the bending moment and the shear force distribution, which significantly affected the axial force profiles. The bending moment increased along the uncoated and bitumen coated steel test pile. However, interestingly, it reached a constant value in the soft soil layer along the bitumen coated steel pile (Figure 12 (e)). The constant bending moment resulted in a neutralization of the shearing force in the soft soil layer. The presence of shear forces, especially at the boundaries between sand and the soft soil layer (at 3.5 and 7-8 m depth), generated tensile strain within the shear plane and affected the interpretation of axial force distribution.
