Fellenius, B.H., 2025. Use of wick drains and an unsuccessful piled foundation. Keynote Lecture to the 31st Symposium of the Vancouver Geotechnical Society, Vancouver, BD, 17 p.

# A case history on use of wick drains and unsuccessful piled foundation

**Bengt H. Fellenius, Dr.Tech.**

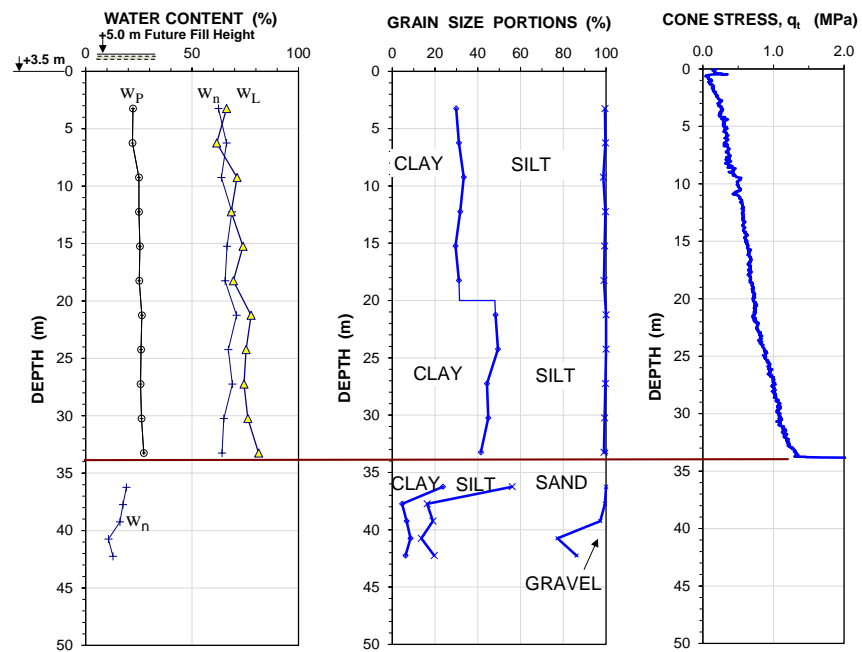
Fig. 2 Consistency limits, grain size distribution, and CPTU cone stress

The soil profile at the site consists of 30 to 40 m of compressible clay and silt deposited on sand with trace clay and silt. [Figure 2](#) shows the distribution of water content and consistency limits. Total saturated density is about 1,600 kg/m<sup>3</sup> throughout the clay (from  $w_n = 66\%$ ). The saturated density of the sand below the clay is 2,100 kg/m<sup>3</sup> (from  $w_n = 19\%$ ). The figure also shows the grain size distribution and the distribution of cone stress,  $q_t$ , in the clay from a CPTU sounding made before the construction start.

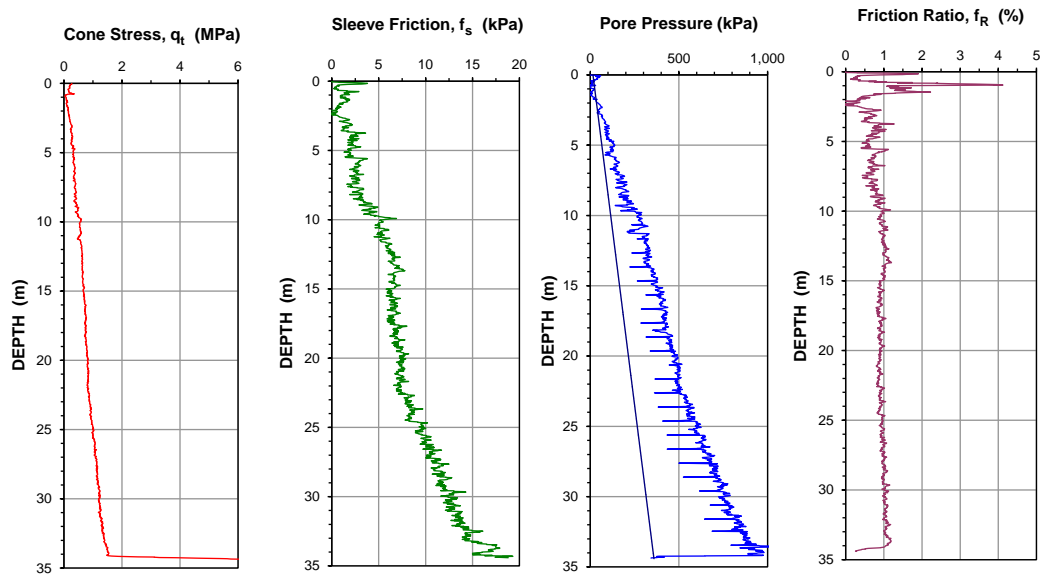
Fig. 3 Results of a CPTU sounding at the site. The spikes occurring when adding the next rod have not been removed (visible in the pore pressure diagram).

Figure 3 shows a representative CPTU sounding from the site. The cone-stress diagram indicates the soil deposit to be very soft throughout. Vane shear tests, FVT, were also carried out in a few places. The vane shear strength ranged from 10 through 15 kPa at 2 m depth, increasing approximately linearly to about 50 kPa through 80 kPa at 30 m depth. This characterizes the clayey silt as soft to a depth of 20 m and firm below. The correlation coefficient, NKT, between CPTU pore pressure adjusted cone stress and vane shear stress is about 15.

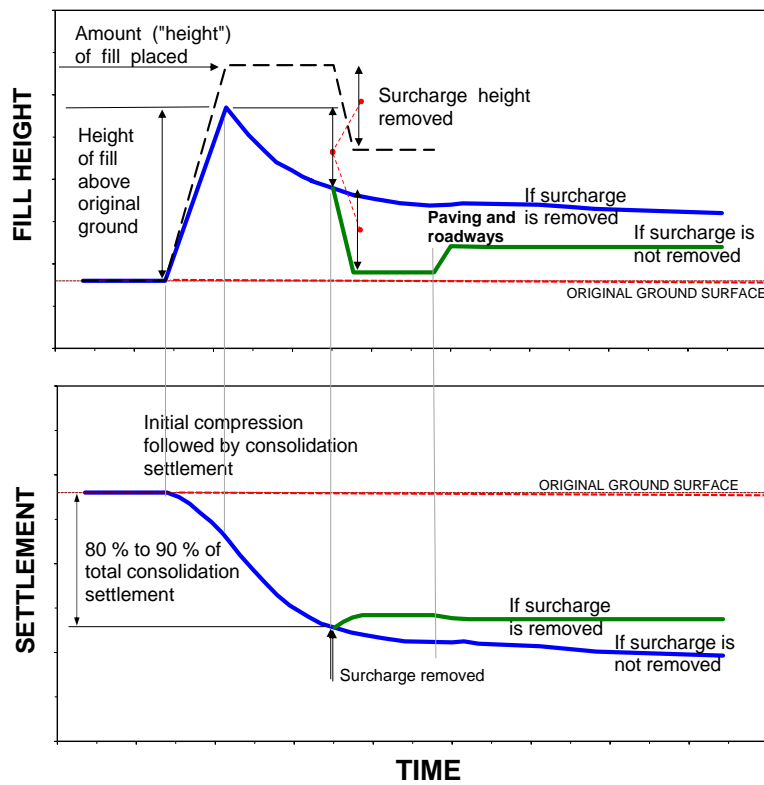
Fig. 6 Principles of wick drain and preloading in site improvement work

The main approach to using the wick drains and preloading site improvement work, as applied to the project, are illustrated in Figure 6, showing the development of immediate compression and

consolidation settlement. The effect of secondary compression is not shown. The figure shows that the amount of fill actually placed will be larger than that indicated by the fill surface elevation, as some of the fill is needed to compensate for the induced settlement.

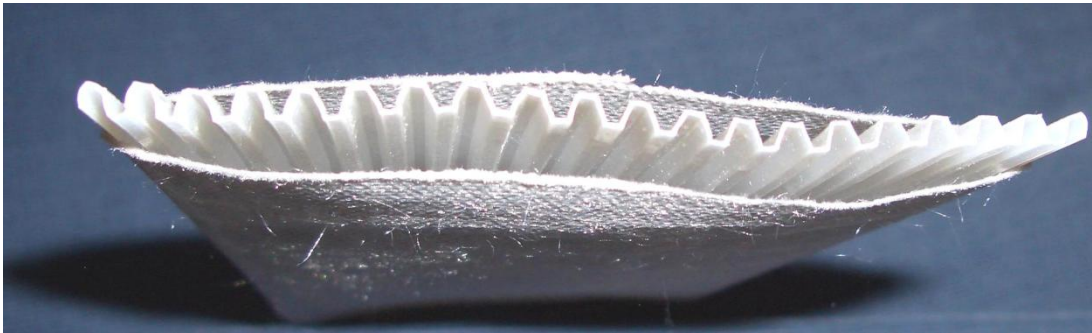
Fig. 7 Photo of the wick drain used for the project

The wick drain used for the project was a corrugated plastic core, 100 mm wide and 2 mm thick, wrapped with a synthetic filter. Figure 7 shows a photo of the wick drain. The particular wick drain is not robust and could flatten and become squashed at large soil stress, which would impair the flow through the drain. In the extreme, this could cause it to cease to function. In my previous experience with similarly designed types of drain, I found them not suitable for use to deeper embedment than 10 to 15 m including the fill height.

It is also possible that the drain function also in the upper layers had become compromised due to the large relative compression of the clay and subsequent micro-folding, a development that this particular corrugated drain is susceptible to.

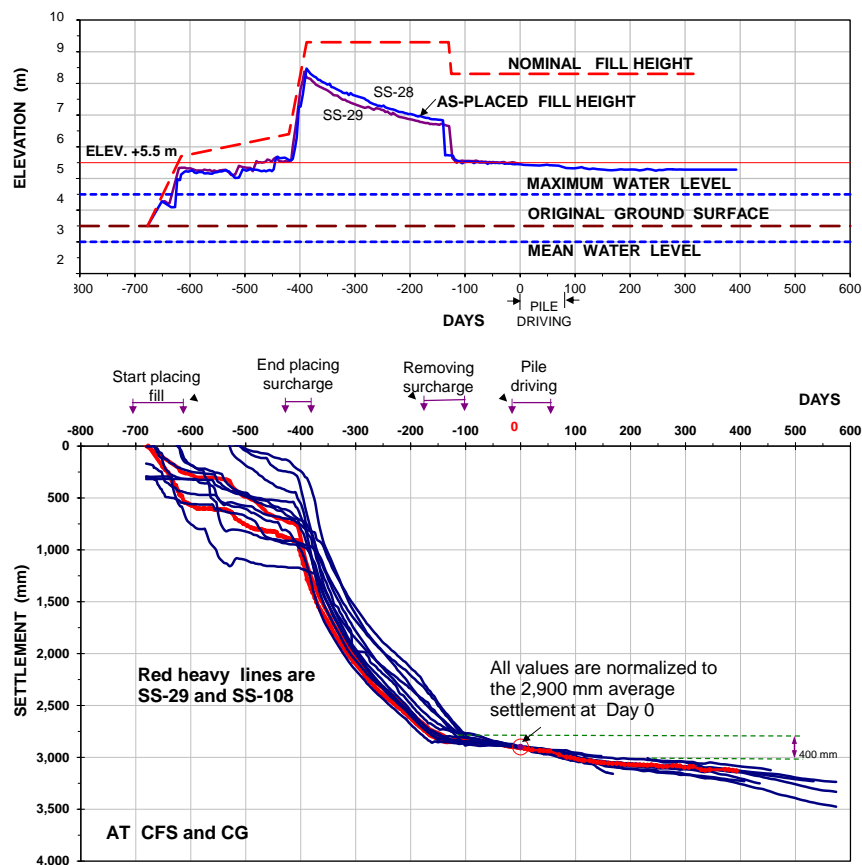
Fig. 10 Normalized ground surface settlement

Figure 10, lower diagram, shows the settlement development after the removal of the surcharge. The settlements are normalized to the 2.9-m average settlement at Day 0. The upper diagram in Figure 10 shows the fill surface elevation measured at the two buildings (at SS-28 and SS-29). The line labeled as "as placed fill" is the measured surface elevation after settlement. Note, the volume of soil and placed fill settled to below the water table, causing a reduction of the imposed stress, which has been considered in the settlement analysis.

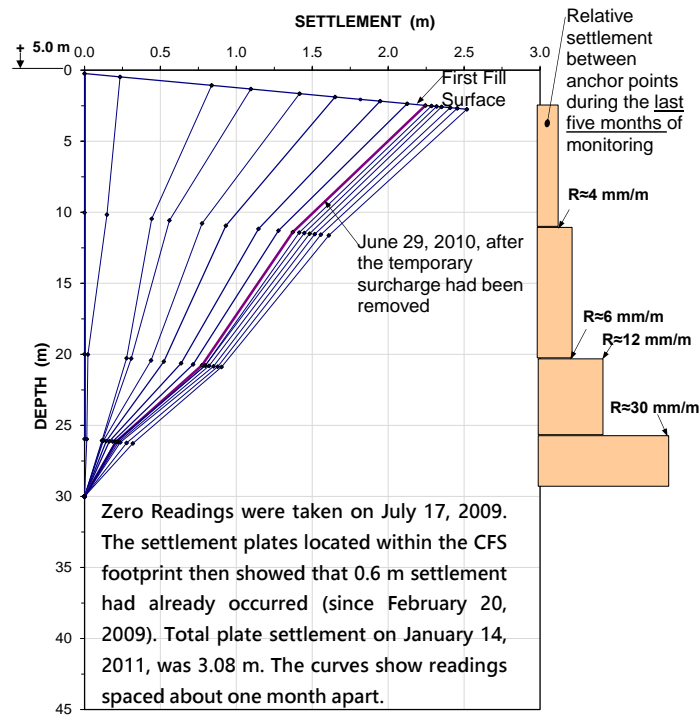
Fig. 11 Settlement with depth July 17, 2009 through January 14, 2011

Figure 11 shows the settlement distribution with depth as measured at extensometer station, Ext-09 next to the CFS building at 10, 20, 26, and 30 m depths (original depths) from July 17, 2009, through January 14, 2011, i.e., Day -127 through Day 409, when the Ext-station was removed because it was in the way of the pile driving. The four settlement anchors were referenced to a presumed zero for the fifth anchor point placed at 30 m depth. The ground-surface settlement (uppermost anchor) was found to agree approximately to the average of SS-28, SS 29, SS-33, and SS-34 for the same time period. At the installation of Ext 09, a 0.6-m ground-surface settlement had already developed. The settlement distribution is almost linear from the fill surface to zero at 30 m depth. The sketch to the right in Figure 9 shows the relative settlement within the anchor points (depths) as measured during the last five months, i.e., after the removal of the surcharge. The sketch shows that below about 20 m depth, the then ongoing relative settlement was twice to several times larger than that above that depth. Evidently, consolidation continued below about 20 m depth after the removal of the surcharge.

mentioned observation that the consolidation was not completed in the lower portion of the profile (c.f., Figure 11) and supports the conclusion that the wick drain did not function below about 15 depth.

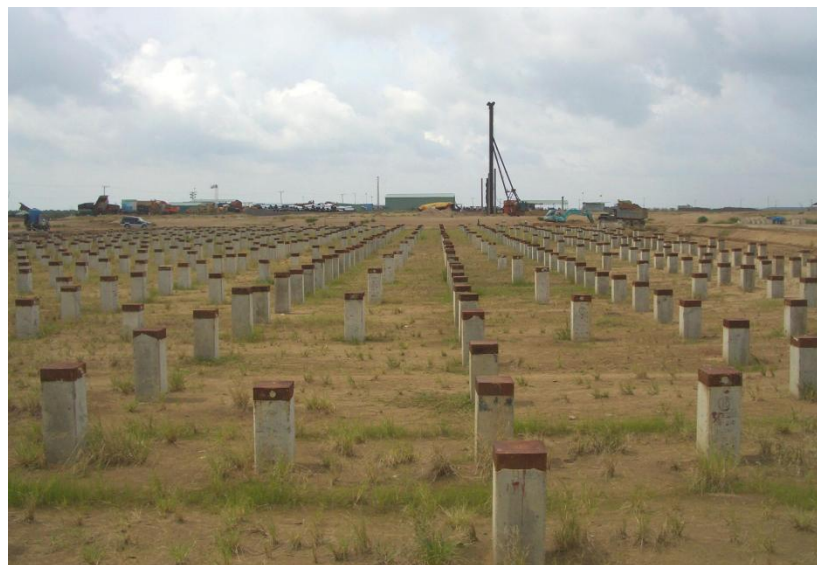
Fig. 14 View on October 4, 2011, from south end of CFS building showing some of the about 750 piles driven for the CFS building. (Authors' photo).

Both piled foundations are wide. Figure 14 shows a view toward the CG building of the piles driven for the CFS building.

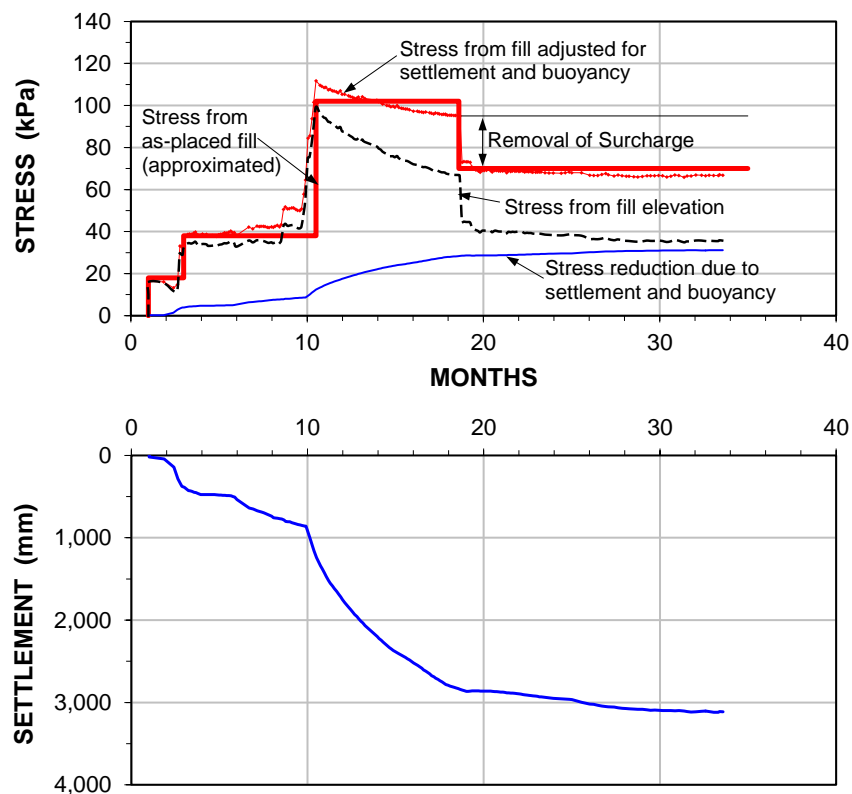
Fig. 16 Actual loading and unloading stress and measured settlement vs. time

The loading input is illustrated in Figure 16, which shows the stress from the measured height of fill (SS-29) and the reduction of the fill height due to the soil and fill settling below the water table vs. months from the project start. The figure shows the correction of imposed stress for the loss of applied stress due to buoyancy. The stress adjusted for this effect is indicated in the figure and approximated to three loading and one unloading occasions. The lower diagram shows the settlement measured at settlement plate SS-29 in the CFS building.

The calculations and analyses were carried out using the UniSettle software ([www.UnisoftGS.com](http://www.UnisoftGS.com)) with input of stress events (c.f. Figure 16). Figure 17 shows the results of the measured settlement versus time and the UniSettle calculated curve fitted to the measured by adjusting input parameters. The fit to the settlement measured up to the end of the consolidation period (24 months) was obtained for input of an immediate compression modulus number of 150 ( $j = 1$ ) and a consolidation virgin modulus number,  $m$ , of 6 ( $j = 0.5$ ) and reloading (unloading) modulus number,  $m_r$ , of 60 ( $j = 0.5$ ). However, while the input resulted in a fit between calculated and measured settlement development for the first 24 months including six months of monitoring after the removal of the surcharge, the fit was not good beyond this time. The calculations indicated that only little settlement should occur beyond the 24 months, but the plot of the measured settlement shows that significant settlement did indeed occur beyond 24 months.

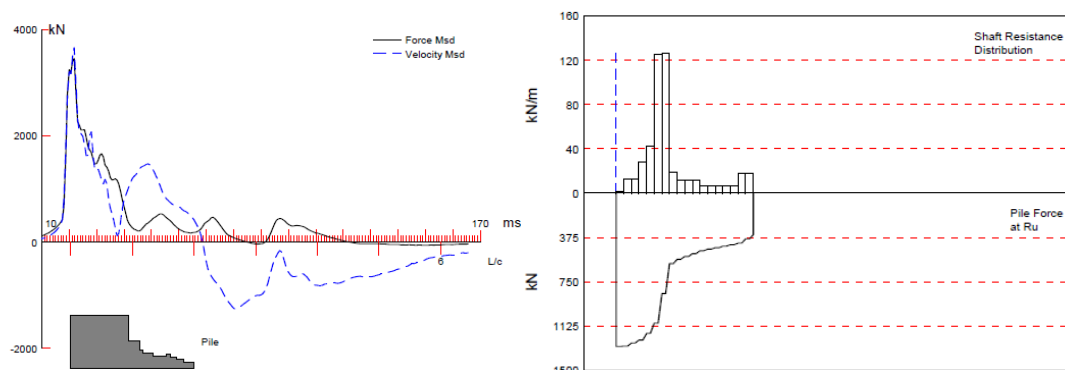
Fig. 18. Results of CAPWAP analysis on a lengthened pile. Courtesy of SACL Ltd., Ottawa)

Figure 18 shows the results of a CAPWAP analysis of a hammer impact on a lengthened pile when at 36 m depth. It is likely that the results are typical of the lengthened piles. The analysis indicates severe damage.

The indication that the redriving of the lengthened piles severely damaged the piles appears to contradict the observations that the foundation piles ceased to settle with the ground. However, settlement of a wide piled foundation is a function of the compressibility of the soil below the pile toe level (Fellenius 2018). I suspect the reason for the short-term ceasing of building settlement is less the effect of the piles obtaining bearing in the sand below the compressible clay, and more due to the large volume of concrete introduced to the clay, reducing its average compressibility, thus, resulting in reduced compression of the soil and, therefore, reduced foundation settlement.
