Wick Drains and Piling for Cai Mep Container Port, Vietnam

GeoMEast 2018 International Congress, Cairo, Egypt, November 2018

Bengt H. Fellenius¹⁾, Dr.Tech, P.Eng.

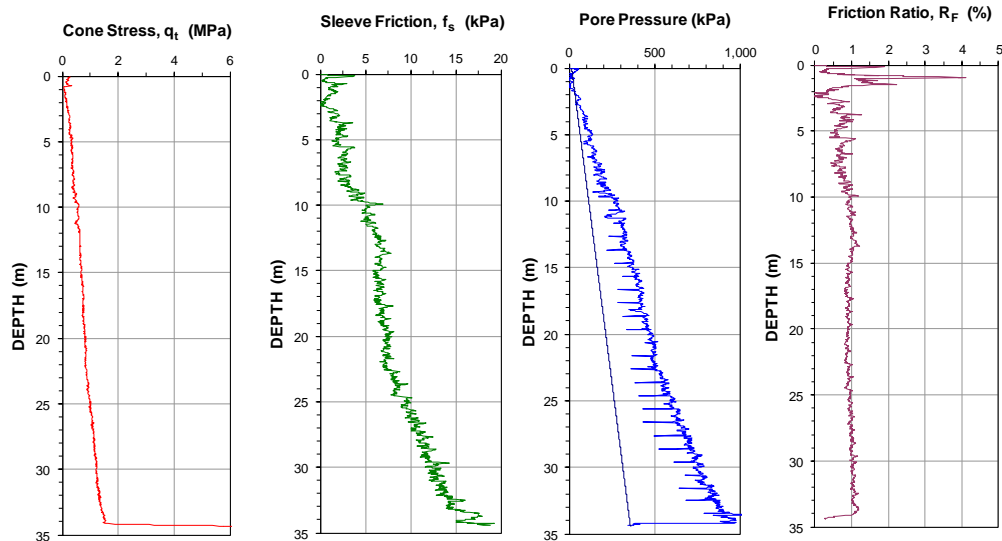
Fig. 3 Results of a CPTU sounding at the site. The spikes occurring when adding the next rod have not been removed (visible in the pore pressure diagram).

Figure 3 shows a representative CPTU sounding from the site. The cone-stress diagram indicates the soil deposit to be soft throughout. Vane shear tests, FVT, were also carried out in a few places and showed a vane shear strength ranging from about 10 through 15 kPa at 2 m depth, increasing approximately linearly to about 50 kPa through 80 kPa at 30 m depth. This characterizes the clayey silt as soft to a depth of about 20 m and firm below. The correlation coefficient, N_{KT} , between CPTU pore pressure adjusted cone stress and vane shear stress is about 15.

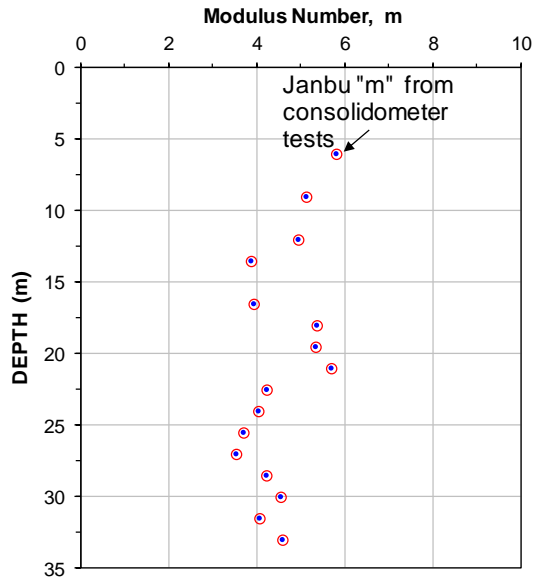
Fig.5 Distribution of modulus number determined from consolidometer tests and CPTU q_t stress. The depth reference is from original ground surface; Elev. +3.5 m.

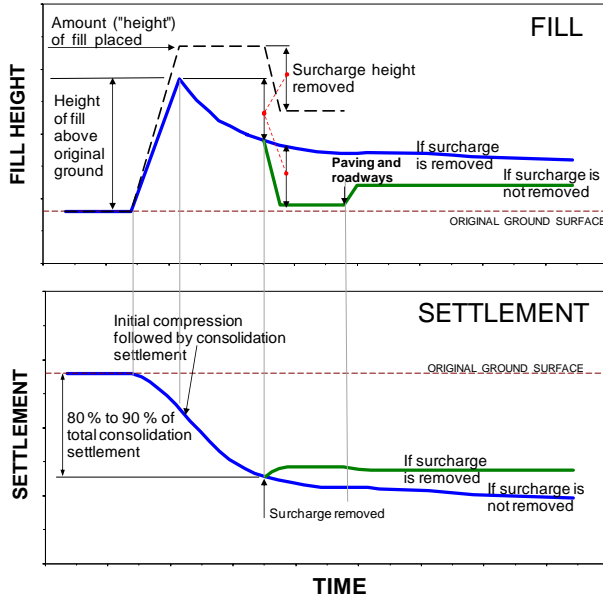
Fig. 6 Principles of wick drain and preloading in site improvement work

The main approach to use of the wick drains and preloading site improvement work as applied to the project are illustrated in Figure 6, showing the development of immediate compression and consolidation settlement. The effect of secondary compression is not shown. The figure shows that the amount of fill actually placed will be larger than that indicated by the fill surface elevation, as some of the fill is needed to compensate for the induced settlement.

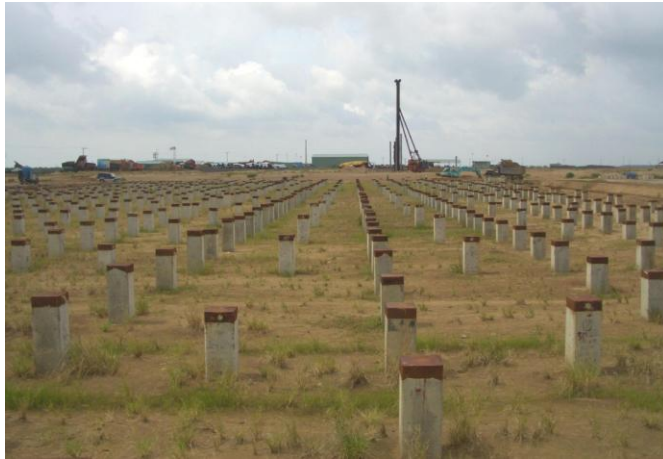
Fig. 14 View on October 4, 2011, from south end of CFS building showing some of the about 750 piles driven for the CFS building. (Authors' photo)

Both piled foundations are wide. Figure 14 shows a photo of the piles driven for the CFS building taken toward the CG building.

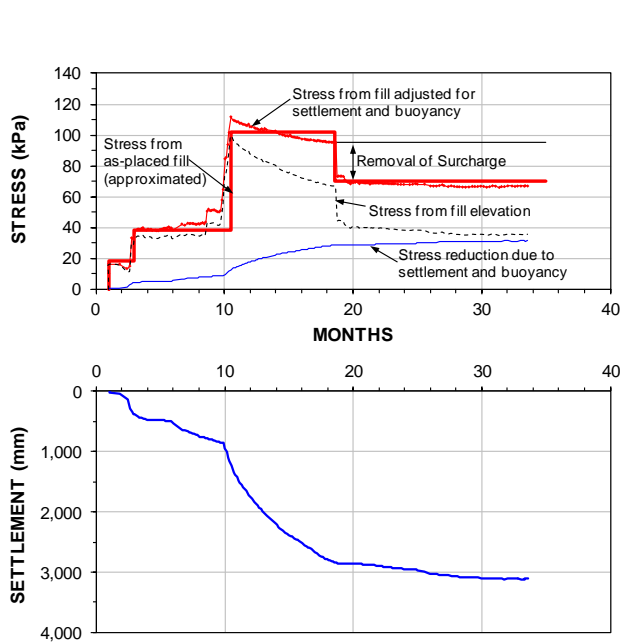
Fig. 16 Actual loading and unloading stress and measured settlement vs. time.

The loading input is illustrated in Figure 16, which shows the stress from the measured height of fill (SS-29) and the reduction of the fill height due to the soil and fill settling below the water table vs. months from the project start. The figure shows the correction of imposed stress for the loss of applied stress due to buoyancy. The stress adjusted for this effect is indicated in the figure and approximated to three loading and one unloading occasions. The lower diagram shows the settlement measured at settlement plate SS-29 in the CFS building.

The calculations were carried out using the software UniSettle4 (Goudreault and Fellenius 2011) with input of stress events (c.f. Figure 16). Figure 17 shows the results of the calculations plotted together with the measured settlement versus time. The fit to the settlement measured up to the end of the consolidation period (24 months) was obtained for input of an immediate compression modulus number of 150 ($j = 1$) and a consolidation virgin modulus number, m , of 6 ($j = 0.5$) and reloading (unloading) modulus number, m_r , of 60 ($j = 0.5$). However, while the input resulted in a fit between calculated and measured settlement development for the first 24 months including six months after the removal of the surcharge, the fit was not good beyond this time. The calculations indicated that only little settlement should occur beyond the 24 months, but the plot of the measured settlement shows that significant settlement did indeed occur beyond 24 months.
