BUCKLING OF PILES DUE TO LATERAL SOIL MOVEMENTS

Fellenius, B.H., 1972. Buckling of piles due to lateral soil movements. Proceedings of the 5th European Conference on Soil Mechanics and Foundation Engineering, Madrid, April 10-13, Vol. 2, pp. 282-284.

Bengt H. Fellenius, Swedish Geotechnical Institute
Bengt Johansson, Sven Tyren AB

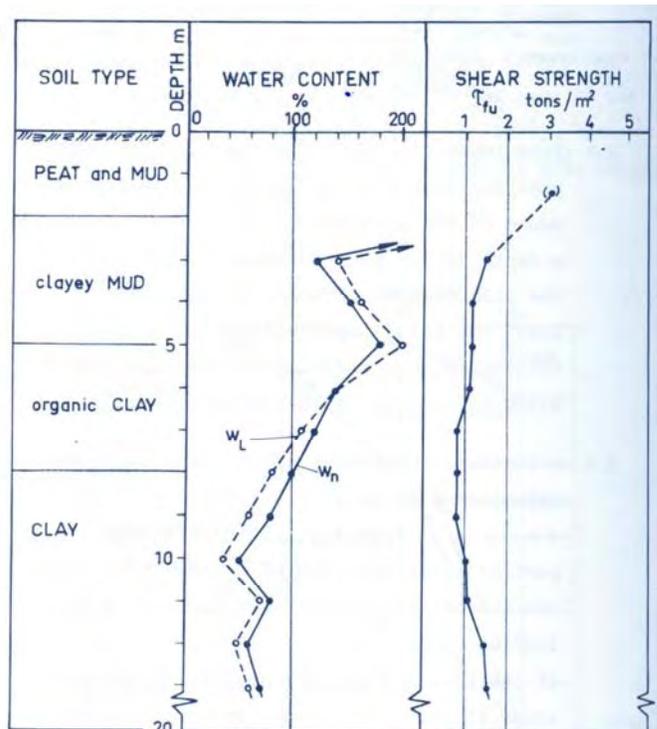
Fig. 1 Soil profile

Ten years ago a two storey building in Huddinge near Stockholm in Sweden was founded on 20 m long piles driven through a soft clay undergoing consolidation. The piles were square, 250 mm by 250 mm, precast concrete piles with four longitudinal reinforcement bars 12 mm in diameter. Generally, the soil in the area consists of an upper layer of mud and peat on 20 m thick layers of soft clay. The undrained shear strength of the clay is about 1 ton/m² and that the water content varies considerably. A representative soil profile is shown in Fig. 1.

The shear strength is determined by the Swedish fall cone method and is unreduced.
