Nguyen M.H., and Fellenius, B.H. 2013. Analysis of a piled-raft foundation for Cai Mep Container Port, Vietnam. Proceedings of the Seventh International Conference on Case Histories in Geotechnical Engineering, Edited by S. Prakash, Wheeling, April 29-May 4, Paper No. 2.12, 6 p.

ANALYSIS OF PILED-RAFT FOUNDATION FOR CAI MEP CONTAINER PORT, VIETNAM

Nguyen Minh Hai

Bengt H. Fellenius

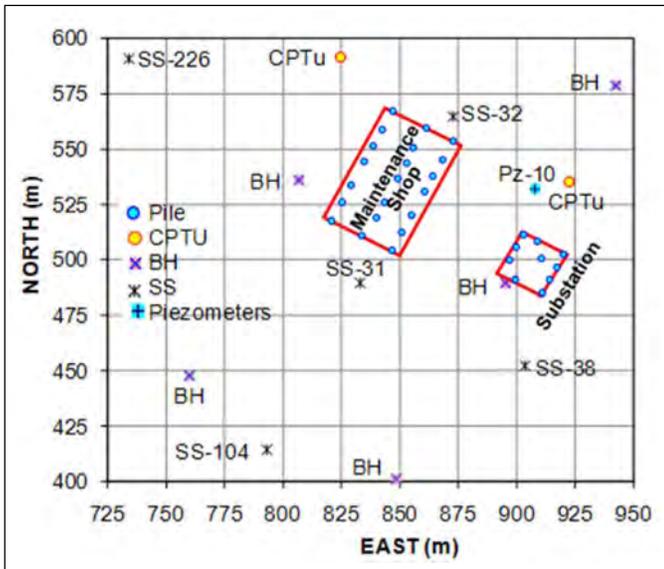
The site lay-out of Maintenance Shop and Substation is indicated in Figure 2 together with monitoring stations around the buildings. After the piles had been driven, the pile head elevation of several piles was monitored by surveying and these piles are marked out in the figure. The building footprints are 1,680 and 419 m², respectively.

Fig. 2. Plan view of location of field instrumentation, the two buildings, and the monitored piles

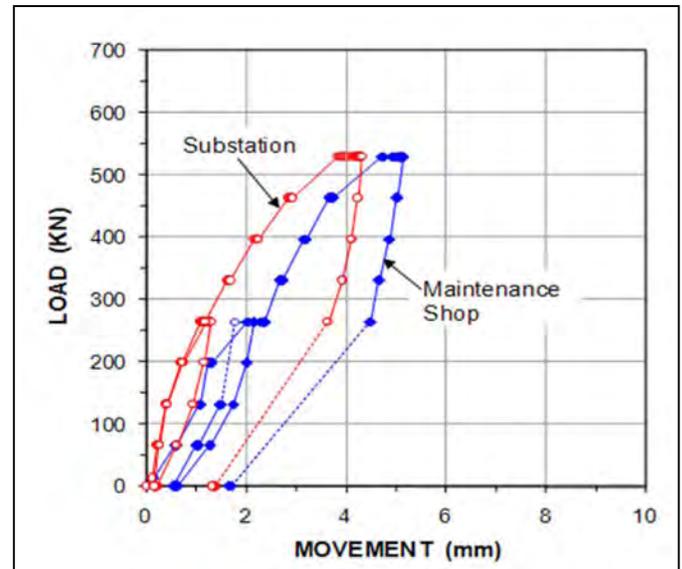
Fig. 3. Pile-head load-movement curves from static loading tests performed 17 days after driving
