Nguyen M.H., and Fellenius, B.H. 2013. Failure of embankment on soil-cement columns for Thi Vai Port, Vietnam. Proceedings of the Seventh International Conference on Case Histories in Geotechnical Engineering, Edited by S. Prakash, Wheeling, April 29-May 4, Paper No. 3.08, 11 p.

FAILURE OF EMBANKMENT ON SOIL-CEMENT COLUMNS FOR THI VAI PORT, VIETNAM

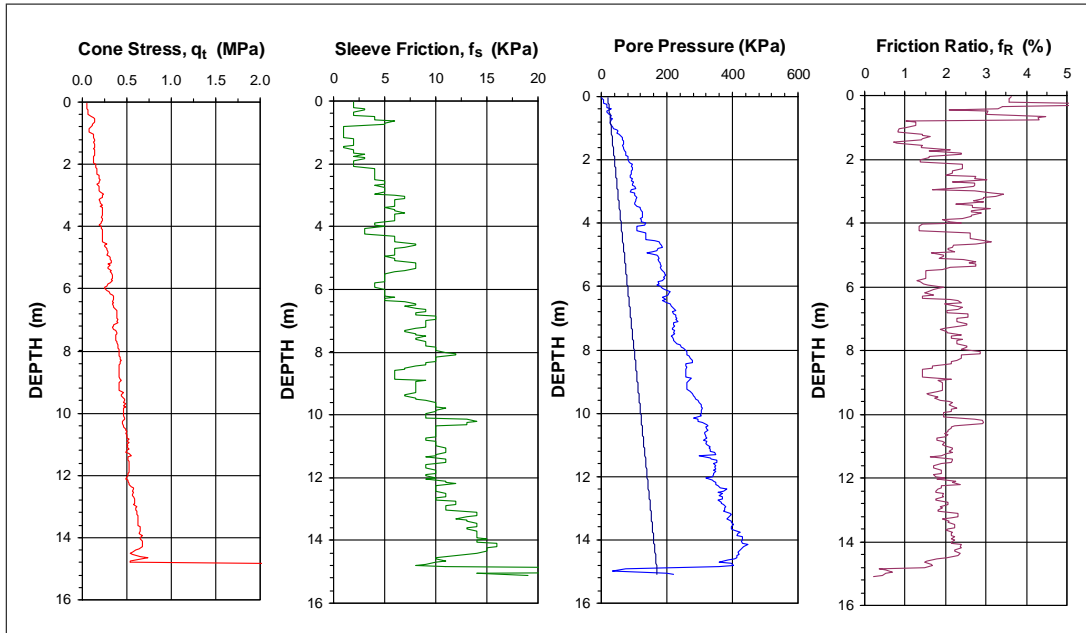
Fig. 4 Diagram of CPTU sounding pushed before construction start

The soil profile is illustrated in Figures 4 and 5. Figure 4 shows the results of a typical CPTU sounding pushed at the site before construction start. Figure 5 shows the distribution of the basic soil parameters. The natural water content of the clay is 70 to 75 % and the total saturated density is about $1,500 \text{ kg/m}^3$. The density of the sand below the clay is estimated to $1,800 \text{ kg/m}^3$. The field vane shows the clay to be very soft above 10 m depth and soft below. The correlation

coefficient, NK , between CPTU cone stress and vane shear stress is about 18.

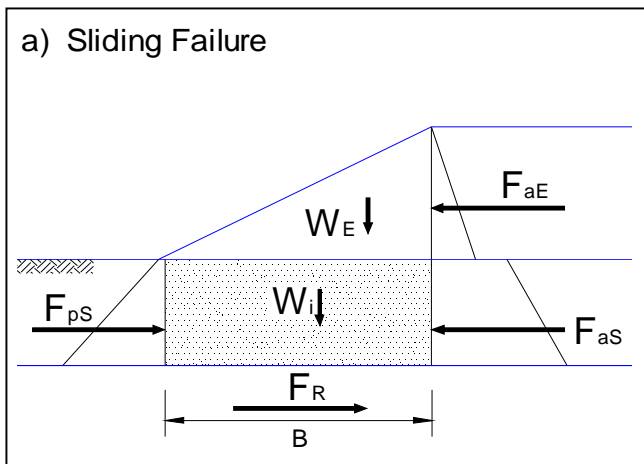
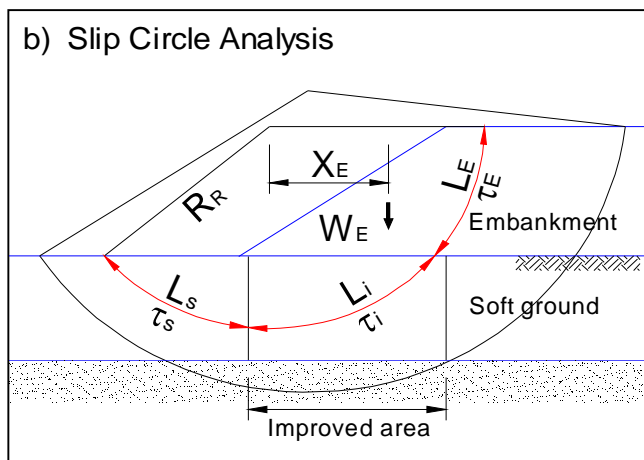
Fig. 6 Typical modes of stability analysis for embankment on soil-cement columns (Technical Standards and Commentaries for Port and Harbor Facilities in Japan 2002)

Figure 6a shows the principle of translational slope stability as applied in the design. The failure mode is based on the horizontal load equilibrium of active and passive earth pressures acting on the side boundaries of the improved area and the shear strength mobilized at the bottom of the improved area of width B . The shaded area is the soil-cement column and wick drain treated ground. The labels W_E indicates the weight of the embankment above the treated ground. The labels F_{pS} and F_{aS} stand for passive and active earth stress, respectively acting on the treated ground, and F_{aE} is the active earth stress from the embankment fill.

Figure 6b shows the principle of a rotational cylinder—slip-circle—slide failure (TSCPHF 2002) as applied in the design. The improved ground is assumed composite material with constant shear strength along the slip circle arc. The labels L_E , L_i , and L_s indicate length of circular arc in embankment, improved and original soft ground, respectively. The b_{ee} , i_f and a_s indicate shear strength of embankment, improved and original soft ground, respectively. W_E is the weight of the embankment and E_X is horizontal distance of embankment from center of slip circle. The R_R is the radius of the slip circle. The more shallow slip circle assumes linear increase in undrained shear strength of the soft ground with depth. The deeper slip circle assumes that the undrained shear strength is constant in the soft clay.

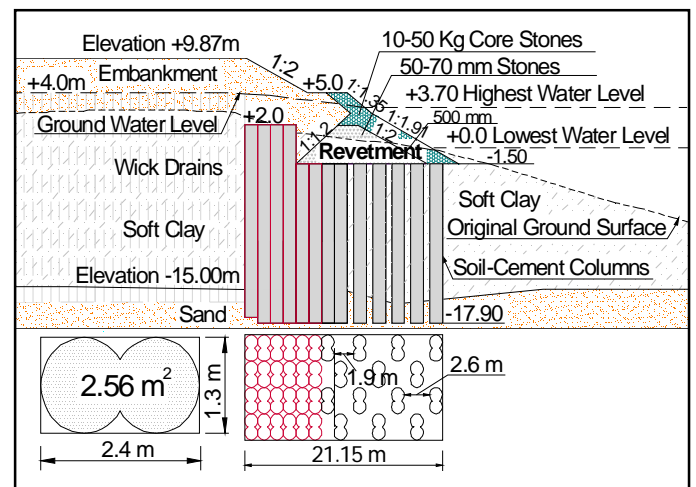
Fig. 7 Typical Cross Section of Embankment on Soil-Cement Columns

Figure 7 shows a section of the river bank with the treated ground before slope failure. The soil-cement columns were constructed through the soft clay using the wet deep mixing method designed to have an unconfined compressive strength of 500 KPa and, therefore, an undrained shear strength of 250 KPa. The column diameter was 1,300 mm. One group of columns was constructed with each overlapping the next by 0.1 m. A second group was constructed as similarly overlapping pairs with open spaces between pairs of 1.3 m, 1.9 m, and 2.6 m. The shear strength of the original soft soil was not considered to contribute to the stability. For use in the stability analysis, the average shear strength of improved ground was estimated to be 200 KPa. About 26 m² of 50 to 70 mm stone and 21 m² of core stones with weight in range of 10 to 50 kg were placed on the soil-cement columns to form a revetment for protecting the toe of the slope along the river bank from erosion (total area of about 47 m²).

Wick drains were installed behind the soil-cement columns at a 1.5 m spacing through the clay and into the surface of the sand layer. The wick drains were not installed in the soil-cement column area as it was expected that the soil-cement columns would act as vertical drains.

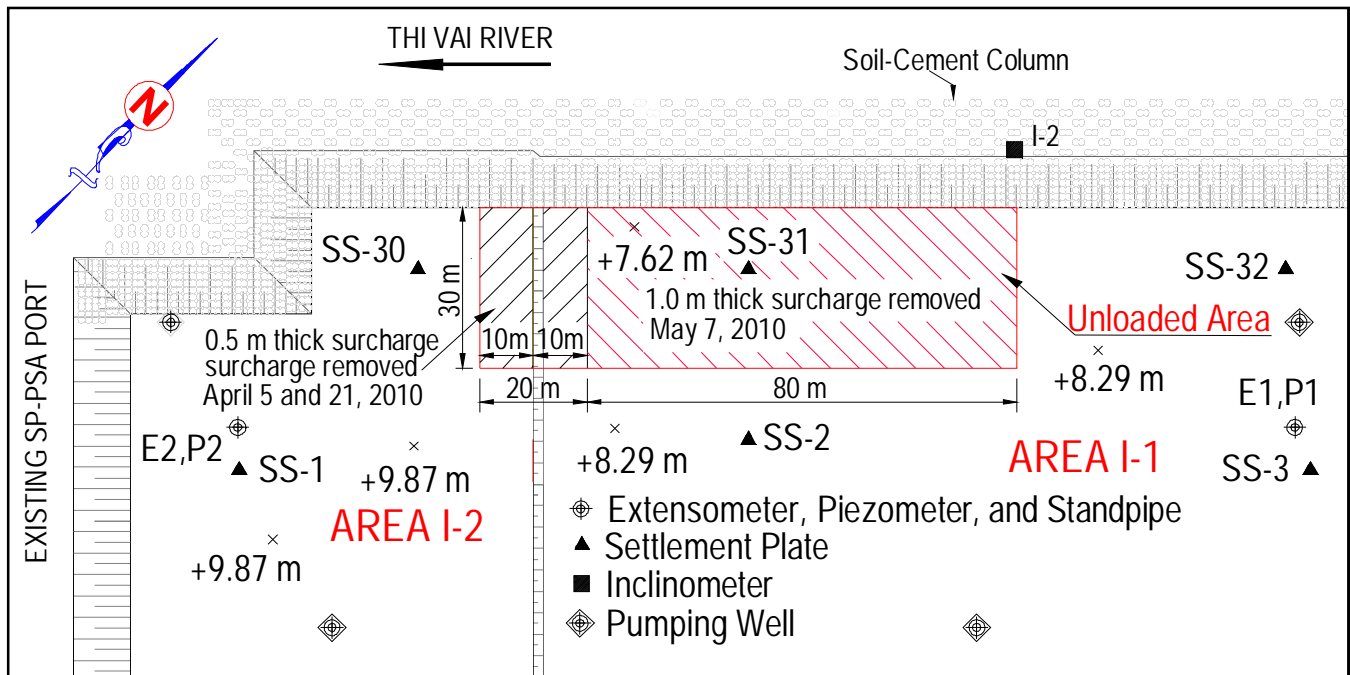
Fig. 8 Plan view of installed instruments and the area affected by the slide

At locations indicated in Figure 8, before start of placing fill on the ground, settlement monitoring plates, SS-plates (SS-1, SS-2, SS-3, SS-30, SS-31, and SS-32) were installed on the original ground surface. Two piezometers (P1 and P2) were installed for measuring pore pressure in two locations at depths of 6.5 m and 14 m, and 6.5 m and 17 m, respectively. Two extensometer gages (E1 and E2) were installed at the same two locations for measuring settlements occurring below depths of 0.2 m, 6.6 m, and 10.0 m, and 14.0 m and 20 m, respectively. Lateral displacement was measured by one inclinometer (I-2) installed to 28 m depth.

When on April 5, 2010, cracks appeared on the fill surface, the soil was unloaded by removing about 0.5 m of the fill over an area of 20 by 30 m and later, on May 7, 2010, about 1.0 m of the fill was removed from an 80 by 30 m strip in Area I 1, as delineated in the figure.

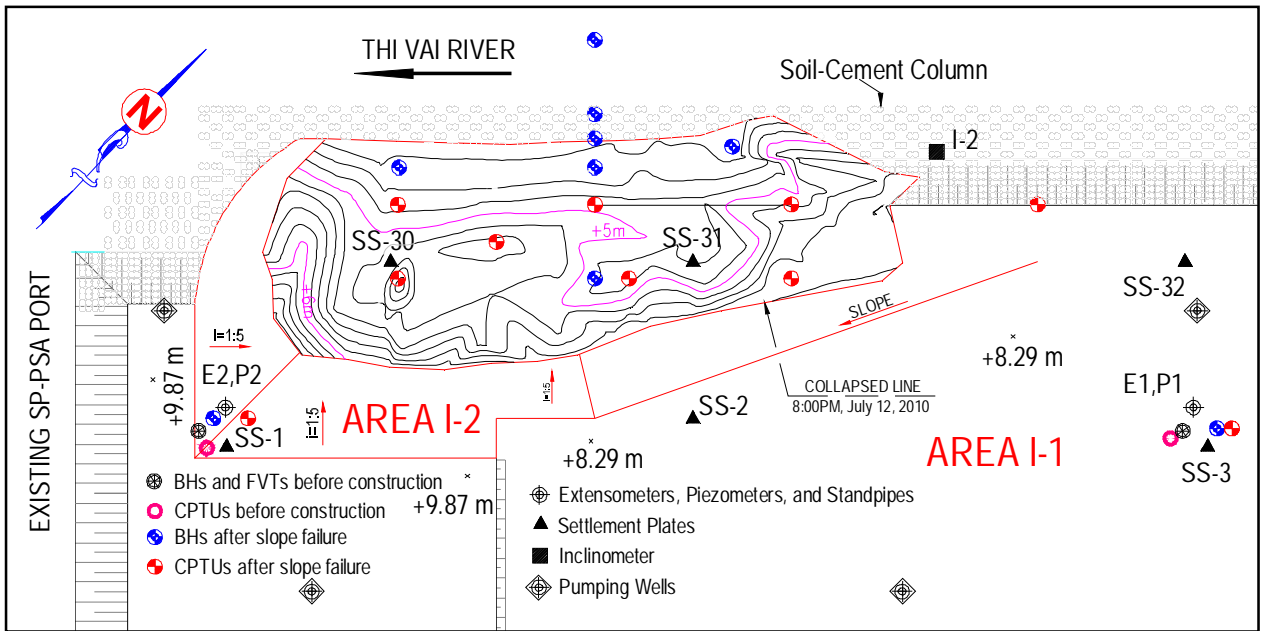
Fig. 9 Boreholes and CPTUs investigated at failed embankment area

After the failure, the shear strength of the soil was investigated. The investigation included cone penetrometer soundings, CPTU, and boreholes at locations shown in Figure 9. No new FVTs were included. Surveying observations indicated that toe revetment material and surcharge fill had moved about 70 m out into the river.
