Static Loading Test on a 45 m Long Pipe Pile in Sandpoint, Idaho

Bengt H. Fellenius¹⁾, Dean E. Harris²⁾, and Donald G. Anderson³⁾

Design of piled foundations for bridge structures for the realignment of US95 in Sandpoint, Idaho, required a pre-design static loading test on an instrumented, 406 mm diameter closed-toe pipe pile driven to 45 m depth in soft, compressible soil. The soil conditions at the site consist of a 9 m thick sand layer on normally consolidated, compressible post-glacial alluvial deposits to depths estimated to exceed 200 m. Field explorations included soil borings and CPTU soundings advanced to a depth of 80 m. The clay at the site is brittle and strain-softening, requiring special attention and consideration in geotechnical design of structures in the area. Effective stress parameters back-calculated from the static loading test performed 48 days after driving correspond to beta-coefficients of about 0.8 in the surficial 9 m thick sand layer and 0.15 at the upper boundary of the clay layer below, reducing to 0.07 in the clay layer at the pile toe, and a pile toe-bearing coefficient of 6. The beta-coefficients are low, which is probably due to pore pressures d

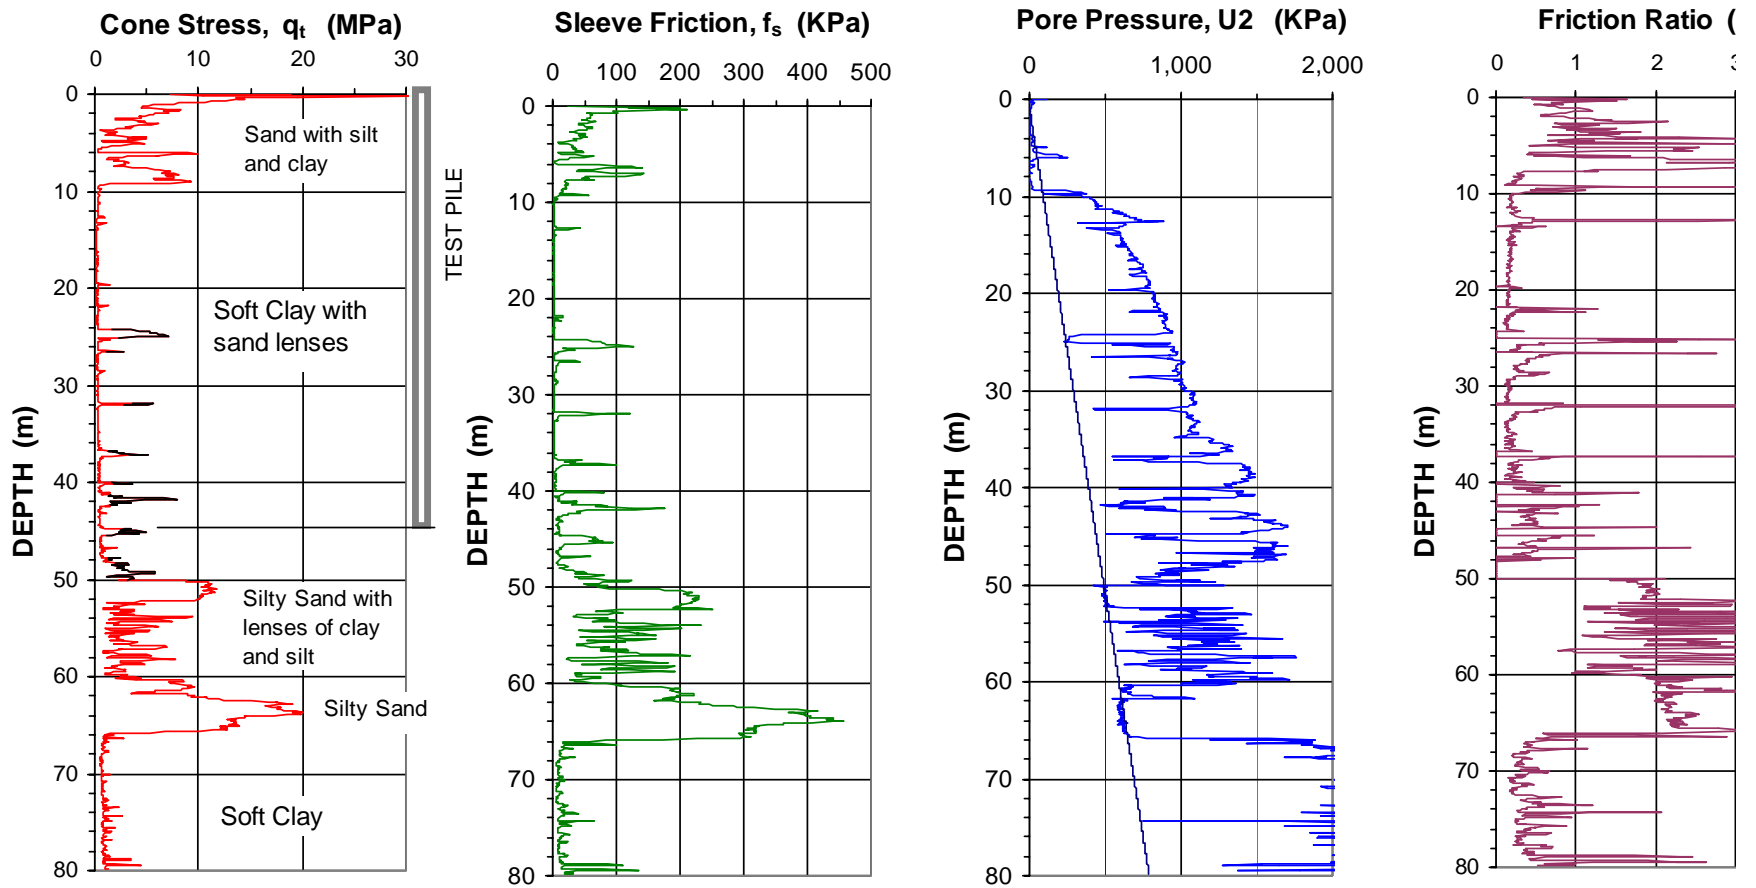
Fig. 1 Results of cone penetrometer testing at the site (CPT-03 80m)

- (Layer 1) a 9 m thick layer of sandy and silty soil.
- (Layer 2) an approximately 40 m thick layer of clay from 9 m to 48 m, containing several approximately 500 mm thick layers or seams of loose to medium dense sandy silt and silt. Five slightly thicker sand zones exist in the clay at depths of 24.6 m (0.90 m thick), 31.9 m (0.20 m thick), 37.1 m (0.40 m thick), 41.8 m (0.20 m thick), and 44.9 m (0.40 m thick).
- (Layer 3) a 17 m thick layer of an alternating sequence of silt, silt with sand, and sandy silt and clay to a depth of approximately 65 m. This sequence is referred to collectively as “silt”.
- (Layer 4) an approximately 15 m thick layer of silt and clay from 65 m depth to the end of the CPTU sounding at 80 m depth, and probably continuing beyond this depth.

The friction ratio in Layers 2 and 4 ranges from 0.2 % to 0.3 %, which is smaller than usually found for clays. Such a small value is considered indicative for sensitive clay. However, vane shear tests at the site do not indicate any appreciable sensitivity.

The capacity of the pile was also compared to the capacity determined from the CPTU. The CPTU results presented in Fig. 1 show that very large pore pressures developed during the penetration of the cone. It is necessary to consider this when using the CPTU-data in the calculation of pile capacity. Fig. 17 presents the results of a calculation using the method proposed by Eslami and Fellenius (1997). For reference, the figure includes also the distributions of measured load and the effective stress calculation of the resistance. The agreement between the two methods of determining the resistance distribution is very good, but may be coincidental. However, because the U2 pore pressures were very high and as they are explicitly incorporated in the capacity estimate from the cone, the CPTU estimate may have been the first warning of the low capacity of the pile.

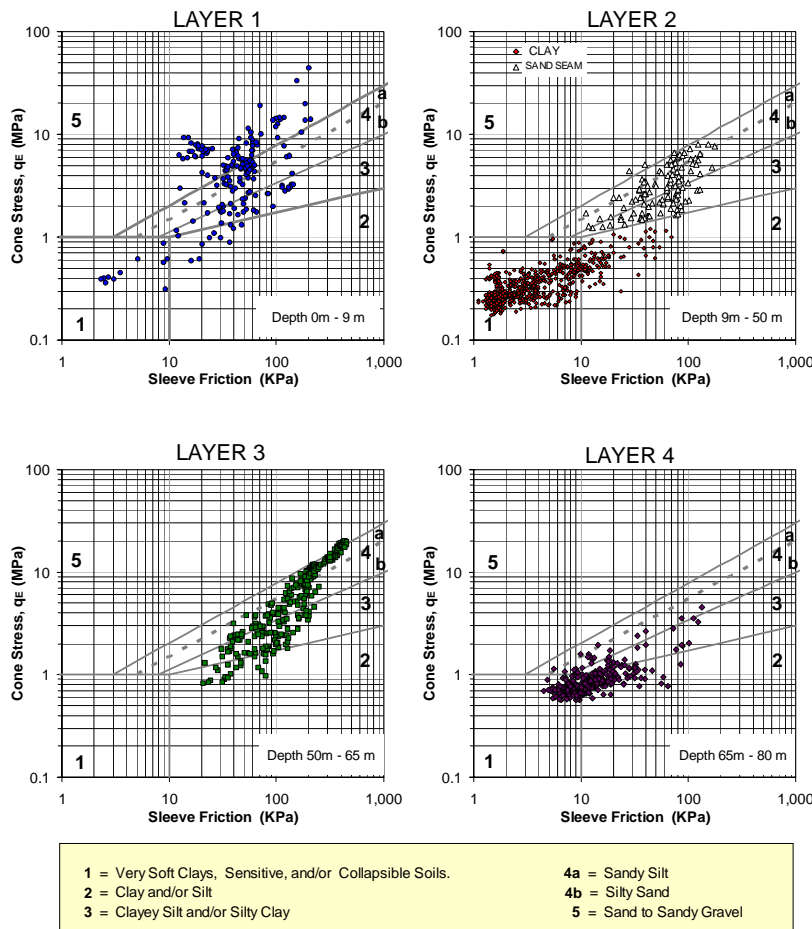
Fig. 2 CPTU soil classification chart according to the Eslami-Fellenius method. The measurements have been plotted separated on the four layers

The results of a soil classification of the CPTU data according to the Eslami-Fellenius CPTU-method (Eslami 1996; Fellenius and Eslami 2000) are presented in Fig. 2. The data points of the CPT sounding have been plotted in four charts, one for each of the four soil layers. For Layer 2, different symbols are used for values classified as clay and for values identifying sand lenses within the clay.

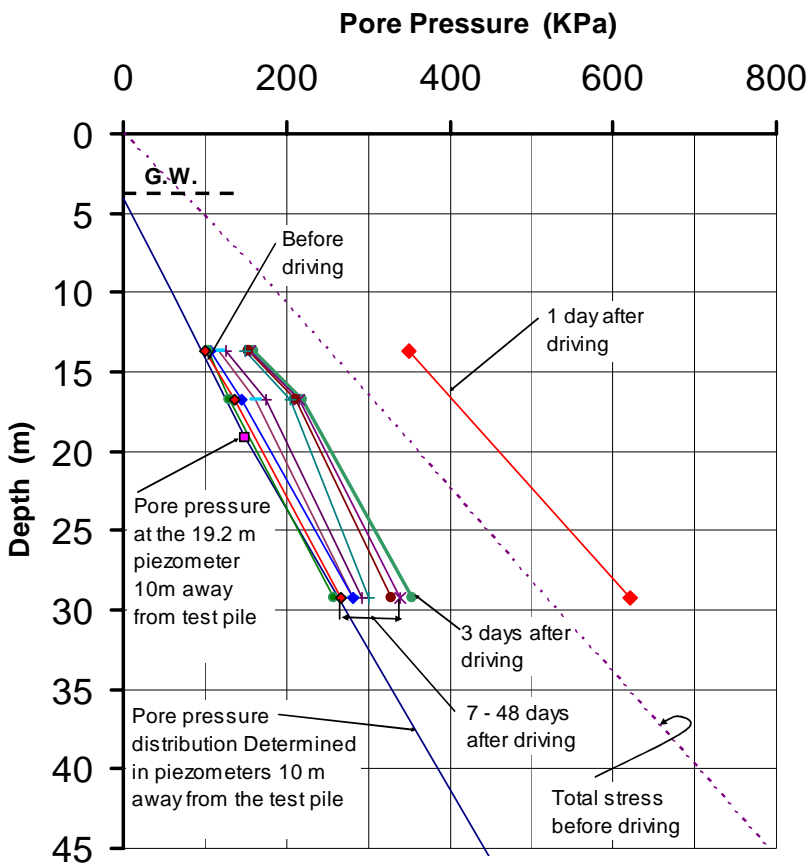
Fig. 3 Pore pressure distribution at the piezometers installed 1.2 m outside the test pile as measured at 1 day through 48 days after driving

To investigate the pore pressures in Layer 2, three additional vibrating wire piezometers were installed at the test site on August 13, 2001, 15 days before the installation of the test pile and reaction piles. All three piezometers were nested in one vertical hole 1.4 m from the center of the test pile location, i.e., approximately 1.2 m away from the surface of the pile. The piezometer tips were placed in Layer 2 at depths of 13.7 m, 16.8 m, and 29.2 m. The pore pressure distribution measured in the new piezometers is consistent with the pore pressures in the piezometer at the depth of 19.2 m, 10 m away. Measurements from 1 day through 48 days after driving are presented in Fig. 3 and show that the pore pressures measured in Layer 2 one day after the driving of the test pile had increased from about 250 KPa to 300 KPa over the pressures existing before the start of the driving of the piles.

The measurements indicate that the pore pressures introduced by the pile driving had essentially dissipated at the time of the static loading test, 48 days after the driving.

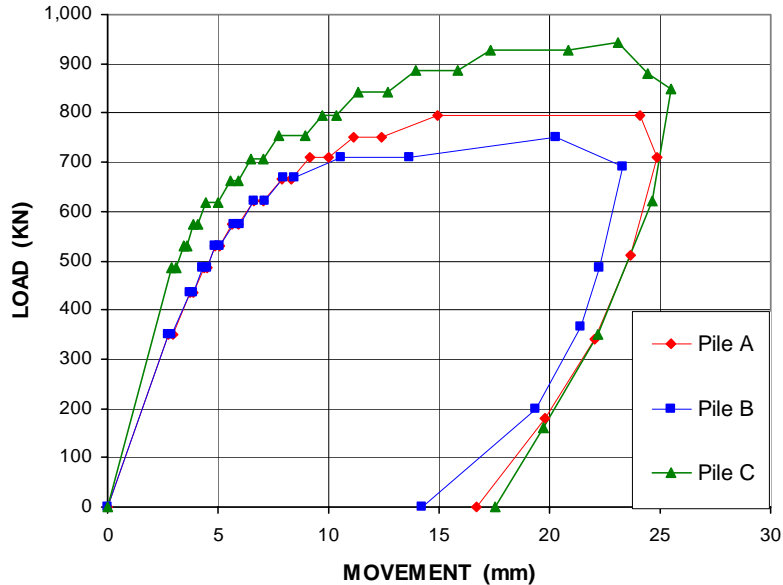
Fig. 4 Results of the 1980 static loading tests on composite piles (Data from Waite et al. 1980)

The authors matched the about 800-KN pile capacities of the test piles in an effective stress analysis, which resulted in a beta-coefficient (β) of 0.18 and a toe-bearing coefficient (N_t) of 5. These are low values. For example, for piles in clay, the Canadian Foundation Engineering Manual (1992) suggests a range of beta-coefficients from 0.25 through 0.32, and a toe bearing coefficient of 9. Fellenius (1999) indicates that the toe bearing coefficient in clay normally ranges from 3 through 30. The authors attribute the low values to insufficient wait time (nine days) between driving and testing.

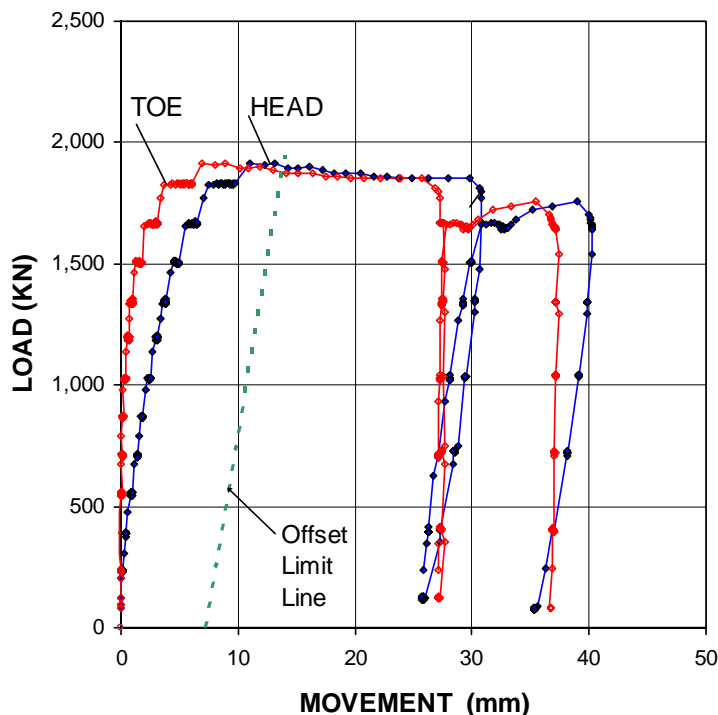
Fig. 5 Load-movement diagram for pile head and pile toe

The load-movement measurements are presented in Fig. 5, showing the applied load versus the pile head movements as well as versus the telltale-measured pile toe movements. At the applied load of 1,670 kN, the movements were small, 6.5 mm and 3.1 mm, respectively. In adding the next load increment of 160 kN (to 1,830 kN), the movements increased by 3 mm. The pile failed in plunging at 1,915 kN load before the intended following load level was reached. The pile head and pile toe movements on reaching this load were 13 mm and 9 mm, respectively. The load-movement curve thereafter showed a softening trend, as evidenced by the decrease in load with increasing movement. The maximum movement of the pile head was 31 mm and, for the pile toe, 27 mm. Immediately after the unloading, the pile was reloaded. The maximum load reached in the test during the second loading, was 1,755 kN, 160 kN smaller than that reached in the first loading — due to loss of strength caused by either further pore water pressure increase or soil remolding.

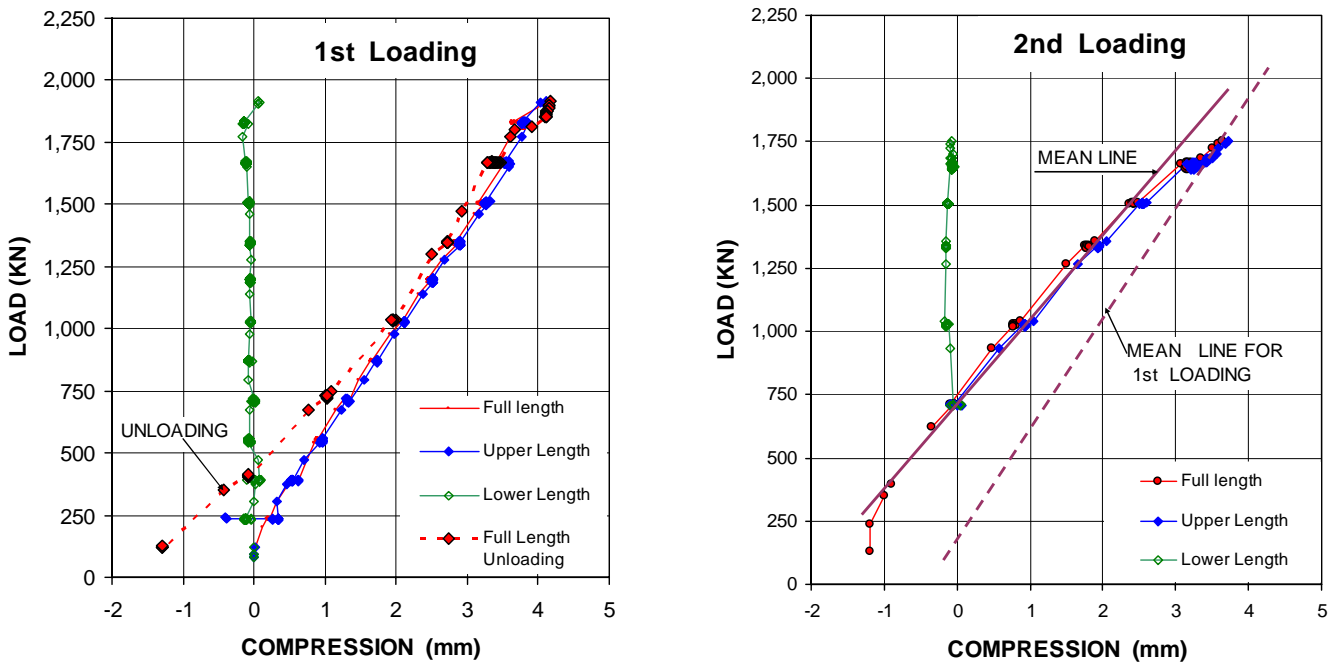
Fig. 6 Pile compression due to the applied load as measured by the telltales

Fig. 6 presents the pile shortening (compression due to the applied load) measured by the telltales for the 1st and 2nd loadings of the pile. The strain-softening response of the soil is evident by that the slope of the unloading curve (only the full length unloading curve is shown) is less steep than the slope of the loading curve. The strain-softening is also indicated by that the slope of the “mean line” loading curve for the second loading is less steep than that for the first loading.

It is noteworthy that very little shortening occurred in the lower 6.45 m length of the pile. This is a sign that this length of the pile was subjected to residual load compressing the pile already before the start of the test. (Residual load is due to negative skin friction along the upper part of the pile, which is resisted by positive shaft resistance along the lower part). The absence of appreciable shortening over the lower length of the pile shows that positive shaft resistance along the lower length and the toe resistance were fully mobilized (by the residual load).

The maximum shortening of the pile is 4.2 mm. After unloading the pile, the telltale measurements show that the pile rebounded 5.7 mm. The reason is that some of the locked-in load has been released and, as a result, the pile rebounds by a greater amount than it compressed in the test.

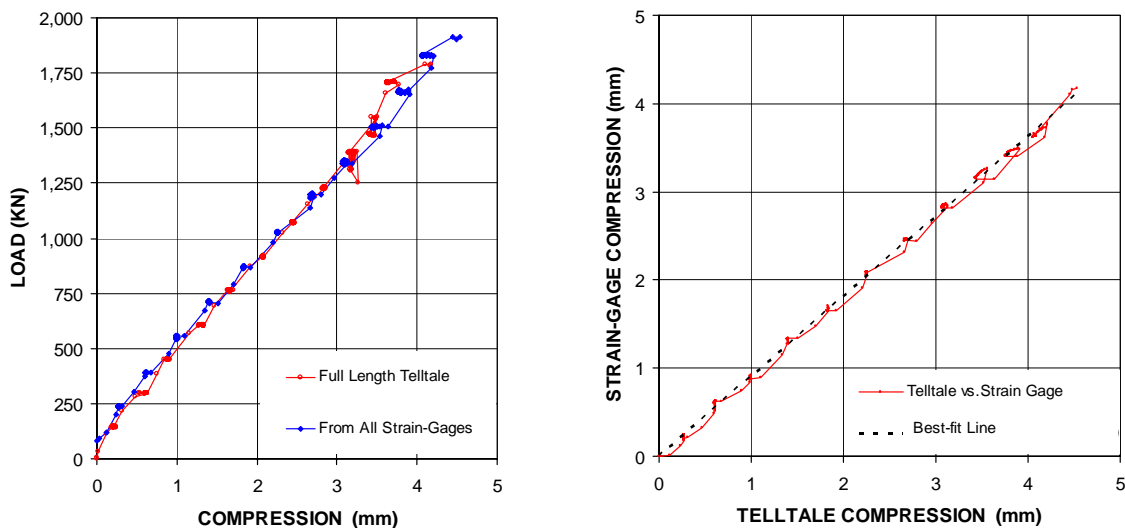
Fig. 7 Comparison of pile compression measured by the full-length telltale and accumulated by the strain-gages

half the distance to the one above and half the distance to the one below). The so calculated compressions for the applied loads are presented in the left diagram of Fig. 7 together with the compressions measured by the full-length telltale. The method for calculating the shortening presumes a linear distribution of strain and load as opposed to the more probable curved distribution, which means that the method underestimates the accumulated strain values.

The diagram displays a very good agreement between the two independent methods of determining the pile compression. This observation is reinforced by the right side diagram showing the compression calculated from the strain-gages versus the compression measured by the full-length telltale. Because of the mentioned underestimation of the accumulated strain value, the telltale measurements indicates slightly larger shortening of the pile. The overall agreement supports the conclusion that both system of gages have provided reliable data. Note, strain gage instrumentation is for measuring load, and compression calculated from accumulating strain-gage values should only be used in lieu of telltale measurements. Telltale instrumentation is for measuring movement, e.g., pile toe movements, that can be accepted within an accuracy of only about a millimetre. Due to the low accuracy, load values calculated from telltale data are at best approximate, but if lacking other means, telltale data can be used to determine approximate values of load as averages over a length of pile.

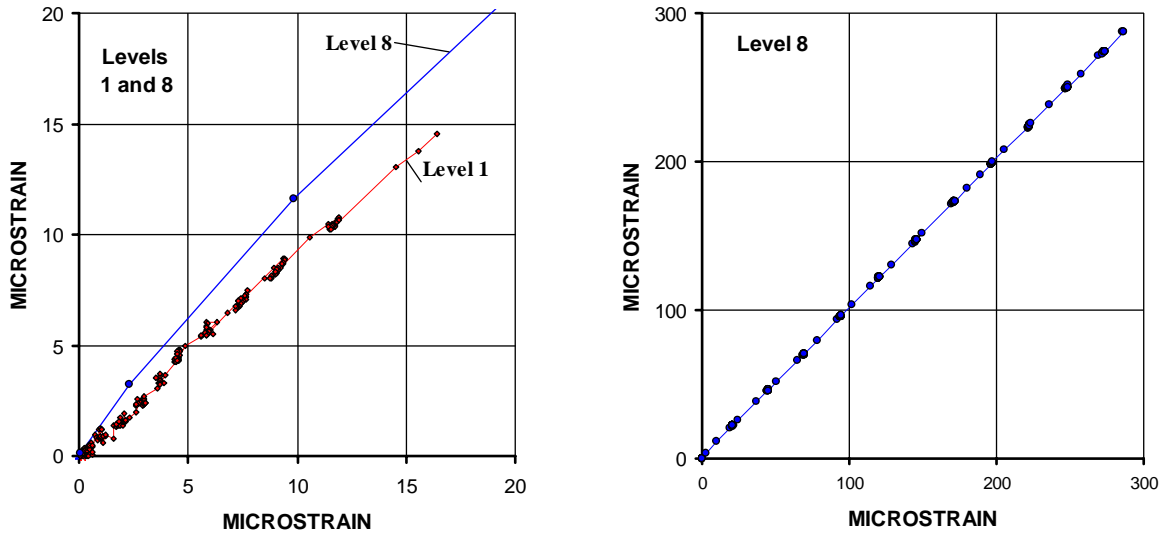
Fig. 8 Comparison between pairs of strain-gage measurements at Levels 1 and 8

The doubling up of the vibrating wire strain gages at Levels 1 and 8 allows a comparison between the two pairs, as presented in Fig. 8. Very small strain values were recorded at Level 1, whereas relatively larger strain values were recorded at Level 8, which is why two separate diagrams are necessary to present the data. For the Level 8 larger strain values, the data plot on a 1:1 line showing that equal strain values were recorded by the two gage pairs. The agreement between the records of the two pairs provides a considerable confidence in the accuracy of the strain-gage data. Due to the small strains measured at Level 1, the small error in each value is more apparent than it is for the plot of the Level 8 strain values. At small strains, the records at both levels are slightly off from a 1:1 agreement.

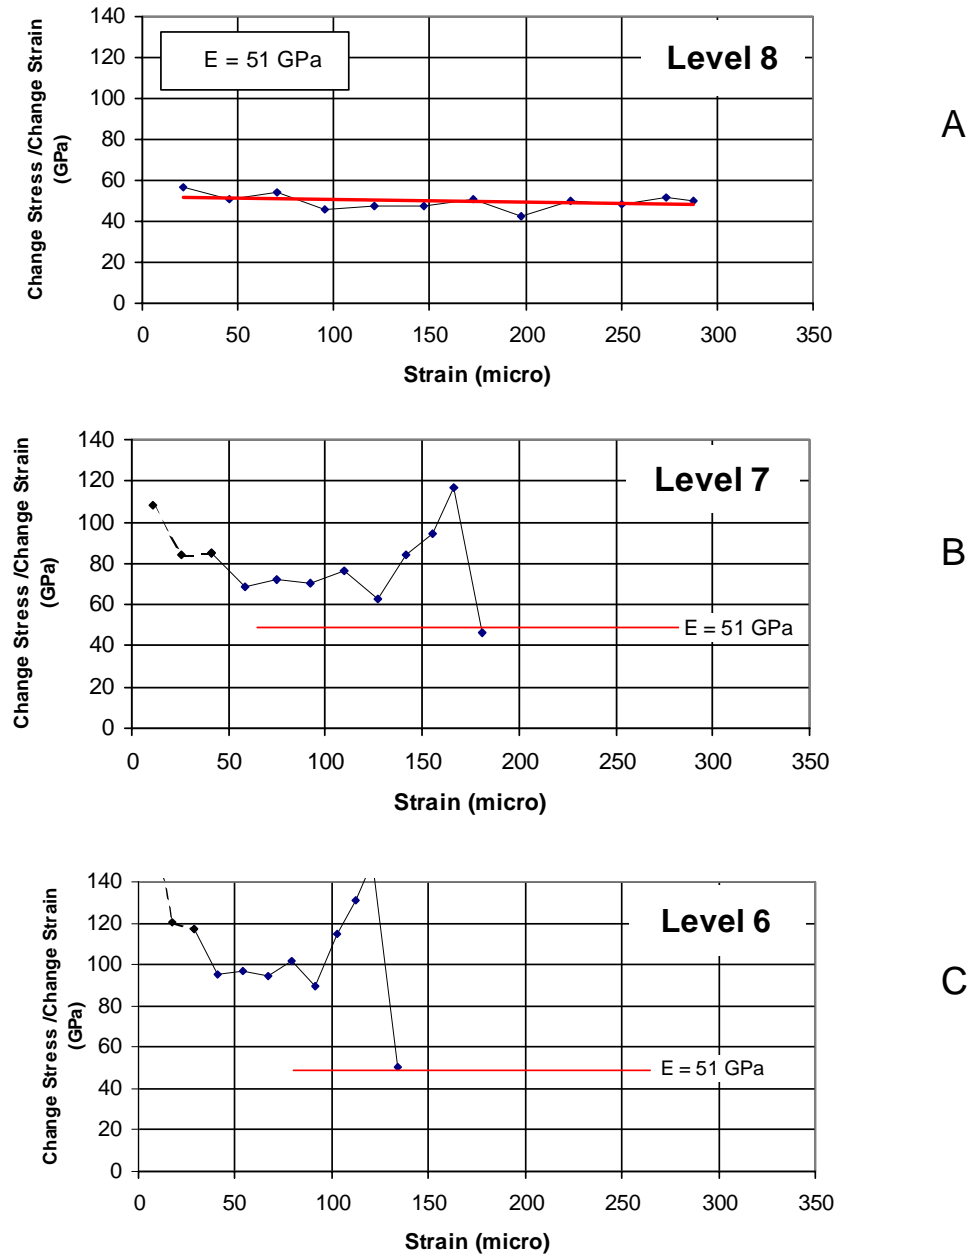
Fig. 9 Tangent modulus versus strain for strain gage Levels, 8, 7, and 6

The analogous tangent modulus evaluation for the values recorded at Levels 7 and 6 shown in Figs. 9B and 9C do not establish a modulus. This is because of three factors:

1. The pile is very stiff, resulting in nearly equal magnitude of movement at Levels 7 and 6.
2. The pile toe resistance is very small. More toe resistance would have allowed measurement values beyond the level of full mobilization of the shaft resistance.
3. The soil exhibits a strain-softening response. As indicated, for both Levels 7 and 6, shaft resistance was still building up until the next to last increment and only the values for the last increment established the modulus.

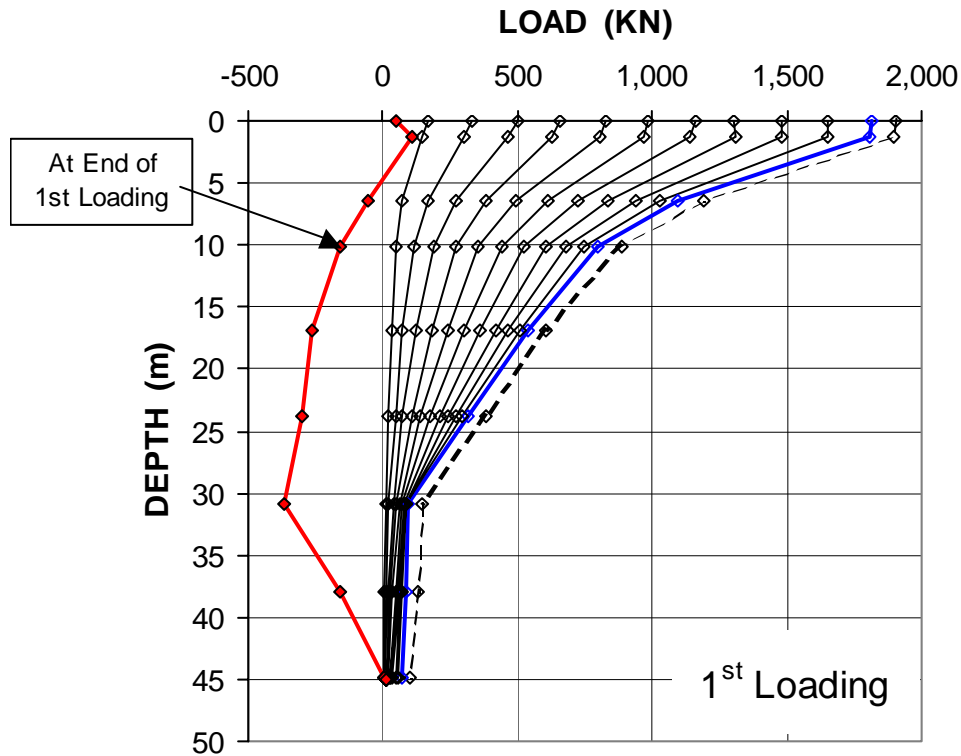
Fig. 10 Measured load distributions for 1st loading with loads in relation to readings at start of test

The loads determined from the strain values measured at the eight vibrating wire gage levels were calculated with reference to the change of strain from the start of the loading test (i.e., as if assuming the loads in the pile to be zero at the start of the test). These measured load values are presented in Fig. 10 in the form of load-distribution curves showing the load at the each strain gage location along the pile for each load applied to the pile head. Also shown is the similarly calculated loads in the pile after removing the applied load — but for a load of 60 KN left on the pile head to keep jack, load cell, and spacers in compression.

The loads in the pile after unloading appear to indicate that tension loads developed as result of the loading test. This is false. The tension loads are due to a release of some of the residual load in the pile. As mentioned earlier on, this is also indicated by that the pile rebounded to longer total length than its length before the test.

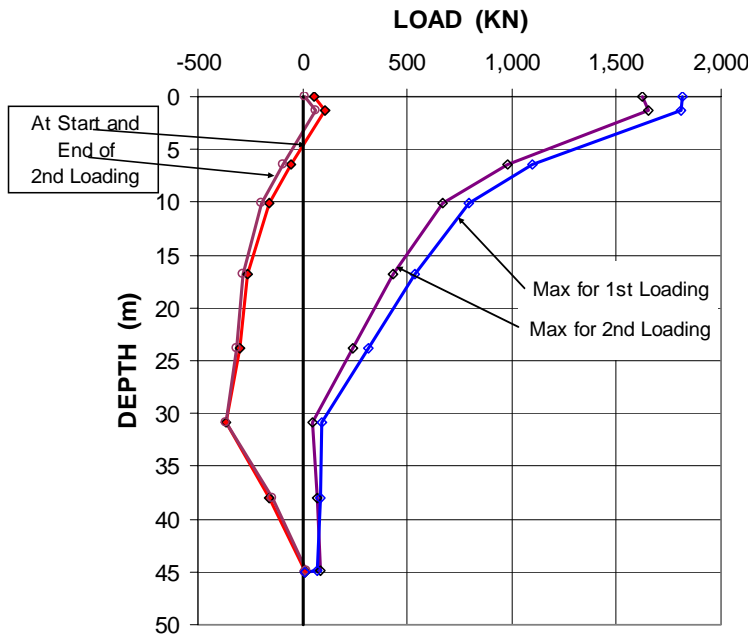
Fig. 11 Measured load distributions for 1st loading and 2nd loading combined

As shown in Fig. 11, between the depths of 10 m and 30 m, the slope of the load distribution curve (at the maximum load) for the 2nd loading is slightly steeper than that for the 1st loading, indicating that the engaged

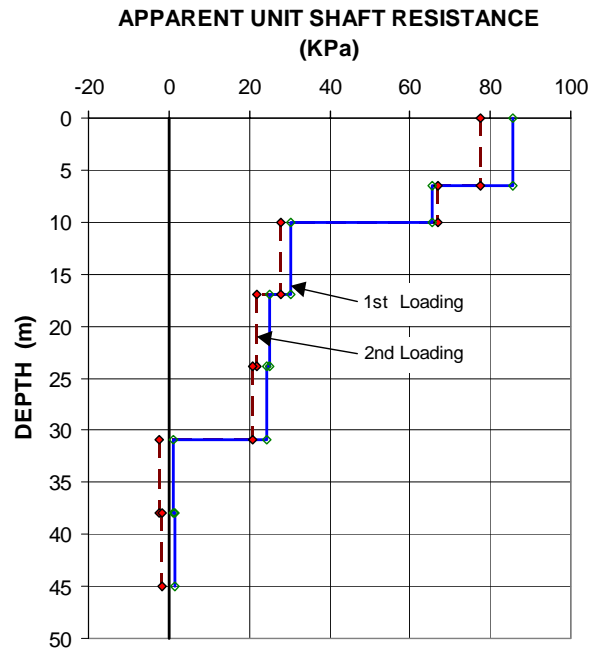
Fig. 12 Distribution of Apparent Unit Shaft Resistance

shaft resistance was smaller for the 2nd loading as opposed to the resistance for the 1st loading. Fig. 12. shows the distributions of apparent unit shaft resistance for the two loadings as determined from the average change of measured load between gage locations divided by the distance between the gage locations and the circumference of the pile. Both distributions falsely suggest that no resistance was obtained below about 30 m. Moreover, the small negative values in the lowest portion of the pile measured at the 2nd loading are due to the release of residual load.

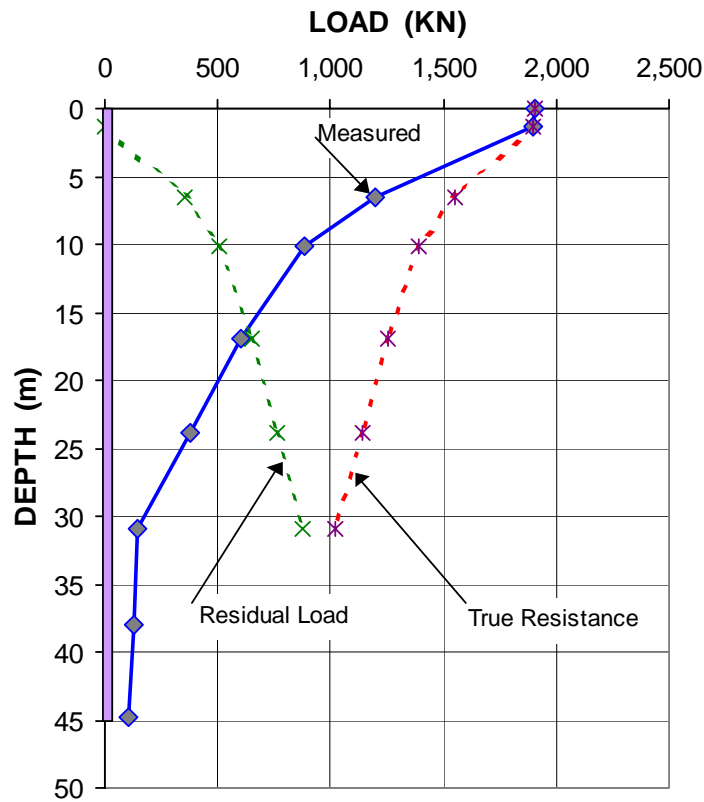
Fig. 13 Beginning of construction of the distributions of maximum true resistance and residual load (Fully mobilized negative skin friction is assumed)

The measured load distributions shown in Figs. 10, 11, and 12 exclude the distribution of residual load in the pile at the start of the test. Down to the depth of the neutral plane—the location of equilibrium between the negative and positive direction shear forces locked into the pile—the true resistance is the measured load plus the residual load. The true resistance is the fully developed positive shaft resistance along the pile. When the residual load is due to fully developed negative skin friction down to the depth of the neutral plane, the true resistance is half the apparent resistance and is easily calculated from the measured loads. The details of the method are presented by Fellenius (2002a; 2002b). The construction of the so-determined distributions of true resistance and residual load are shown in Fig. 13. The diagram includes the loads determined from the gage readings taken immediately before the start of the test.

The distributions of true resistance and residual load cannot be determined as easily below the neutral plane. However, in a uniform soil, as in the current case, the assumption can be made that the conditions for the true resistance in the soil above the neutral plane prevail in the soil below the neutral plane and the distribution of true resistance can be extrapolated to the toe of the pile. This extrapolation requires matching the three curves in an effective stress analysis.

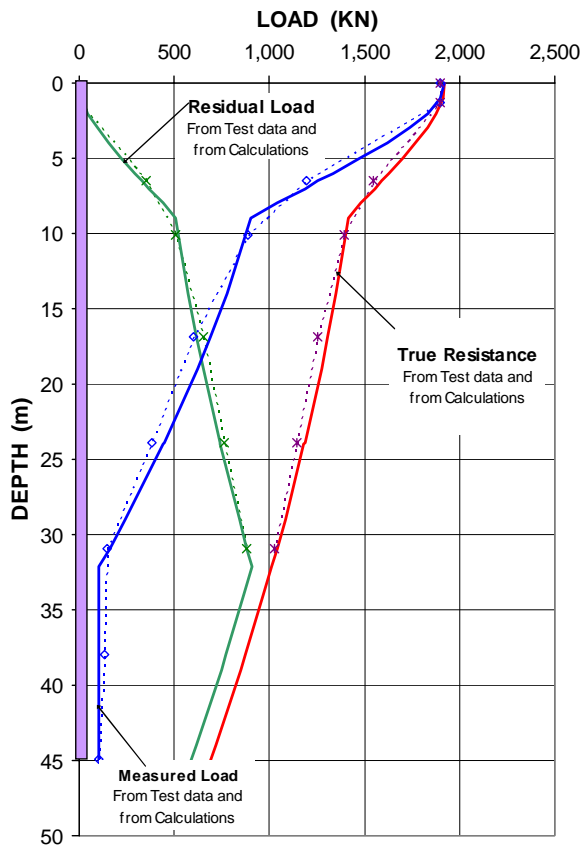
Fig. 14 Results of effective stress calculation assuming fully mobilized residual load

The calculation results based on the upper boundary conditions are presented in Fig. 14. The agreement (match) to the measured loads is obtained from a curve fit using a beta-coefficient of 0.7 in the upper sand layer, which is a reasonable value for a sand, albeit somewhat high, and a beta-coefficient of 0.07 throughout the clay, which is an extremely low value. The match also results in a toe coefficient, N_t , equal to 15, which magnitude, however, conflicts with the low beta-coefficient for the clay. Therefore, the true shaft resistance is in all likelihood larger and the toe resistance smaller than what is indicated by the upper boundary calculations. It is obvious that the assumption of fully mobilized residual load acting on the pile before the start of the test is only valid along the uppermost and lowest lengths of the pile, that is, the length of the transition zone must be long. A more probable distribution of residual load in the pile is determined as follows.

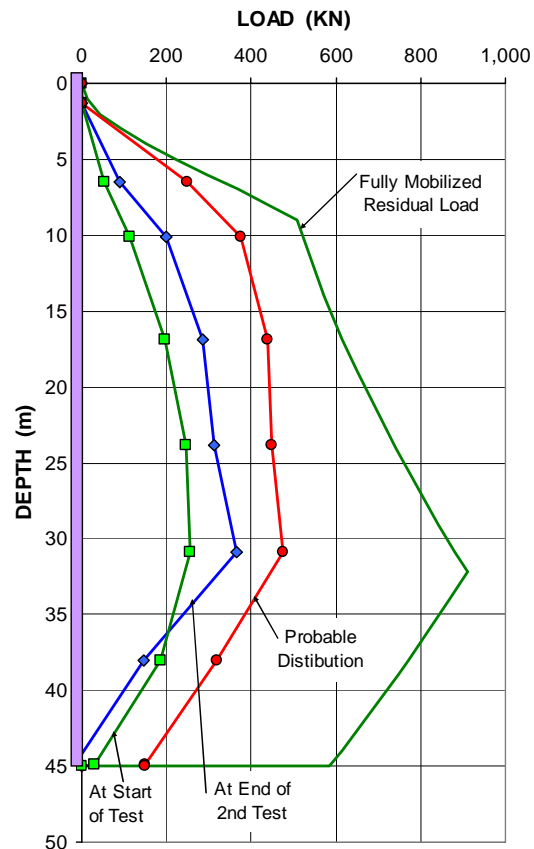
Fig. 15 Comparisons between distributions of residual load

unloading (1st test), and change of load at start of test per factory no-load calibration

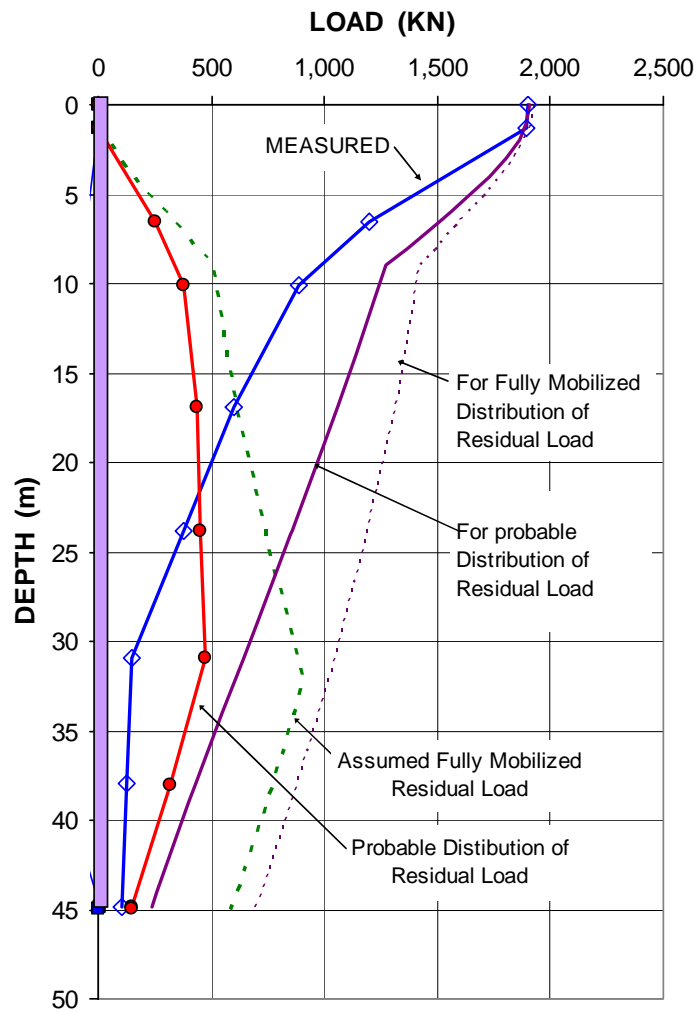
Fig. 16 True load distributions after correction for residual load with resistance distributions for fully mobilized residual load and the probable distribution of the residual load

Fig. 16 presents the distribution of residual load, measured load, and true load in the pile. (For comparison, the upper boundary distributions of residual load and true resistance have been added to the figure). The true resistance distribution is obtained by adding the residual distribution to the measured distribution. Matching the true resistance distribution in an effective stress analysis, results in beta-coefficients in the sand of 0.8 above 5 m depth and 0.7 below. In the clay, the beta-coefficients are 0.15 at 9 m depth reducing to 0.07 at the pile toe level at 45 m depth. The maximum toe resistance is small. The toe coefficient, N_t , is 6 and it is likely that the presence of the sand layer at the pile toe has had no strengthening effect.. The values in the clay are very small, but equally so for both shaft and toe coefficients.

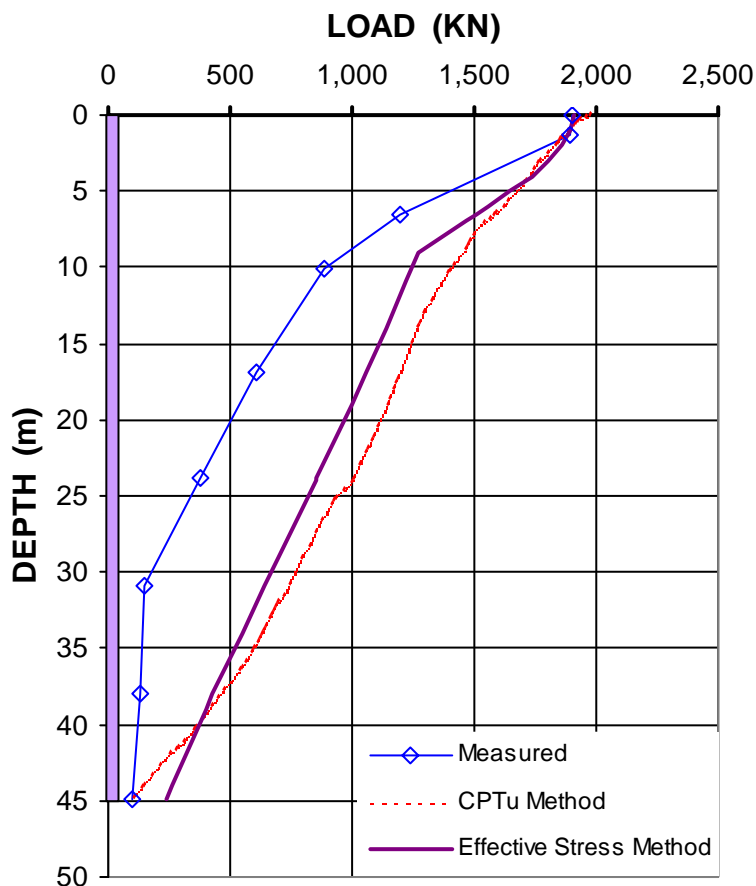
Fig. 17 Estimated true resistance distribution according to Eslami-Fellenius CPTU method and according to measured results adjusted for residual load

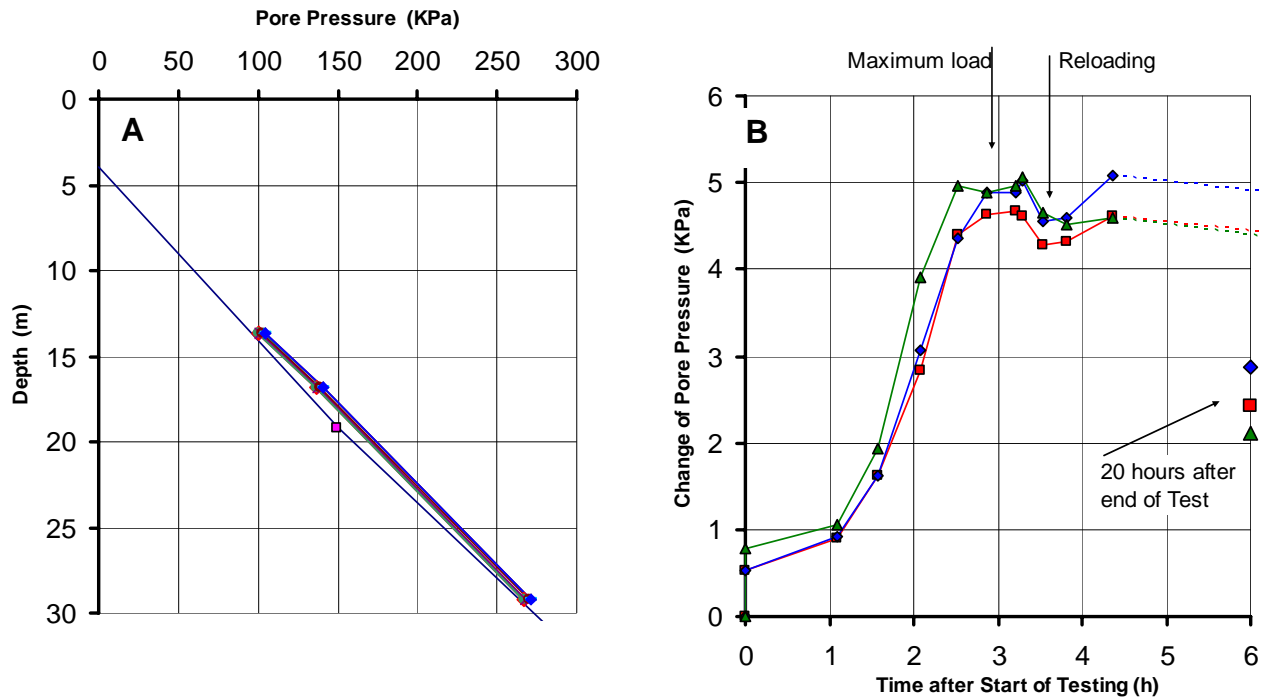
Fig. 18 Pore pressures measured during the static loading test in the piezometers at 1.2 m away from the test pile

During the static loading test, the pore pressures in piezometers installed at a distance of 1.2 m away from the test pile (depths of 13.7 m, 16.8 m, and 29.2 m) were continuously recorded. The measurements are presented in Fig. 18. The records indicate a slight increase in pore pressure occurred during the test as compared to values before the test. The right diagram (Fig. B) shows the relative increase of pore pressures during the test. The measurements show that the small movement of the pile, about 10 mm, in relation to the soil generated about 5 KPa pore pressures.

Although the relative increase of pore pressure is small, the authors find it unexpected that the small movement of the pile, in particular during the unloading and reloading of the pile, would have a measurable effect as far as 1.2 m distance away from the pile. The low beta-coefficients were applied to the effective stresses based on an over-all pore pressure distribution at the site. It may be argued that the pore pressures next to the pile surface increased before the maximum shear was reached in the static loading test, thus reducing the effective stress near the pile surface. Had it been possible to consider such increase of pore pressure and coupled decrease of effective stress, the back-calculated coefficients might have been larger and more in line with values expected in clay. However, were this true, then, the shaft resistance along the lower 15 m length of the test pile would have reduced as the test progressed and shown a negative load and no such negative load was measured.
