FELLENIOUS, B.H., KIM, S.R., and CHUNG, S.G., 2009. Long-term monitoring of strain in instrumented piles. *ASCE Journal of Geotechnical and Geoenvironmental Engineering*, 135(11) 1583-1595.

Long-Term Monitoring of Strain in Instrumented Piles

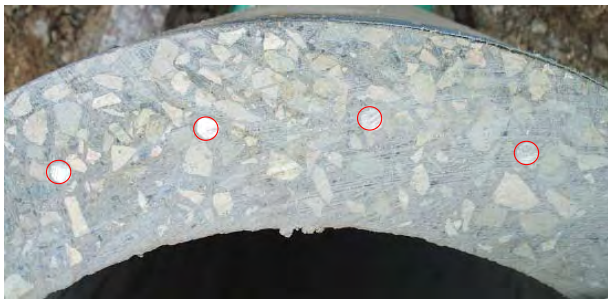
Fig. 1 Photo of the PHC cylinder pile cross section. Four prestressing rebars are circled in red.

The PHC test pile used at the site is a 600 mm outside diameter prestressed concrete cylinder with an 85 mm wall (cross section area = 1,375 cm²) embedding twenty-four 9.2 mm rebars (steel area to concrete area ratio of 1.1 %) anchored to steel end plates with a 430 mm central hole. The net prestress is about 8 MPa. The pile is cast in 5 m to 15 m segments. The segments are spliced by welding the end plates together in the field, one splice at a time as the pile is driven. The concrete consists of Portland cement and concrete aggregates of crushed granite. The nominal cube strength is 80 MPa. Figure 1 shows a photograph of a portion of the pile cross section.

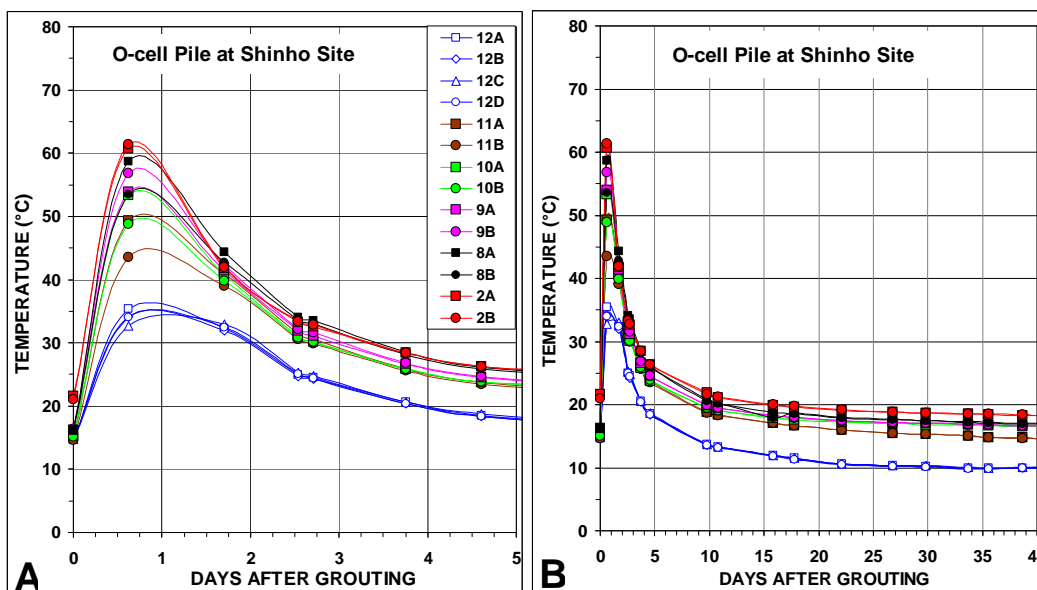
Fig. 2 Development of temperature in the O-cell pile at the Shinho site.

As shown in Figure 2, the hydration process of the cement grout gave rise to a steep increase of temperature during the first about 15 hours after grouting the pile, whereafter the temperature diminished at a progressively smaller rate to a stable temperature after about ten days.

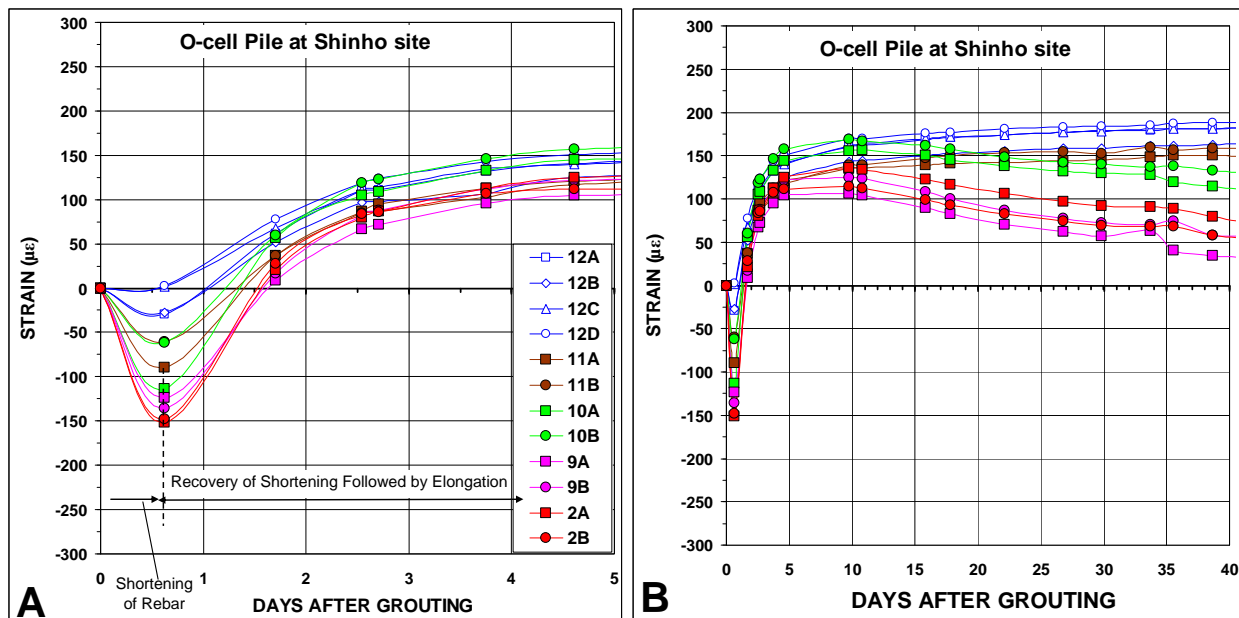
Fig. 3 Development of strain in the O-cell pile at the Shinho site.

The recorded strain changes in the rebars are shown in Figure 3. During the first 15 hours, coinciding with the increase of temperature, the vibrating wire readings decreased, that is, the rebars shortened, suggesting increasing compression in the pile. When the temperature reduced, the readings indicated that the rebars first recovered the shortening and then elongated, suggesting that tension developed in the pile. When the temperature had stabilized, which took about ten days, the measurements indicated a net tension in the pile.

The strain values are not adjusted to the difference in thermal coefficients between the rebar and the concrete and grout. Adjustment (see discussion below) would have reduced the values somewhat during the first few days, when the temperature kept changing. However, the later elongation—tension trend—of the rebars at constant temperatures would still occur.

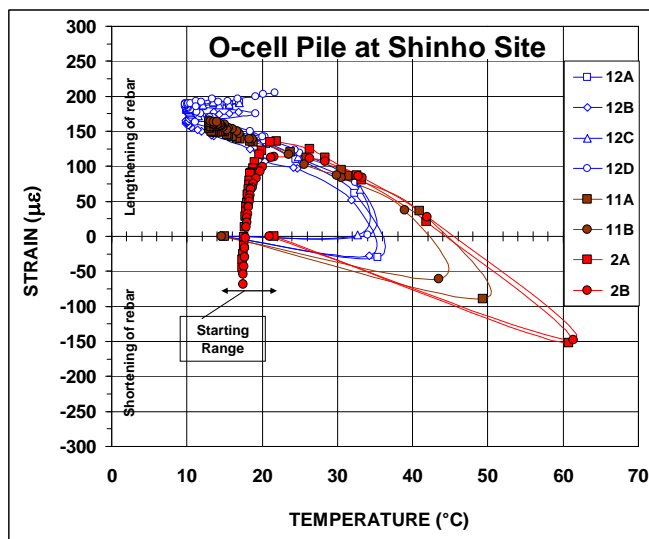
Fig. 4 Development of strain versus temperature in the O-cell pile at the Shinho site.

The temperature dependency is more clearly demonstrated in Figure 4 showing the strains as a function of the recorded temperature.

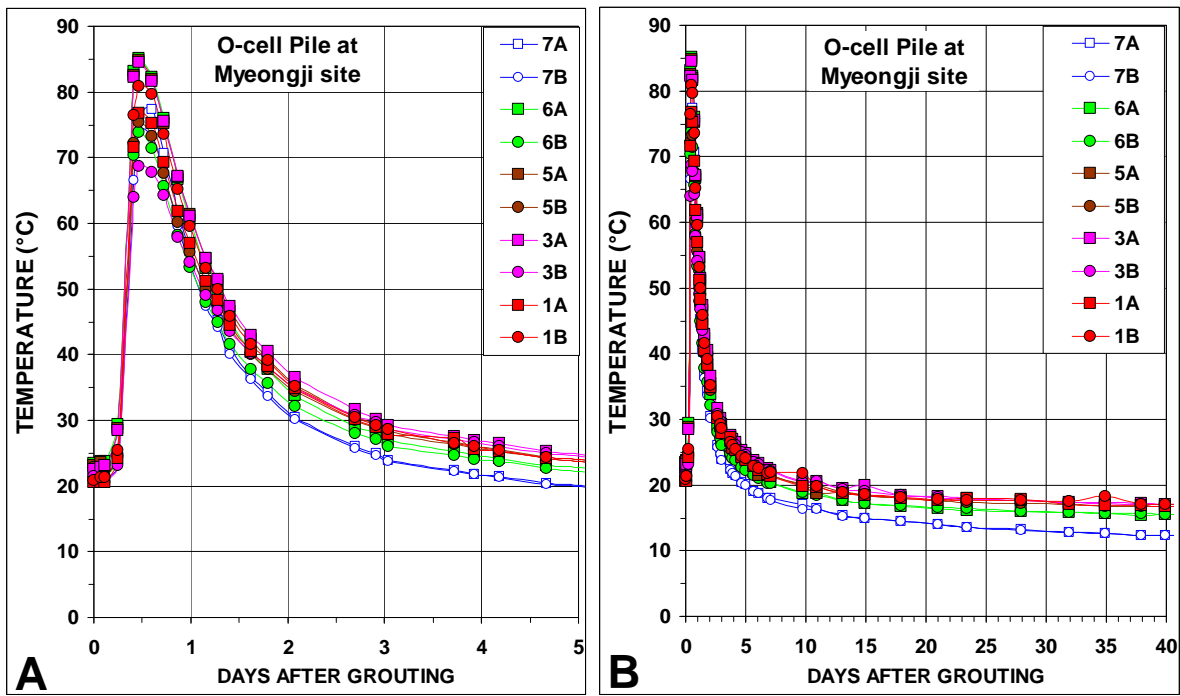
Fig. 5 Development of temperature in the O-cell pile at the Myeongji site.

Figures 5 through 7 show the similar development of temperature and strain recorded by the gage-pairs placed in the O-cell pile at the Myeongji site. The uppermost gage pair is marked #7A and #7B. The strain values shown are from single gage pairs (#7, #6, #5, #3, and #1) placed at depths of 4 m, 9 m, 14 m, 24 m, and 30 m below the ground surface. Intermediate gage records are omitted for clarity. The trends of temperature strain developments in the Myeongji pile are similar to that of the Shinho pile. However, the recorded temperature and strains are much larger for the Myeongji pile. The difference could be due to the different water/cement ratios of the grout for the piles, 33 % as opposed to 45 %, respectively.

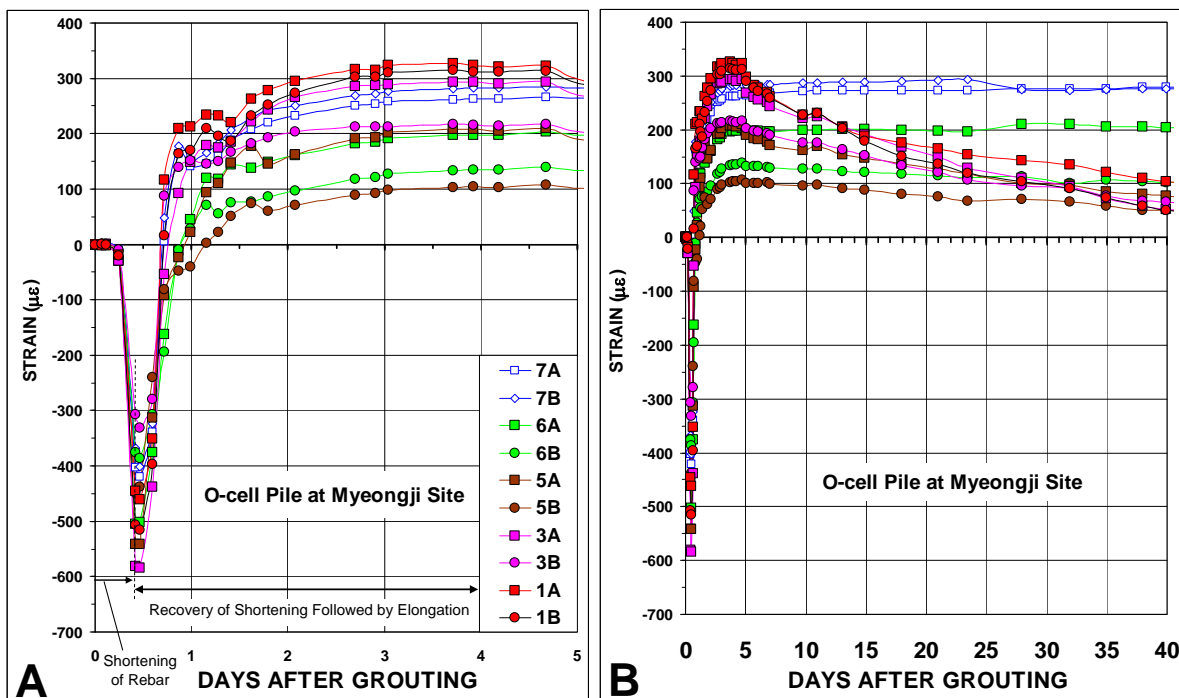
Fig. 6 Development of temperature in the O-cell pile at the Myeongji site.

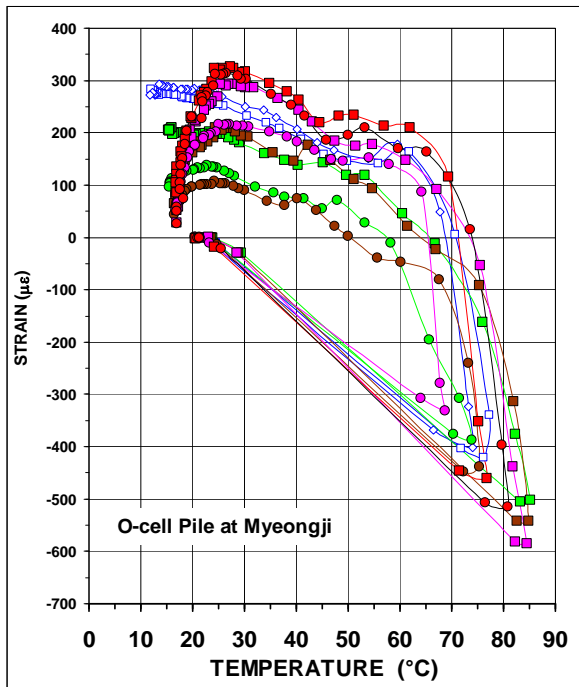
Fig. 7 Development of strain versus temperature in the O-cell pile at the Myeongji site.

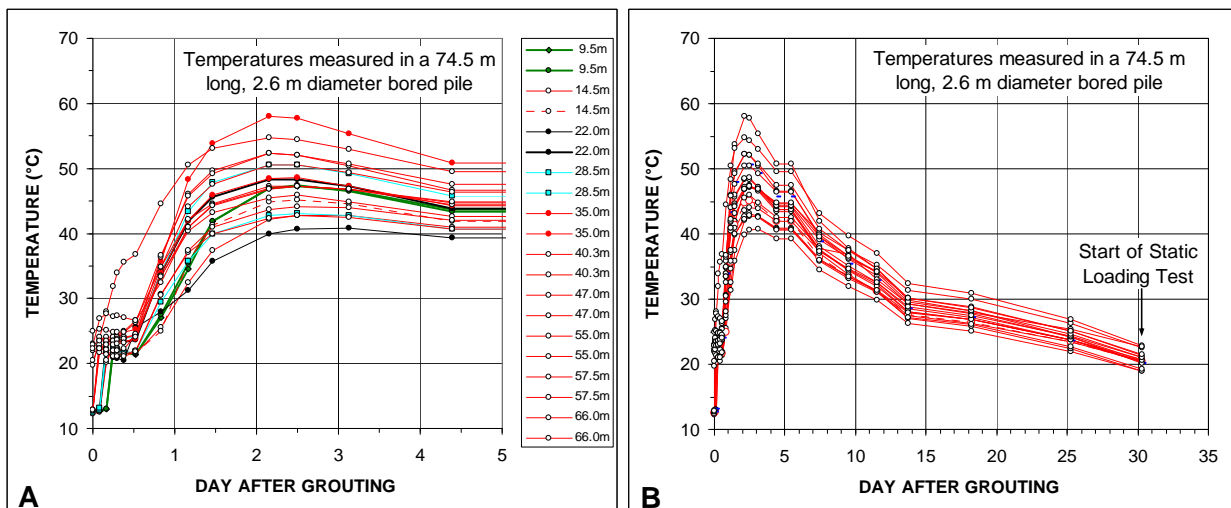
Fig. 8 Temperature records during curing of grout in the Golden Ears Bridge test pile. (Data courtesy of Trow Engineering Inc. and Amec Inc., Vancouver, BC).

For comparison, measurements are offered of strain in a bored pile during the curing of the concrete taken in a 74.5 m deep, 2.6 m diameter pile constructed in 2006 in the Fraser River deltaic soil, Golden Ears Bridge, Vancouver, BC. A 22 m long permanent steel casing was installed prior to concreting. The pile was instrumented with ten levels of vibrating wire strain-gage pairs Type Geokon. The most shallow gage level was at 9.5 m depth and the deepest was at 66 m depth. No information is available on the composition of the grout. The measurements were taken from the grouting of the pile until the start of a static loading test (multi-level O-cell test), 35 days later. Figure 8 shows the temperature measurements at the gage levels. The maximum temperature is approximately the same as for the Shinho pile, but it took two to three times as long to reach. At the time of the static loading test, most but not all hydration heat had dissipated. The measured temperatures varied between individual gages and depths, but there was no correlation to depth or to whether a gage level was inside or below the upper 22 m casing.

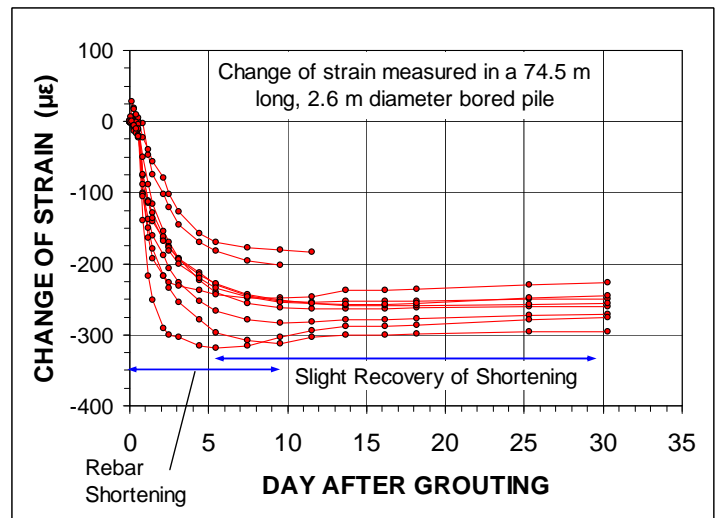
Fig. 9 Change of strain during the curing of grout in the Golden Ears Bridge test pile. (Data courtesy of Trow Engineering Inc. and Amec Inc., Vancouver, BC).

The recorded changes of strain in the Golden Ears bored pile are presented in Figure 9. All curves shown are from uncased portion of the pile. During the first five to ten days, the strain measurements show that the rebar shortened. Thereafter, a slight recovery of shortening occurred. There was no net elongation of the rebars.

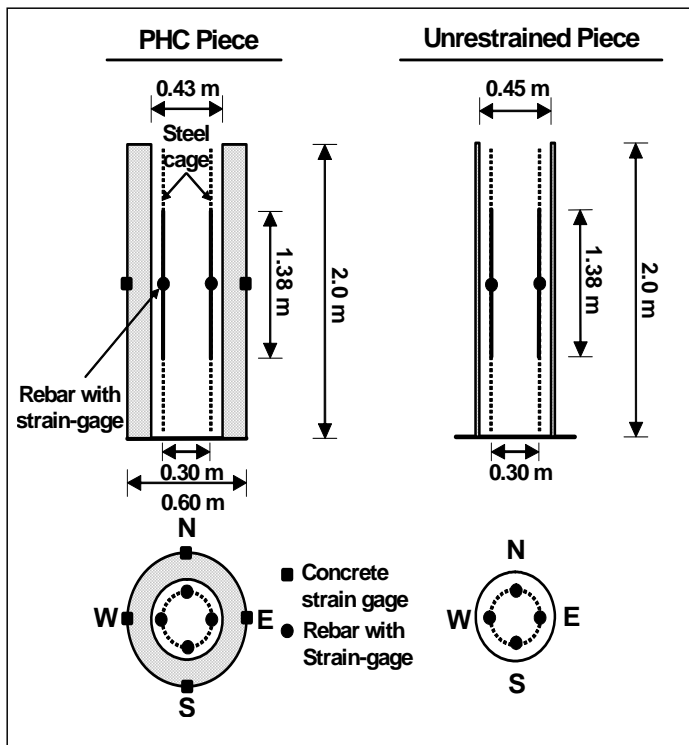
Fig. 10 Arrangement of gages in the two short pieces

The laboratory study started on April 25, 2006. Figure 10 shows a sketch of the short-piece test arrangement.

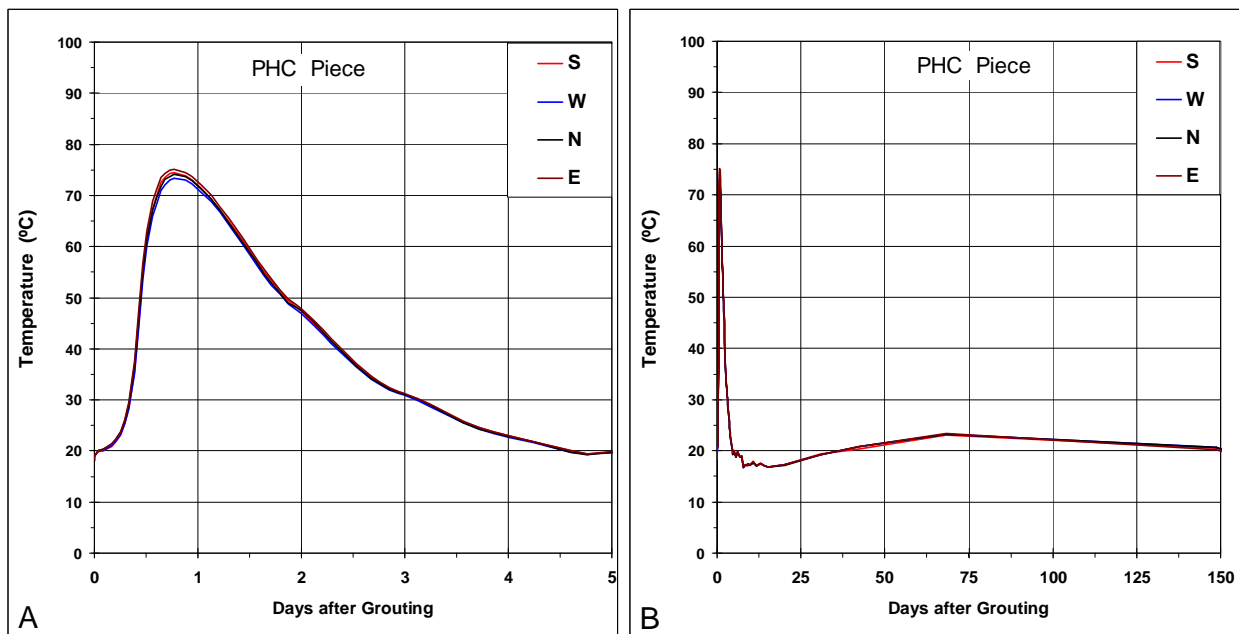
Fig. 11 Measurements of temperature in the PHC piece during first 150 days after grouting..

As indicated in Figures 11 and 12, the temperature development is very similar for the two pieces and similar to the observations in the piles. The slight temperature change beyond the first five days is due to the fact that the short pieces were placed in the outside and the temperature was affected by the changing ambient air temperature between April and July in Busan.

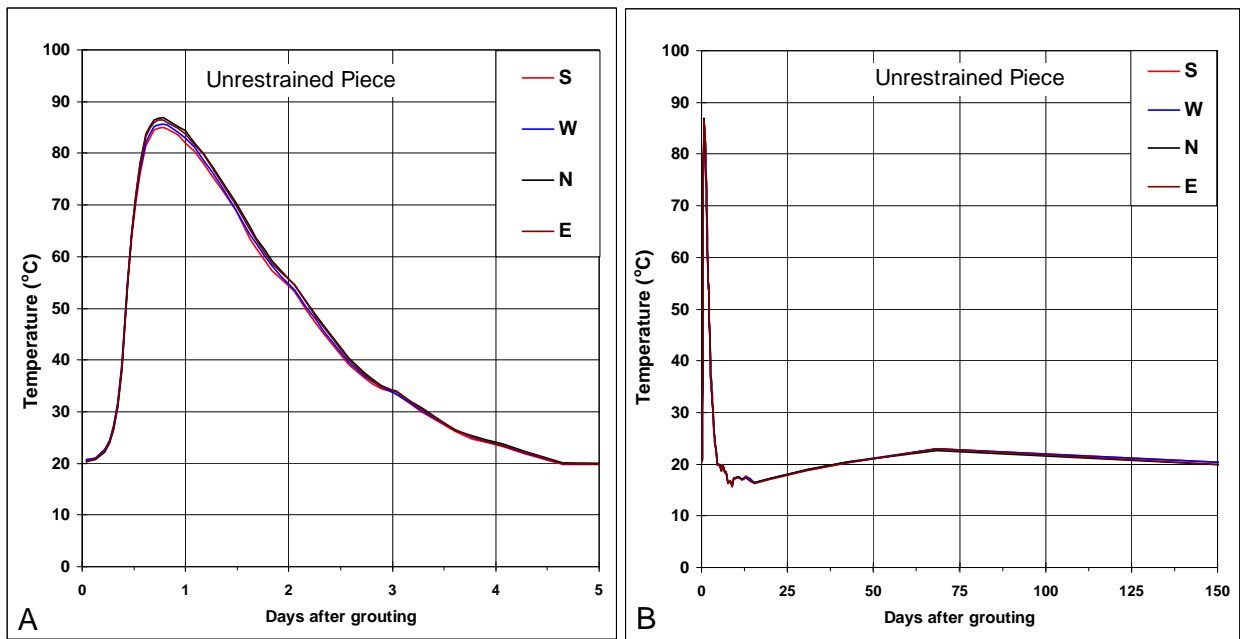
Fig. 12 Measurements of temperature in the unrestrained piece during first 150 days after grouting.

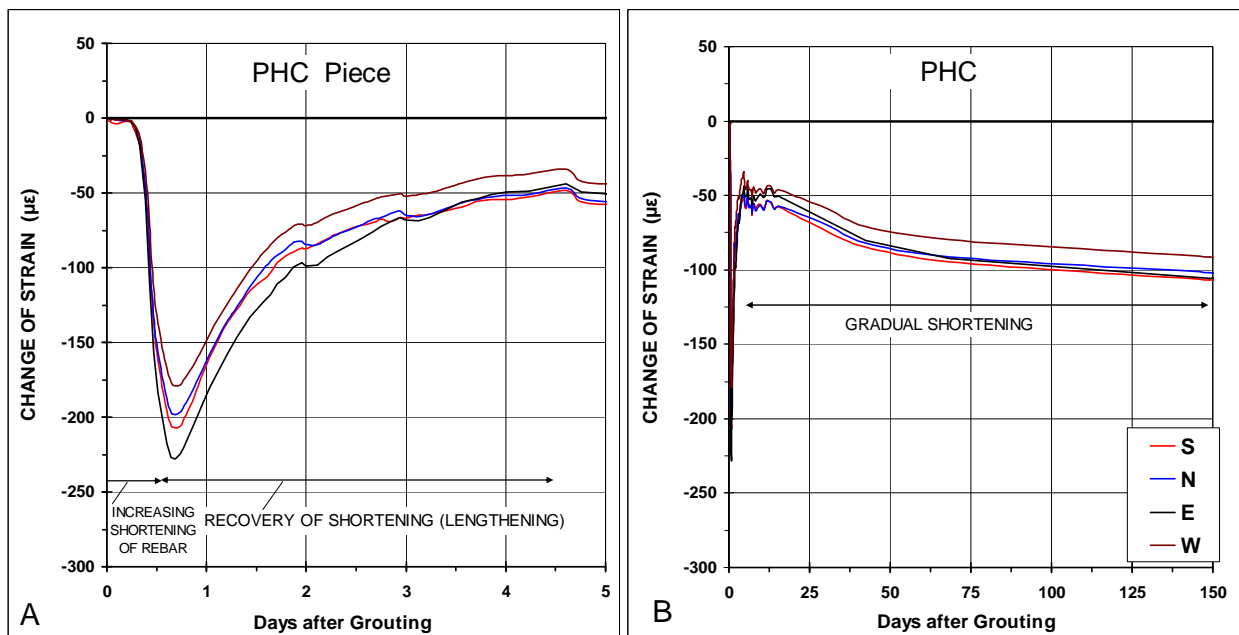
Fig. 13 Rebar strain in the PHC short piece recorded during first 5 days and the first 150 days after grouting. The strain values have not been adjusted for the difference in thermal coefficient between the rebars and the concrete and grout.

The development of strain in the PHC piece is shown in Figure 13. Again, the strain values have not been adjusted for temperature. The values indicate a shortening of the rebars as the temperature increases followed by a recovery of the shortening during the subsequent cooling. The trend is similar to that observed in the piles. However, after the cooling is completed, the PHC piece is left with a shortening, about $50 \mu\epsilon$,

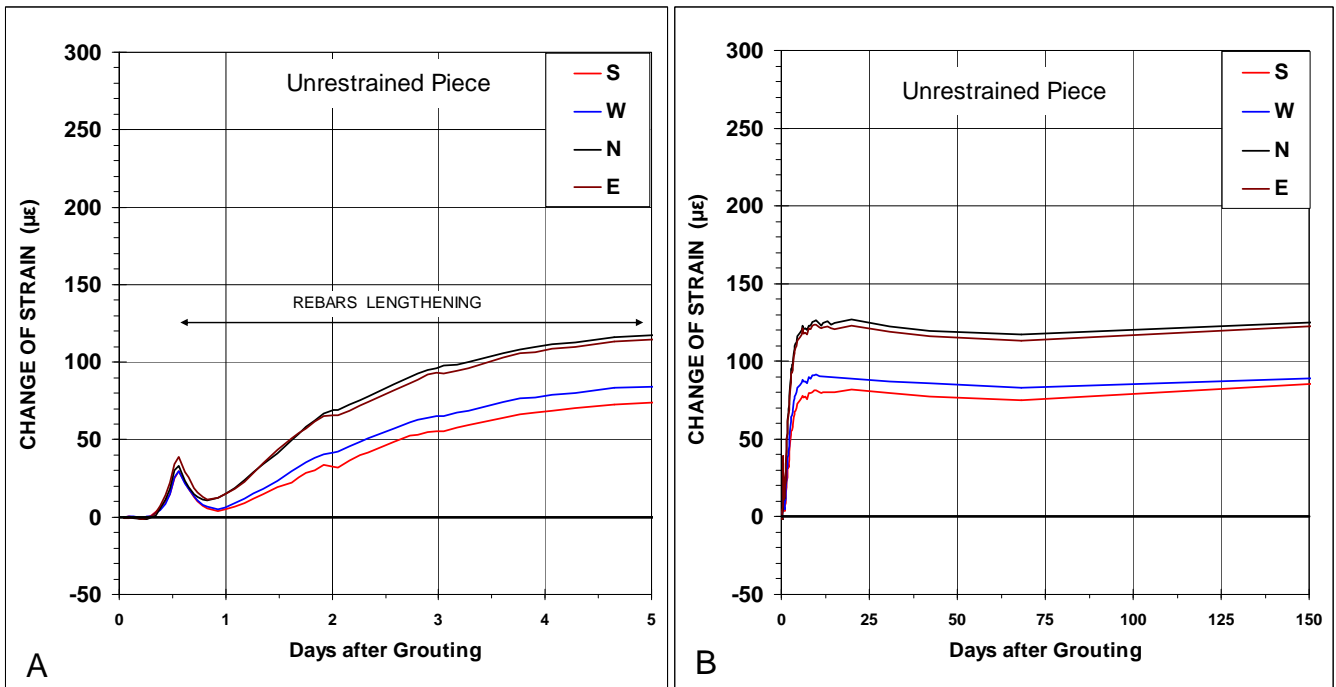
Fig. 14 Rebar strain in the unrestrained short piece recorded during first 5 days and first 150 days after grouting. The strain values have not been adjusted for difference in thermal coefficient between the rebars and the concrete and grout.

The development of strain in the unrestrained piece, as shown in Figure 14, differs from that of the PHC piece, indicating the substantial effect of the restraining concrete cylinder wall on the rebar strains. In fact, it is not just that the strains are smaller, the trend during the large rise of temperature and subsequent cooling observed during the first about 15 h is reversed for the unrestrained piece. When the temperature returned to the ambient temperature, the rebar of the unrestrained piece was left with a net elongation of about $100 \mu\epsilon$, in contrast to the rebar in the PHC piece where the net change was a net shortening of about $50 \mu\epsilon$. Moreover, after the return to stable temperature at about Day 10, the PHC piece shows a gradual shortening of about $50 \mu\epsilon$ until Day 100, whereas the unrestrained piece shows essentially no strain change between Day 10 and Day 100.

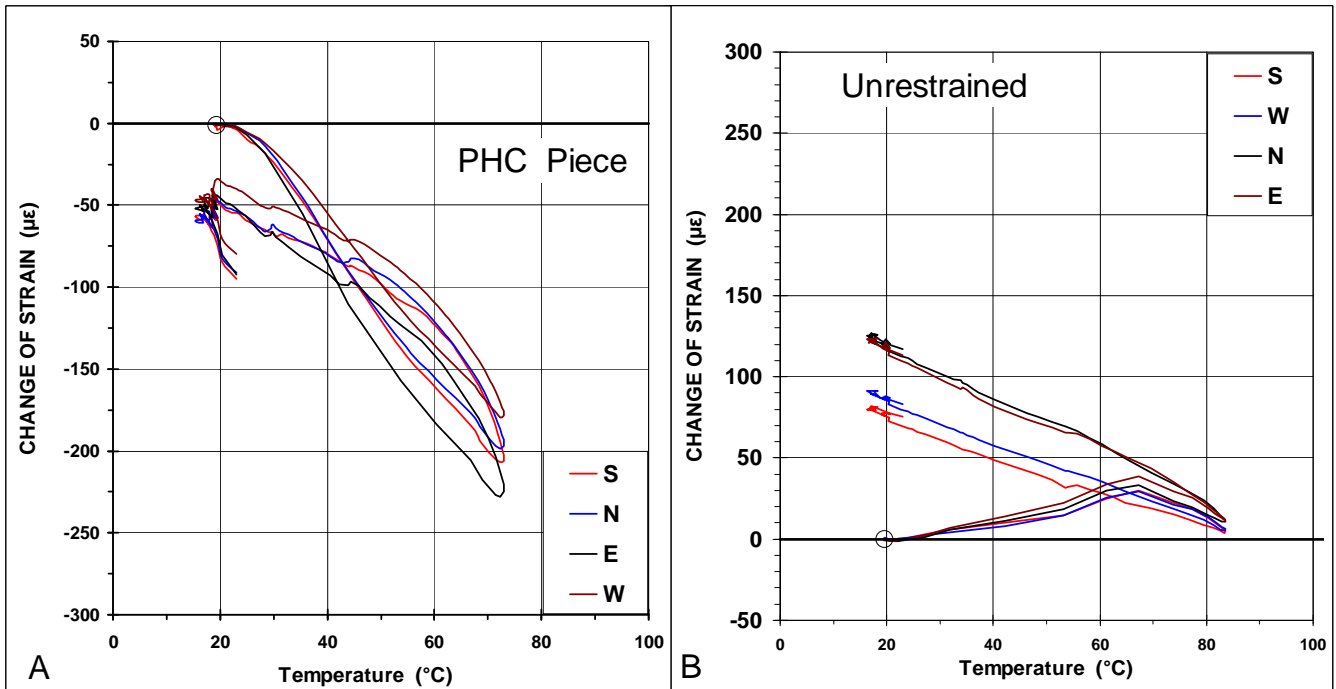
Fig. 15 Rebar strain versus temperature in the short pieces during first 150 days after grouting.

The difference between the PHC piece ("restrained piece") and the unrestrained piece is further demonstrated in Figure 15 showing the measured strain changes versus temperature.

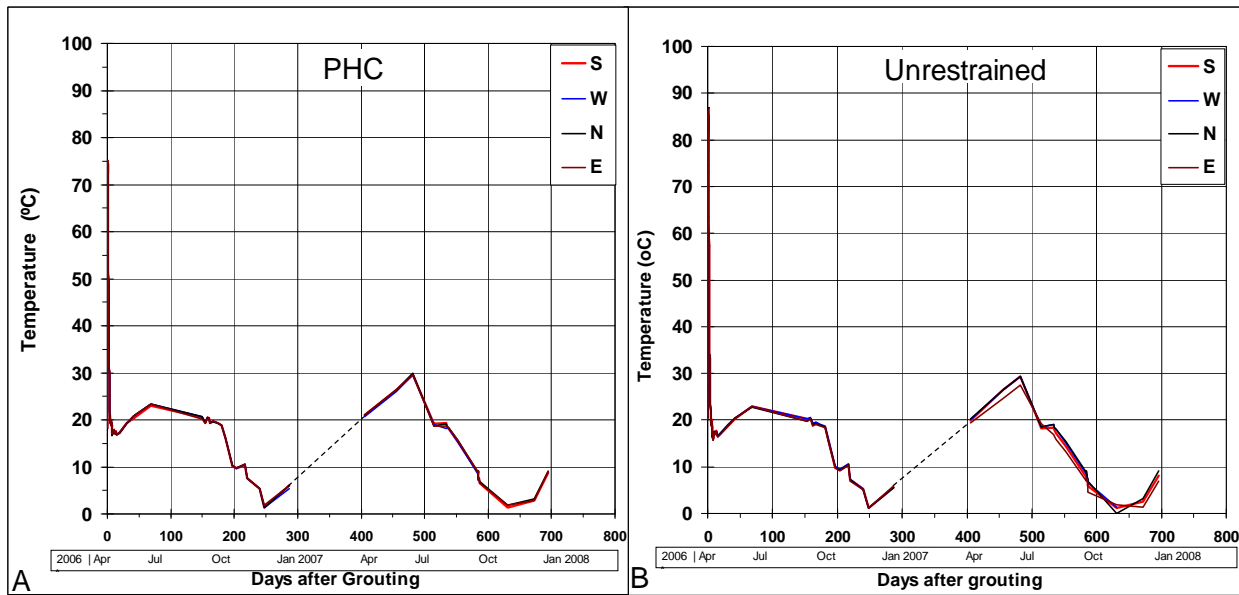
Fig. 16 Development of temperature in the short pieces during the measurement period.

After five months of observations, on September 29, 2006, Day 154, the two short pieces were submerged in water by means of filling the 800 mm plastic pipe around the pieces with water that then could be freely absorbed by the concrete. (Immediately before, the unrestrained piece was stripped of its plastic casting mold). Measurements were then continued for a full additional year (until 700 days after grouting), with an accidental monitoring pause between February through May, 2007, Days 287 and 405. Figure 16 shows the measurements of temperature during the entire measurement period.

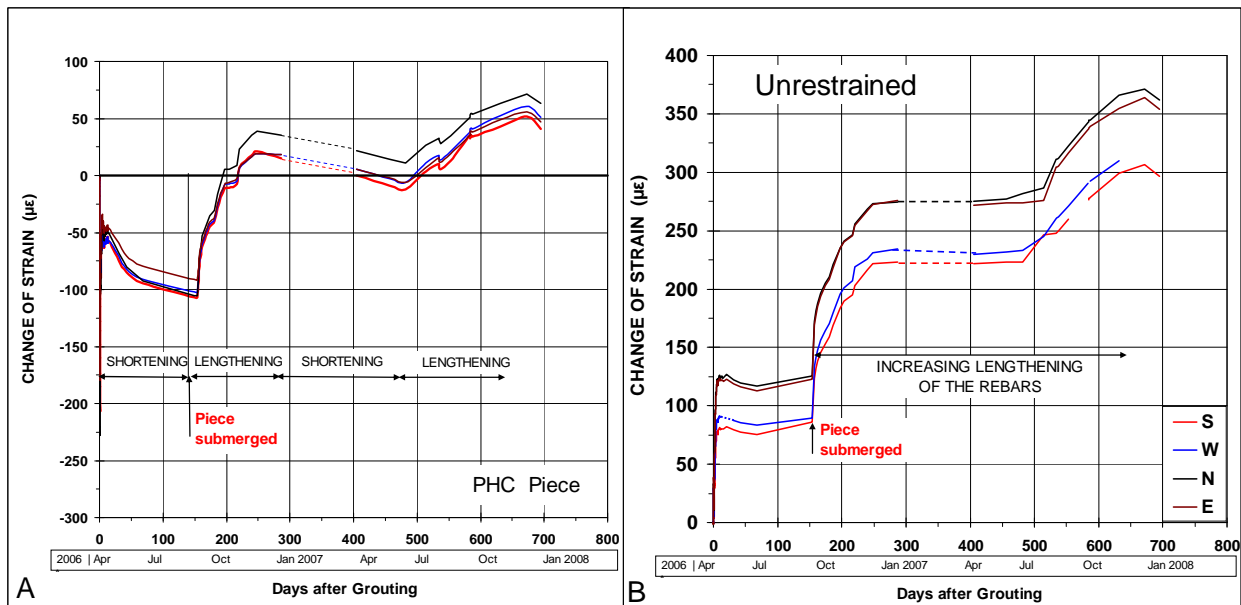
Fig. 17 Development of average rebar strain in the short pieces during the measurement period.

Immediately upon submerging, the pieces began to swell as evidenced by the progressively increasing elongation shown by the strain-gages (Figure 17). Significant swelling continued for about three months, Day 154 through Day 250, with the total swelling amounting to about $150 \mu\epsilon$ for both pieces. Beyond Day 250, the measured strains are considered due to a combination of continued swelling and, to a minor extent, the temperature changes. The dashed lines indicate the interlude when no measurements were taken.

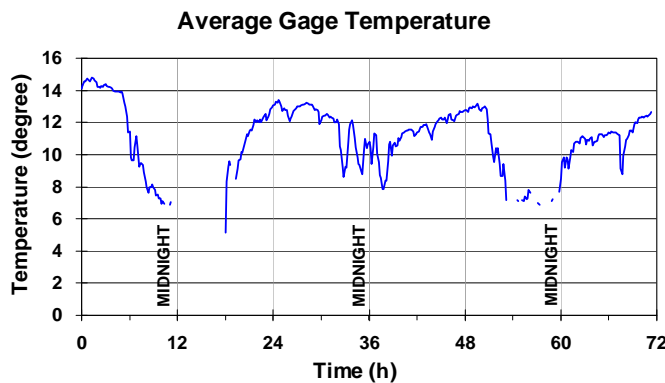
Fig. 18 Variation of temperature ($^{\circ}\text{C}$) during the study of gage temperature sensitivity.

Model 4911A gages, the same type as used in the piles, and two were a similar type of Korean manufacture as used in the short pieces. The temperature ranged from 7°C through 16°C. Figure 18 shows the measured variation of temperature and measured changes of unadjusted strains during the 72 hours of monitoring.

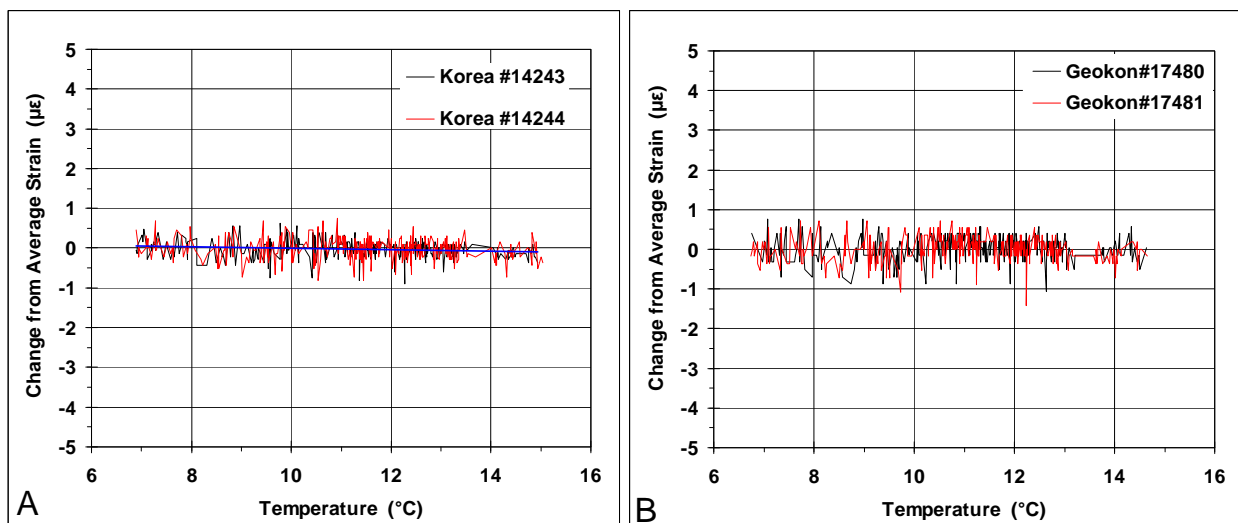
Fig. 19 Recorded variation of zero strain reading during the 72-hour observation period.

The differences in strain between each recorded zero strain values to the average strain value are shown in Figure 19. The results of the narrow temperature range, simple verification test indicates that neither gage manufacture is affected by temperature change. Therefore, gage own temperature sensitivity is considered not to be a cause of measured strain variations for the piles and short pieces, and the measured strain changes in the pile pieces are the results of hydration effects, temperature (thermal expansion difference), and swelling, occurring more or less simultaneously. It is, of course, desirable to quantify and separate the three effects.

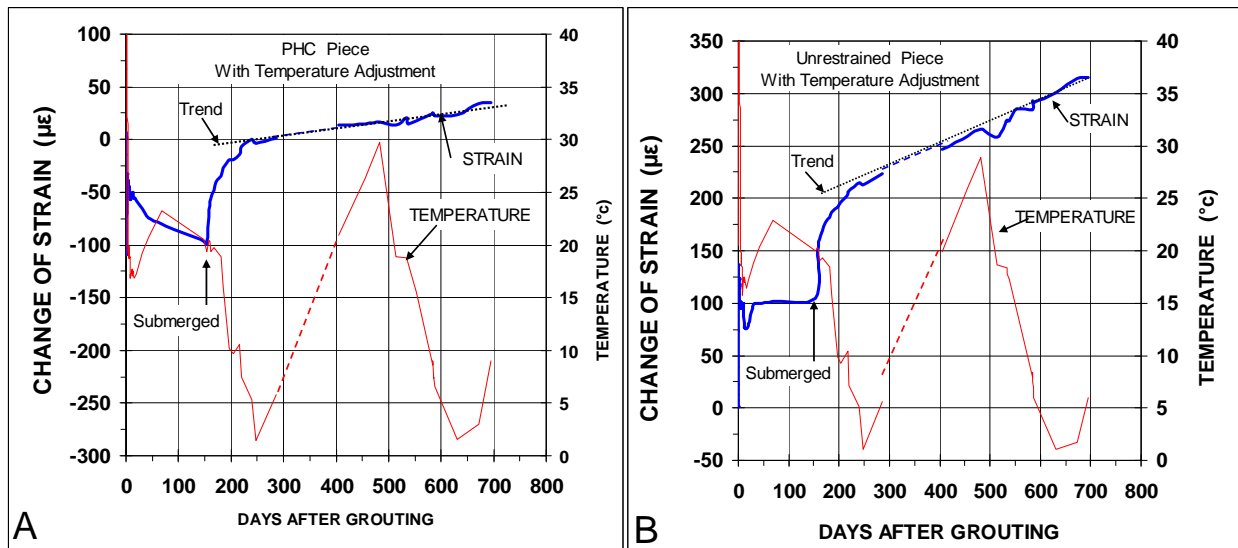
Fig. 20 Average rebar strains when the effect of temperature is removed by means of applying a temperature-expansion difference coefficients of 1.7 and 1.8 for the PHC and the unrestrained short pieces, respectively.

The strain changes during the period immediately after submerging the pieces are due to both the swelling and the effect of temperature change. It is assumed that if swelling was acting alone, the strain-time curve would be reasonably smooth and show a steady trend. As it was established that a change of temperature has minimal or no effect on the strain gage readings themselves, a suitable temperature-expansion coefficient can be deduced to correct the strain values for temperature, that is, eliminate the change of strains in the rebars due to the change of temperature. Figures 20A and 20B show the strain-time curve for the PHC and the unrestrained pieces, respectively, when applying thermal-expansion difference coefficients of 1.7 and 1.8, respectively.

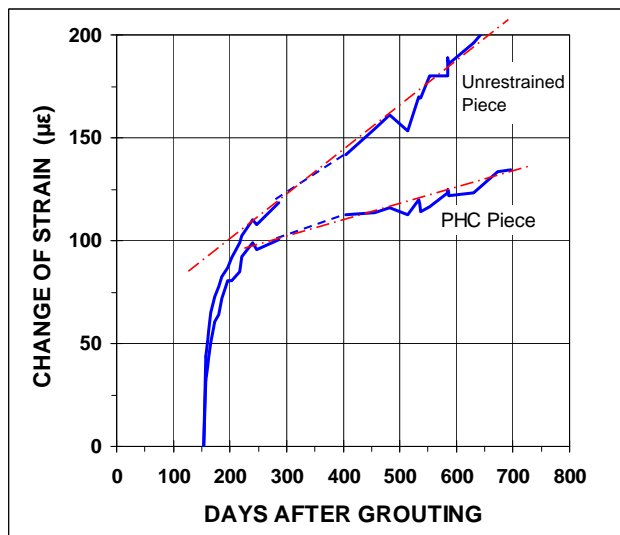
Fig. 21 Strain due to swelling alone of the short pieces after Day 154.

The strains remaining after the temperature adjustments are considered those caused by the swelling alone. After the initial rapid swelling and after about two months, the trend is linear with time and continuing for the duration of the measurements. The strains during the first 100 days after submerging are essentially equal for the two pieces. Thereafter, however, the rate of increase in the PHC piece is about $2 \mu\epsilon/\text{month}$ ($10 \mu\epsilon/80$ days), while it is three times larger for the unrestrained piece. The difference is thought to be due that the concrete wall is less able to swell than the concrete grout. However, as it is also more pervious than the grout, the wall can absorb water faster than the grout, which compensates for its smaller swelling ability and, coincidentally, makes the initial swelling rate about the same for the two pieces. As the water reaches the grout, the PHC wall restrains the swelling caused by the water absorbed by the grout, which does not happen for the unrestrained piece. While a difference of $2\mu\epsilon$ between two values measured some time apart could be due to gage drift, the observed changes of strain due to swelling over the about two-year measurement period accumulated to about $50\mu\epsilon$ and $150\mu\epsilon$, respectively, which is much too large to be considered due to any gage drift.

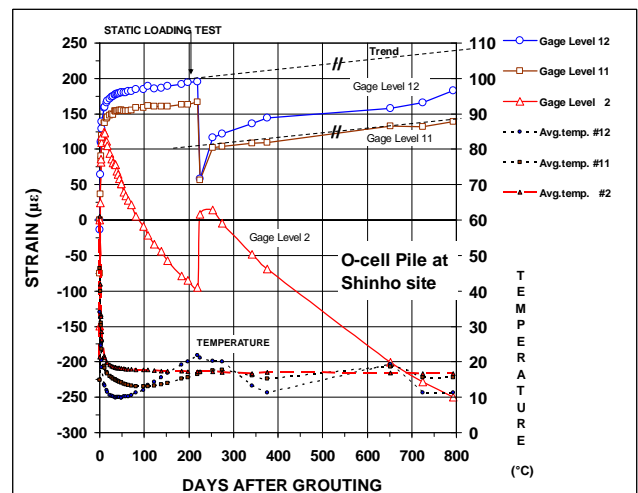
Fig. 22 Temperatures and temperature-adjusted strains in the Shinho pile.

The results of the measurements of strain and temperature in the Shinho PHC pile are shown in Figure 22. For clarity, only the data of three gage levels are shown: Level 12, which is at the ground surface, Level 11, which is at a depth of 4 m, and Level 2, which is a depth of 49 m. Gage Level 12 is affected by temperature variation and so is Level 11, but to a lesser degree. No variation of temperature occurs at Level 2. The pile is equipped with an O-cell at the toe and an O-cell static loading test was performed at Day 218 followed by a head-down static loading test. The strain data are adjusted by the temperature-expansion difference coefficient of 1.7 established from the short piece test. The elongation trend after the end of the static loading test (about Day 250) for the uppermost gage levels (# 12 and #11) is about $2 \mu\epsilon/\text{month}$, that is, the same as for the PHC short piece.
