360. Nguyen, H.M., Fellenius, B.H., Puppala, A.J. Aravind, P., and Tran, Q.T. 2016. Bidirectional Tests on Two Shaft-Grouted Barrette Piles in the Mekong Delta, Vietnam. Geotechnical Engineering Journal of the SEAGS & AGSSEA 47(1) 15-25.

Bidirectional Tests on Two Shaft-Grouted Barrette Piles in Mekong Delta, Vietnam

ABSTRACT The piled foundation design of the 40-storey Exim Bank Building in Ho Chi Minh City, Vietnam, included bidirectional static loading tests on two shaft-grouted barrette piles tested in September 2013. The soil profile consisted of organic soft clay on silty sand with some gravel and silty clay. The cross-section area of the barrette piles, TP1 and TP2, was 2,800 mm by 800 mm. They were excavated to 65-m and 85-m depth, respectively, using grab-bucket excavation techniques with bentonite slurry and guide wall advanced ahead of the hole. For each pile, the bidirectional cell assembly was installed 16 m above the pile toe level and the reinforcing cage was instrumented with diametrically opposed vibrating wire strain-gages at three levels below and five (TP1) to eight (TP2) levels above the cell level. Shaft grouting was carried out along a 40-m length above the

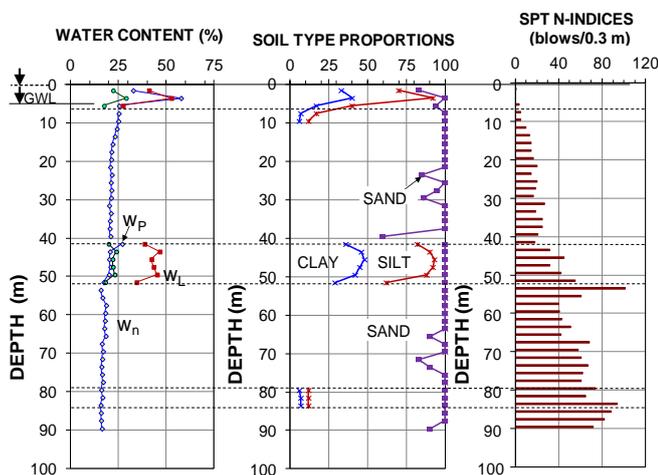
Fig. 3. Water content, soil type proportions, and N-indices

The pore pressure distribution was hydrostatic and corresponded to a groundwater table at 5 m depth below the ground surface. From about 10 m through 40 m depths, the SPT N-indices increased from about 10 blows/0.3 m to about 18 blows/0.3m, indicating compact condition. Below 40 m depth, the N-indices showed the conditions to be very dense.

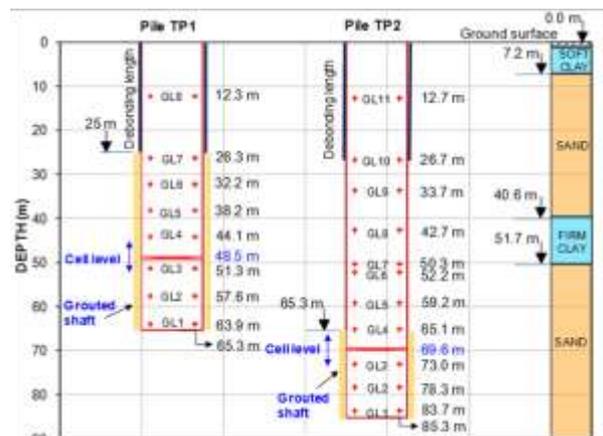
Figure 4 shows for each test pile the locations of the vibrating wire strain-gages attached to the reinforcing cages (three levels below and five through eight levels above the bidirectional cell level). Each gage level (GL) contained two diametrically opposed pairs, Gages A and C, and Gages B and D, respectively. Additionally, Figure 3 also indicates the cut-off level of the construction piles at 25 m depth below the ground surface, i.e., depth of the future lowest basement level. The planners of the static loading test programme had decided to eliminate influence of the shaft resistance above this depth and, therefore, the test piles were constructed inside debonding steel-liners that were first coated with bitumen and, then, wrapped in geotextile and again coated with bitumen to minimize shear forces between the pile and the soil. The construction (working) piles were to be supplied with a temporary casing to 25 m depth and only concreted below that depth.

Fig. 4. Details of grouting and instrumentation

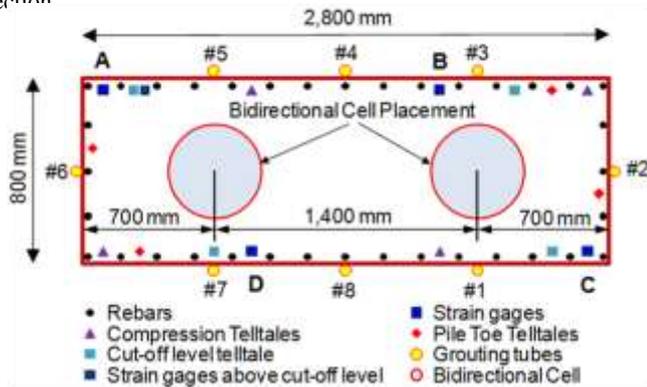
Figure 5 shows the orientation of the reinforcement bars, telltales, strain-gages, and grouting tubes over the cross-section of the piles (the same arrangement was used for both piles). The piles were supplied with a reinforcing cage of thirty-six 32-mm bars, resulting in a steel reinforcement area of 289 cm² and a reinforcement ratio of 1.29 % for the 2.24 m² nominal pile cross section.

Fig. 5. Cross section and layout of instrumentation

The strain-gages were placed diametrically opposed in pairs (gage pairs A & C and B & D), but because of the rectangular shape of the barrettes (Figure 5), the pairs did not cover equal areas of the barrette cross section. That would have meant placing the gages either at each barrette corner or at mid-point of each side (i.e., at grout tube locations #2 & #6 and #4 & #8, respectively). The actual placement indicates a quasi-symmetry across the barrette center for the gage pairs as placed.

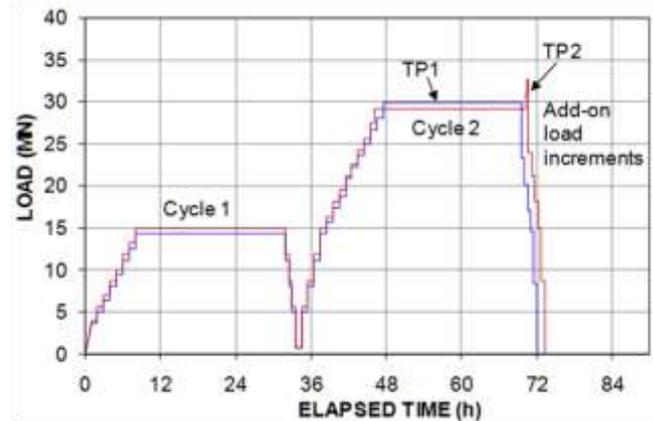
The bidirectional loading tests for both piles were carried out in two loading cycles for both test piles (Loadtest Pte. Ltd. (2013). Figure 6 shows the load vs. time schedule. The Cycle 1 loading for both piles was performed by means of a first load-increment of 3.53 and 3.87 MN, respectively, followed by seven increments ranging from about 1.38 through 1.70 MN to a maximum load of 14.25 and 14.93 MN, respectively. The test piles were unloaded in four steps. Each of the first seven load increments of Cycle 1 was held constant during one

Fig. 6. Loading schedule for the bidirectional assemblies placed 16.0 m above the pile toe and at 49 and 69 m depth for Piles, TP1 and TP2, respectively

All load levels were maintained for 60 minutes, but for Levels 10 and 13, which loads were held for 24 hours. For Pile TP2, two additional load increments of 1.73 MN held for 10 minutes were added after the last long-duration load-holding of Cycle 2 to a maximum load of 32.56 MN before unloading in seven steps.

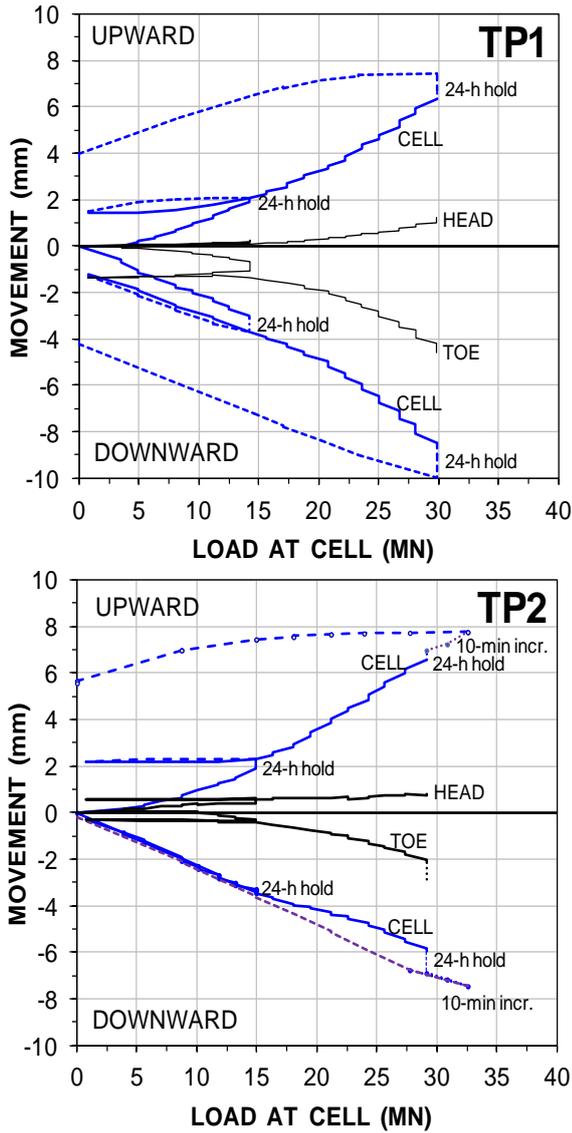
Figure 7 shows the measured upward and downward load-movement curves of the TP1 and TP2 bidirectional tests. Loads are those measured and are not adjusted for pile weight and water pressure at the cell level. At the end of the 60-minute hold for the maximum load, the Pile TP1 and TP2 Cycle 2 downward cell movements were 9.0 mm and 5.9 mm, the toe movements were 4.6 and 2.2 mm, the upward cell movements were 6.7 and 6.9 mm, and the pile head movements were 1.2 and 0.8 mm, respectively. For TP2, the change of the downward load-movement curve to becoming less steep after the unloading and reloading event is probably due to some disturbance to the dial gages. For both piles, the initially very small movements for increasing load were probably due to the piles being affected by some residual load.

Fig. 7. Measured load-movement curves

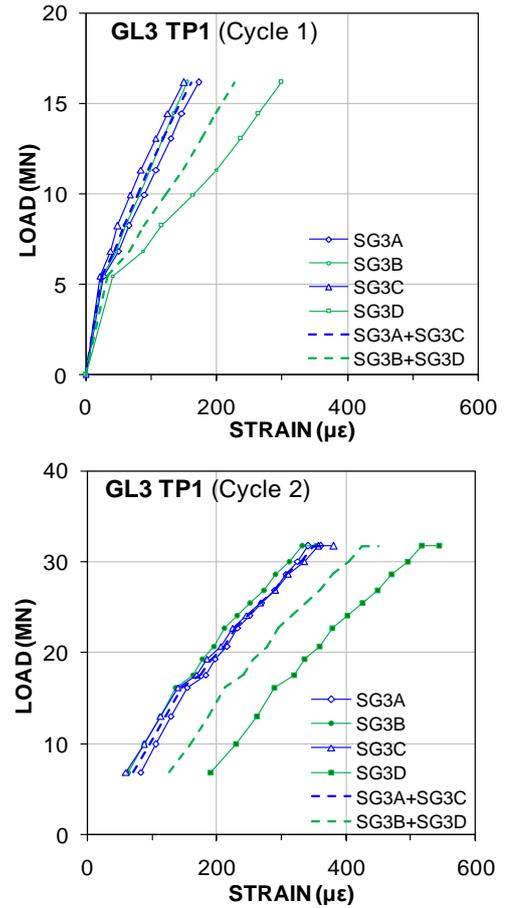
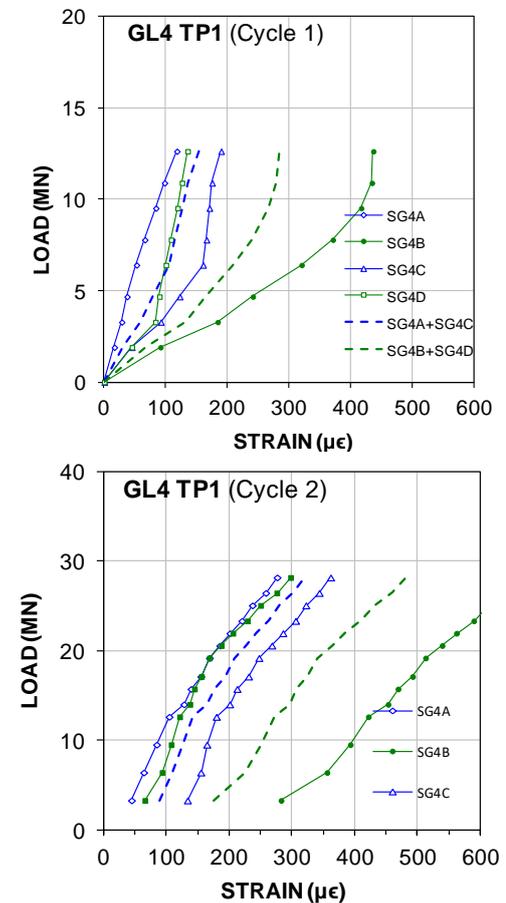
Pile TP1. Figures 8 and 9 show the TP1 load vs. strain recorded at Gage Levels 3 and 4 for Cycles 1 and 2, respectively. The individual gage records are plotted as continuous lines and the average of each gage pair is plotted as a dashed line. For TP1 Gage Level 3, three of the gage records (A, B, and C) are very similar, whereas the fourth (D) deviates from the others. Possibly, the GL3D is "off" but there is no other indication of suspect data in the gage records than the divergence. The Gage GL3(B+D) records were therefore not discarded. In contrast, Gage Level 4 records show a similar scatter of all four gage records: the gage-pair averages (Gage Pairs A+C and B+D) differ at each gage level. The maximum difference between the two averages is about 200 $\mu\epsilon$. The scatter in Level 4 records is due to GL4D appears to have ceased to work properly and GL4(B+D) records were therefore discarded. The other TP1 gage levels, GL1, GL2, GL5, GL6, GL7, and GL8 (not shown here) appeared to functioning adequately and the averages of both gage pairs were considered representative for the axial strain measured at the respective levels.

Fig. 8. Load-strain measured at Level 3 (51.3 m) of TP1

Fig. 9. Load-strain measured at Level 4 (44.1 m) of TP1

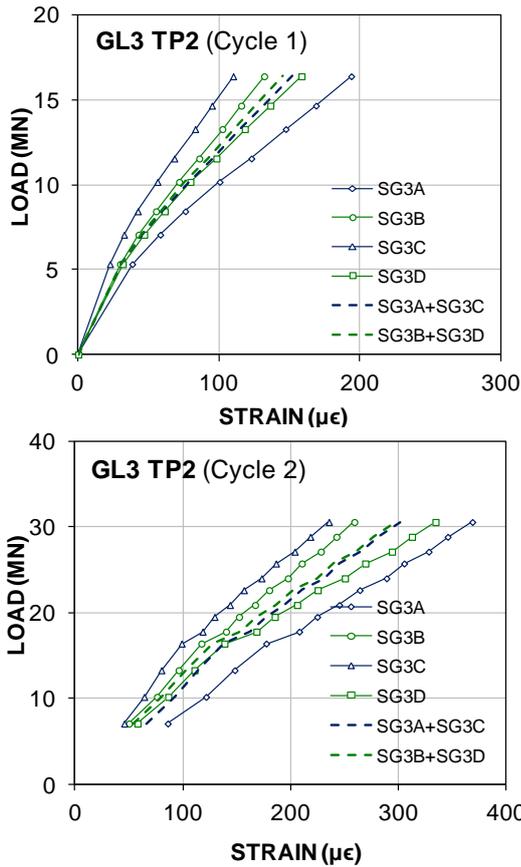
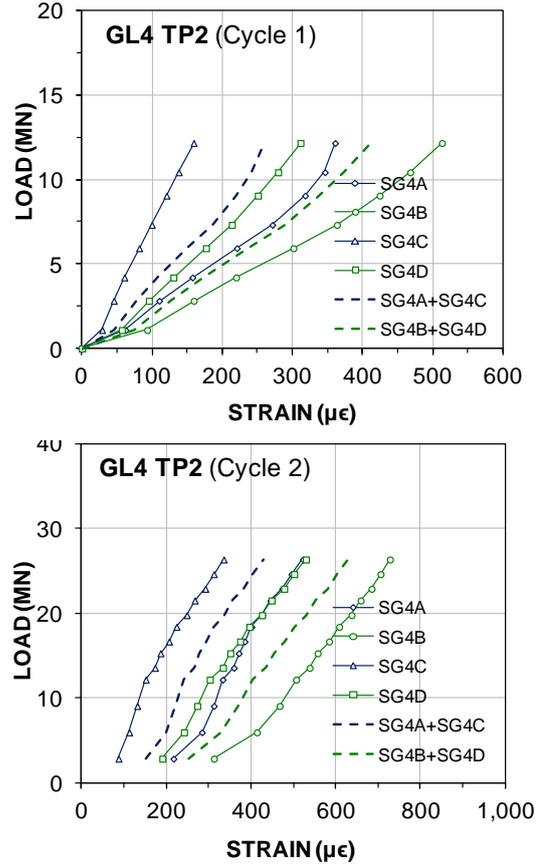
Pile TP2. Figures 10 and 11 show the TP2 load vs. strain recorded at Gage Levels 3 and 4 for Cycles 1 and 2, respectively. The individually measured GL3 strains differ slightly. However, the

Fig. 10. Load-strain measured at Level 3 (51.3 m) of TP1

Fig. 11 Load-strain measured at Level 4 (44.1 m) of TP1

average of the GL3 (A+C) pair is very close to the average of the GL3 (B+D) pair. As in TP1, the records from Gage Level 4 show a scatter. The maximum difference between the two averages is about 500 $\mu\epsilon$. All gage values from GL4 were considered suspect and were therefore discarded. The records from all other gage levels were considered to function satisfactorily and the average strain was considered representative of the axial strain response.

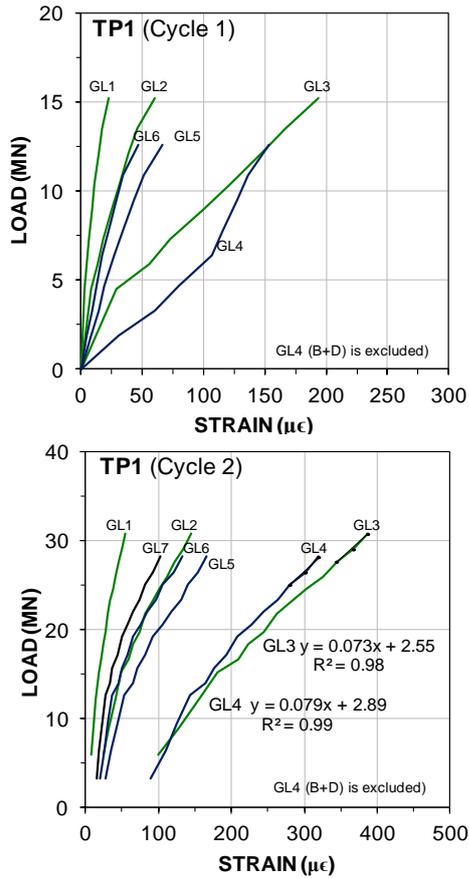
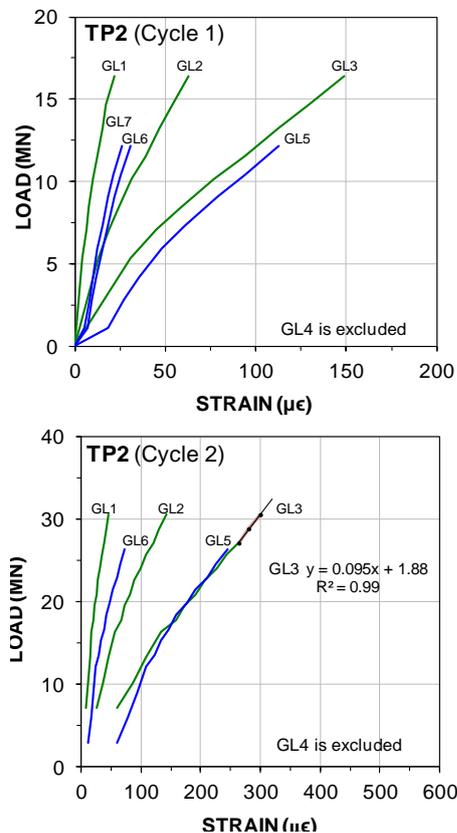
Figures 12 and 13 combine the average strains records for the two load cycles applied to TP1 and TP2, respectively. As is usually the case, the load-strain relations are slightly curved, which is due to the influence of shaft resistance and, but to a minor degree, to the fact that concrete modulus reduces with increasing strain. Short portions of the curves will always appear rather straight, however.

Fig. 12. Bidirectional cell load versus measured strain for TP1 Cycles 1 and 2

Fig. 13. Bidirectional cell load versus measured strain for TP2 Cycles 1 and 2

The average slope of the curve—once the relative movement between the pile and the soil at the gage level is large enough for the shaft resistance to become fully mobilized—will indicate, approximately, the stiffness of the pile (provided that the continued shear force development is neither strain-hardening nor strain-softening to any significant degree). Therefore, the slope of that portion of the curve will be the pile stiffness, EA, as a function of strain as determined by a linear regression analysis (Fellenius 2015).

Thus, at the movement magnitude at GL3 (TP1 and TP2) and GL4 (TP1) toward the end of Cycle 2, the slope of the end of the curves may represent the pile stiffness. The slopes were 73 and 79 GN for TP1 GL3 and TP1 GL4, respectively, and 95 GN for TP2 GL3. However, these stiffness values are larger than usually established in similar tests in the area (e.g., Nguyen and Fellenius 2015), as will be discussed below.

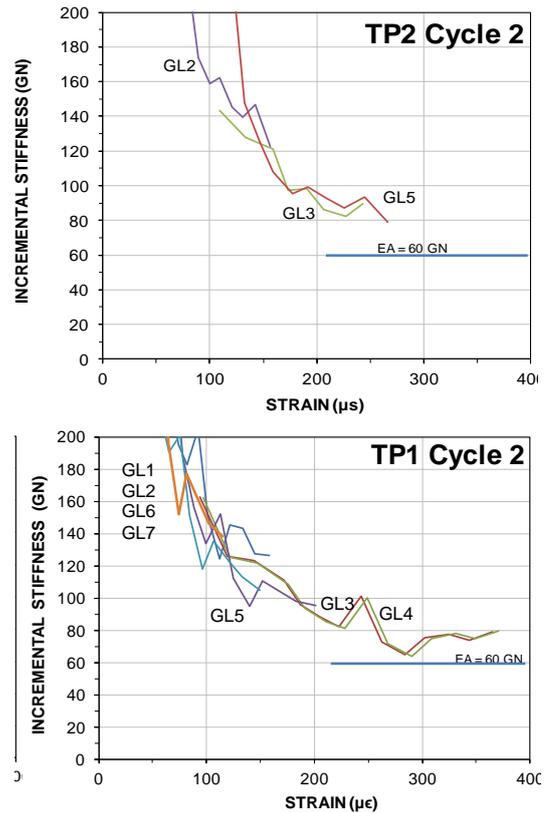
Figure 14 shows the incremental stiffness plot for the gage levels nearest the bidirectional cell levels for the test piles. The maximum strains, about 350 to 400 $\mu\epsilon$ induced by the applied loads are smaller

than ideal. (Ideally, the maximum strains should have been at least 600 $\mu\epsilon$ for the final stiffness to be established accurately and also to establish the strain dependency of the stiffness). The several millimetre relative movement between the pile and the soil would normally have mobilized an ultimate shaft resistance ("plastic" shear) in the Cycle 2 tests. Therefore, the shaft shear is expected to be more or less fully mobilized between the bidirectional cell and GL3 and GL4, and GL4 to GL5 of both test piles. This could be the case also along the lengths between GL2 and GL3 and GL4, and between GL5 and GL6. However, each load-increase resulted in increased shaft shear and the implied stiffness values are too high.

Fig. 14. Load-strain measured at Level 3 (51.3 m) of TP1

This response is typical for a strain-hardening behavior, as opposed to an ultimate "plastic" shear-force vs. movement response. Moreover, the trend shown for TP1 beyond 300 $\mu\epsilon$ is increasing, as opposed to decreasing. This suggests that the pile shaft surface was corrugated. Possibly, outside each grout hole in the grout pipes the grout zone is thicker than between the grout hole levels. Thus, the grouting has created a series of more or less horizontal ribs or "donuts" that act as displacement-dependent "toe resistances" in building up resistance to the pile movement, much in similarity to underreamed piles or step-taper piles (Fellenius 2015). Thus, for the first few millimetre of movement, the resistance is mainly shaft shear. Then, at larger movement, when the shaft shear approaches its ultimate value—although, there may or may not be an ultimate shaft shear resistance—due to deformation similar to toe resistance, the latter response takes over, resulting in an apparent increase of the incremental stiffness.

The actual stiffness was not evident from the records. Judging from other similar tests in the general area, the end stiffness is reasonably about 60 GN, which corresponds to a Young modulus of about 27 GPa on the nominal cross section. It is not possible to use the data to deduce a strain-dependent stiffness toward the 60-GN end value. Therefore, all strain data are evaluated for the 60-GN value, which somewhat underestimates the axial force in the pile at small strains.

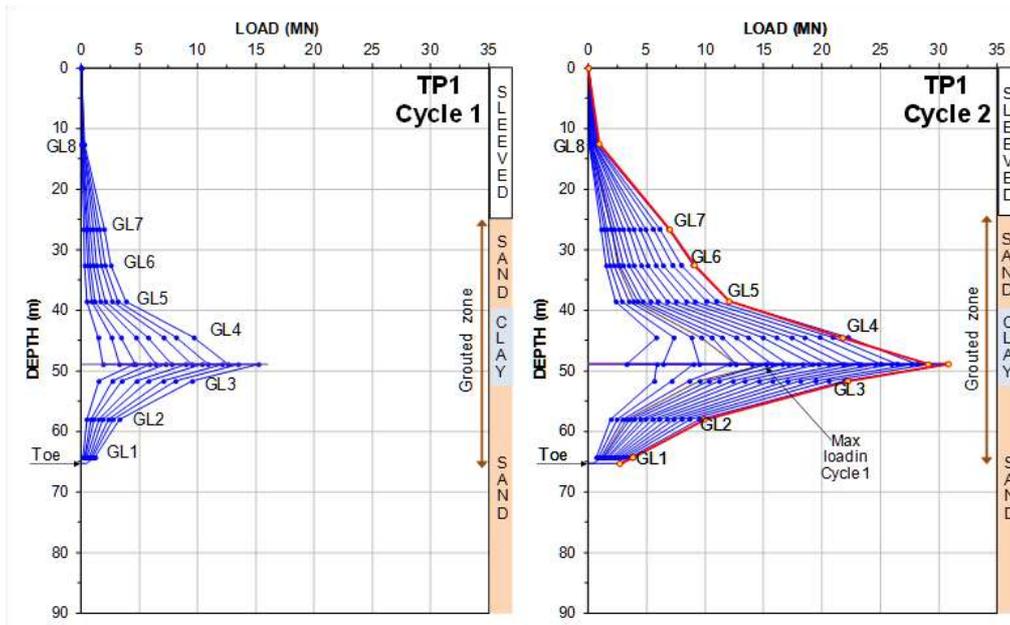
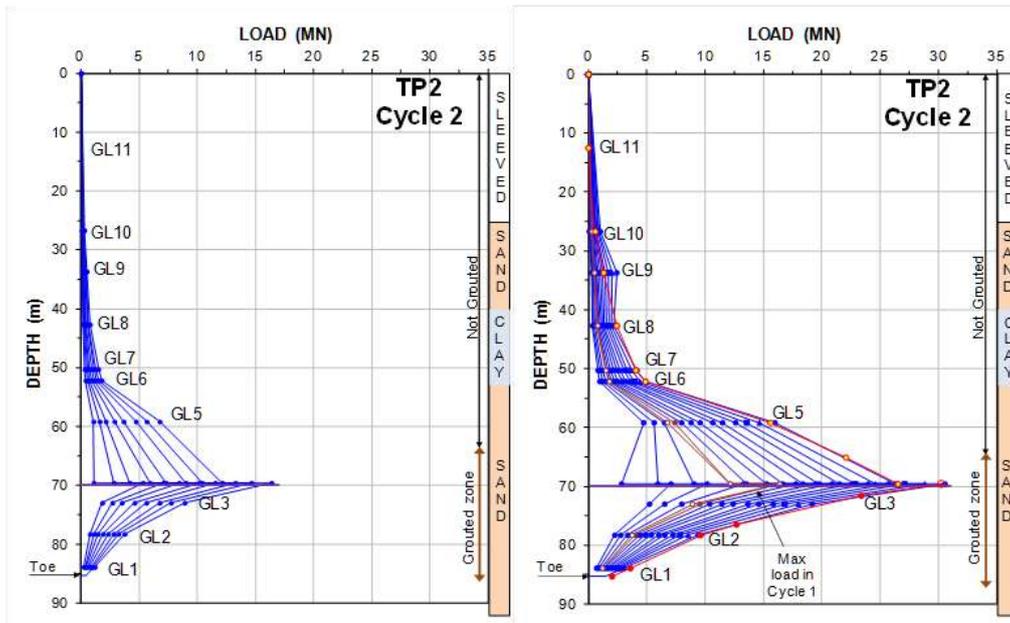
The derived 60-GN pile stiffness was used to convert the average of strain measured at each gage level for each applied load. The results for the two tests are shown in Figures 15 and 16, respectively. The lines of loads plotted above the cell level connect to the respective cell loads minus the buoyant pile weight above the cell level and the lines below connect to a respective cell loads plus the load resulting from the water pressure at the cell level. No consideration of residual load was included.

Fig. 15. TP1 Cycles 1 and 2 load distributions

Fig. 16. TP2 Cycles 1 and 2 load distributions

The even distributions indicated that the chosen 60-GN stiffness is a reasonable stiffness to use for the back-calculation of the load distribution. A larger stiffness would have resulted in load magnitudes at GL3 and GL4 (TP1) and GL3 and GL5 (TP2) too close to the applied cell loads, or even larger than the cell loads. This would only have been possible if the pile had micro-cracks before the start of the test, which is improbable. Micro-cracks may develop in rock sockets, where the shaft shear is able to prevent the concrete from reducing volume (height) during the cooling after the hydration process and, thus, develop cracks, but that does not apply here. Or, the pile could have been subjected to residual (locked-in) loads which then would have had to be caused by positive shaft shear above the cell level and negative shaft shear below. Presence of such locked-in loads is highly unlikely, indeed impossible, as it would have required the soils to have undergone swelling. Above the cell level, presence of residual load would have resulted in strain-gage evaluated loads that are smaller than the true loads.

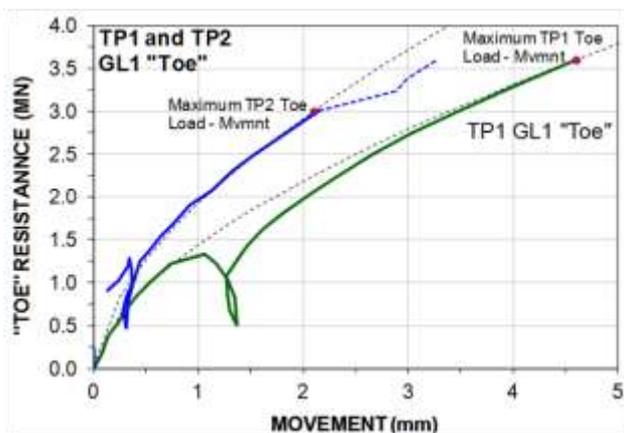
For both piles, the lowest gages, GL1, was located very close to the pile toe. Figure 17 shows the GL1-load vs. the telltale-measured pile toe movement. The Pile TP2 toe movement showed a sudden sideways shift at the end of the test that, probably, was due to some unknown incidence affecting the movement readings. Both curves were fitted to a q-z function curve shown with dashed lines per the ratio function (Fellenius 2015) according to Eq. 1.

Fig. 17. Gage Level 1 in Piles TP1 and TP2 vs. telltale-measured pile-toe movements and q - z fits for the

Thus, when assigning any load/movement pair as the R_{trg}/δ_{trg} , any and all other load-movement pairs are determined by the θ -exponent. As mentioned below, a θ -exponent equal to 0.6 was found to provide a toe load-movement curve that fitted the measured response for both piles.

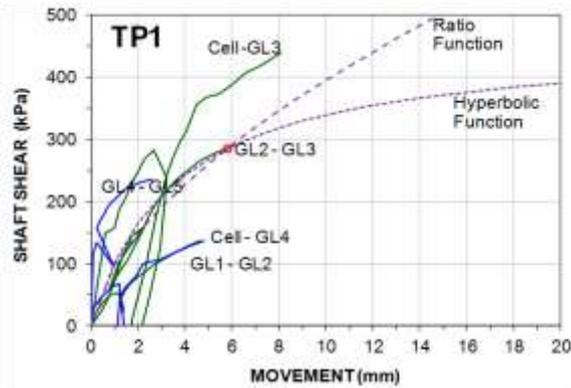
Fig. 18. Pile TP1 shaft shear vs. movement in Cycles 1 and 2 with curves fitted per Ratio and Hyperbolic t-z Functions

The Ratio Function showed to fit the curves for a Θ -exponent ranging from 0.4 through 0.6, as demonstrated by the fit to the average shear resistance between TP1 GL2-GL3 using a Θ exponent equal to 0.60 (Figure 18). However, because the movements are small, a suitable fit can also be found for any other t-z functions that show an increase of resistance for increasing movement. For example, the hyperbolic fit (Fellenius 2015) as expressed by Eqs. 2 and 3.

Within the initial movements up to the maximum value either function provided an acceptable fit. However, at larger movements, the t-z functions deviate considerably.

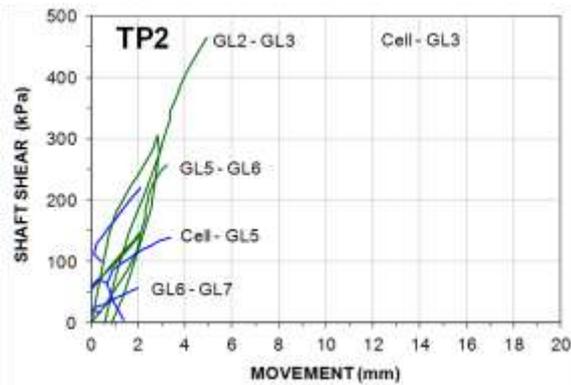
Fig. 19. Pile TP2 shaft shear vs. movement in Cycles 1 and 2

The pile movements were measured at cell level and the pile toe. The movements at GL4 and GL3 above and below the cell level, were calculated as the upward and downward movement, respectively, measured at the cell level minus the average of strain time the distance to the strain gage level. The movements at the next gage levels above and below were calculated with respect to the movements at GL4 and GL3, respectively, and so on for the next level. (As mentioned, the TP2 GL4 records were considered unreliable and were, therefore, not used, which means that Figure 19 does not include curves for Cell-GL4 and GL4-GL5). The movement induced in the test were rather small and, with the possible exception for the pile lengths immediately above and below the cell level, the shaft resistance was not fully mobilized.

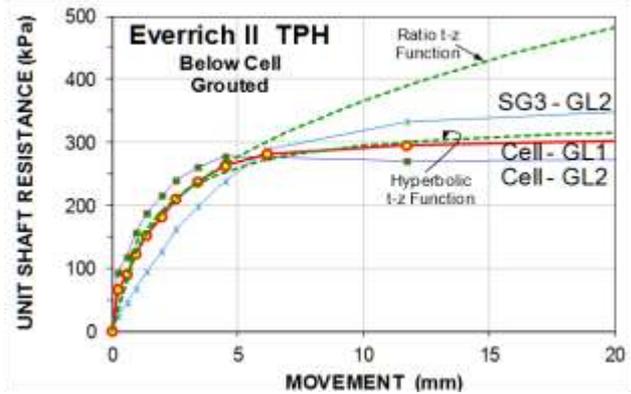
Usually, the Hyperbolic Function is more representative for the mobilization of shaft resistance as opposed to the Ratio Function. The results from the Everrich II tests, which was carried out to much larger movement, suggested that this was the case for the Everich II site. Figure 20 shows the unit shaft shear vs. movement for one of the Everich II test piles. Both the Ratio and Hyperbolic t-z Functions have been fitted to the Cell-GL1 shear force vs. movement curve. The functions provide a good fit to the initial part of the curve. However, for large movement, the Ratio Function overestimated the shear force, whereas the Hyperbolic Function keeps providing a good fit.

Fig. 20. Unit shaft resistances vs. movement determined for the Everrich II test. The TPH pile was a 2,000-mm diameter, 80 m long bored pile (data from Nguyen and Fellenius 2015).

When comparing values for grouted and non grouted lengths, only values for GL5 to GL3 in TP1 and the same depth range values GL8 to GL6 in TP2 apply. In TP1, the beta-coefficient ranges from 0.43 to 0.99; the average was 0.71. In TP2, the range was 0.11 to 0.40; the average was 0.21. This appears to indicate that the grouting did indeed result in an increased shaft resistance and, possibly, one as large as that found in the tests mentioned in the introduction, specifically at the Everrich II test (Figure 20).

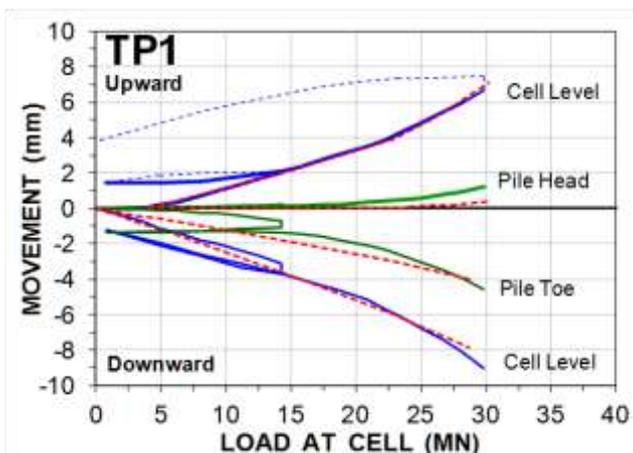
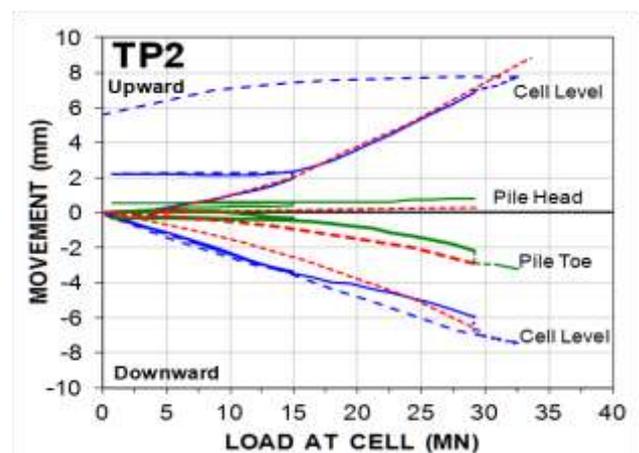
As mentioned, the strain-gage determined load-movements indicated that also the shaft shear response was "strain-hardening". Of the several functions (Fellenius 2015) that can be used to model a shaft load-movement response, only the Hyperbolic Function and the Ratio Function provide increasing resistance with increasing movement. While they can be produced to show similar shapes at small movement, the hyperbolic function shows a more depressed increase for large movements, as opposed to the ratio function. For the subject test, the target beta-coefficients and movements were then combined with either a θ -exponent (Ratio Function) or a resistance, R_{inf} , at infinite movement (Hyperbolic Function). The simulation of the bidirectional test was then carried out for different such parameters until a satisfactory fit was achieved. Both t z functions produced equally good fits to the measured load-movement curves, as shown in Figures 21 and 22.

Fig. 21. TP1 Measured and load-movement curves. Solid lines show the measured curves and dashed lines the simulated curves.

Fig. 22. TP2 Measured and load-movement curves. Solid lines show the measured curves and dashed lines the simulated curves.

Table 1 columns show the input of movement and beta-coefficients used for the UniPile simulation and the R_{inf} resistance that gave the fit shown in the figures. The table also includes the calculated effective overburden stress and the unit shaft resistance at the gage levels as corresponding to the beta-coefficient times the effective stress.

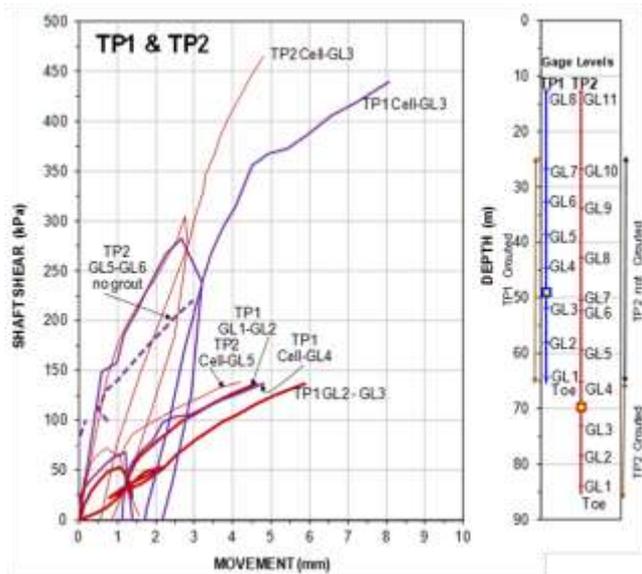
A primary objective of the test was to compare the shaft shear response for a grouted length to that of a non-grouted length. It is however very difficult to discern any clear difference in shaft response between the pile lengths that were grouted (Pile TP1) and not grouted (Pile TP2). The comparison needs to be for gage lengths at equal depths and over pile elements that more or less have mobilized most of the shaft resistance, or at least have been moved an equal distance relative to the soil. This limits the comparison to using the grouted lengths in TP1 to below GL4 and, for Pile TP2, to no-grout lengths between TP2 GL5 and GL7 (TP2 GL4 records were discarded). The shaft shear above TP2 GL7 was not mobilized to a useful degree. The shaft-shear curves suitable for such comparison must be from approximately same depth range. Curves relevant for comparison are assembled in Figure 23. Only one record along a no-grout pile length applies, TP2 GL5-GL6 (the dashed curve). The curves from the length between TP1 cell and GL3 mobilized considerably larger shear force compared to the TP2 GL5-GL6 no-grout length. However, grout-length curves TP1 GL2-GL3 and GL1-GL2, as well as TP1 Cell-GL4 did not show larger shaft shear than the TP2 GL5-GL6 no-grout gage length at similar depth range. Judging by the strain-hardening resistance, the indication is that the grouting increased the shaft shear, but the records plotted in Figure 20 are not definite enough to serve as base for a quantified comparison.

Fig. 23. Comparison of shaft shear vs. shaft movement for grouted and not grouted pile lengths between gage levels
