360. Nguyen, H.M., Fellenius, B.H., Puppala, A.J. Aravind, P., and Tran, Q.T. 2016. Bidirectional Tests on Two Shaft-Grouted Barrette Piles in the Mekong Delta, Vietnam. Geotechnical Engineering Journal of the SEAGS & AGSSEA 47(1) 15-25.

Bidirectional Tests on Two Shaft-Grouted Barrette Piles in Mekong Delta, Vietnam

ABSTRACT The piled foundation design of the 40-storey Exim Bank Building in Ho Chi Minh City, Vietnam, included bidirectional static loading tests on two shaft-grouted barrette piles tested in September 2013. The soil profile consisted of organic soft clay on silty sand with some gravel and silty clay. The cross-section area of the barrette piles, TP1 and TP2, was 2,800 mm by 800 mm. They were excavated to 65-m and 85-m depth, respectively, using grab-bucket excavation techniques with bentonite slurry and guide wall advanced ahead of the hole. For each pile, the bidirectional cell assembly was installed 16 m above the pile toe level and the reinforcing cage was instrumented with diametrically opposed vibrating wire strain-gages at three levels below and five (TP1) to eight (TP2) levels above the cell level. Shaft grouting was carried out along a 40-m length above the

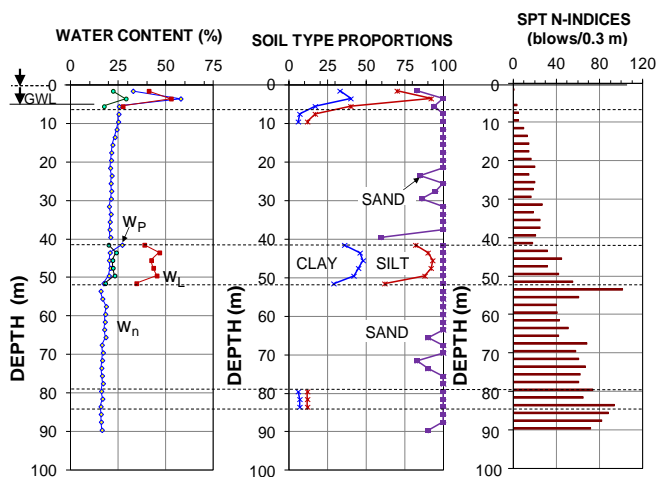
Fig. 3. Water content, soil type proportions, and N-indices

The pore pressure distribution was hydrostatic and corresponded to a groundwater table at 5 m depth below the ground surface. From about 10 m through 40 m depths, the SPT N-indices increased from about 10 blows/0.3 m to about 18 blows/0.3m, indicating compact condition. Below 40 m depth, the N-indices showed the conditions to be very dense.

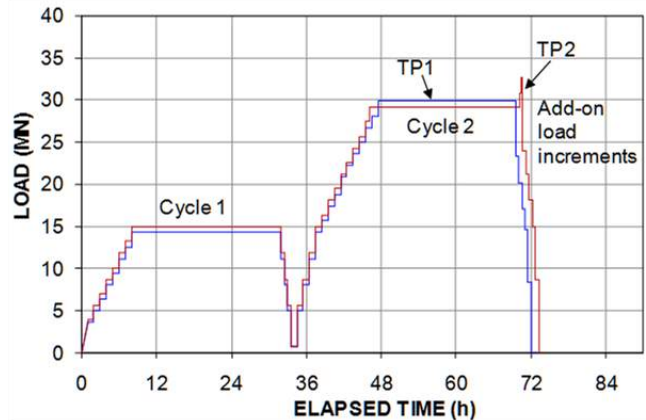
The bidirectional loading tests for both piles were carried out in two loading cycles for both test piles (Loadtest Pte. Ltd. (2013). Figure 6 shows the load vs. time schedule. The Cycle 1 loading for both piles was performed by means of a first load-increment of 3.53 and 3.87 MN, respectively, followed by seven increments ranging from about 1.38 through 1.70 MN to a maximum load of 14.25 and 14.93 MN, respectively. The test piles were unloaded in four steps. Each of the first seven load increments of Cycle 1 was held constant during one

Fig. 6. Loading schedule for the bidirectional assemblies placed 16.0 m above the pile toe and at 49 and 69 m depth for Piles, TP1 and TP2, respectively

All load levels were maintained for 60 minutes, but for Levels 10 and 13, which loads were held for 24 hours. For Pile TP2, two additional load increments of 1.73 MN held for 10 minutes were added after the last long-duration load-holding of Cycle 2 to a maximum load of 32.56 MN before unloading in seven steps.

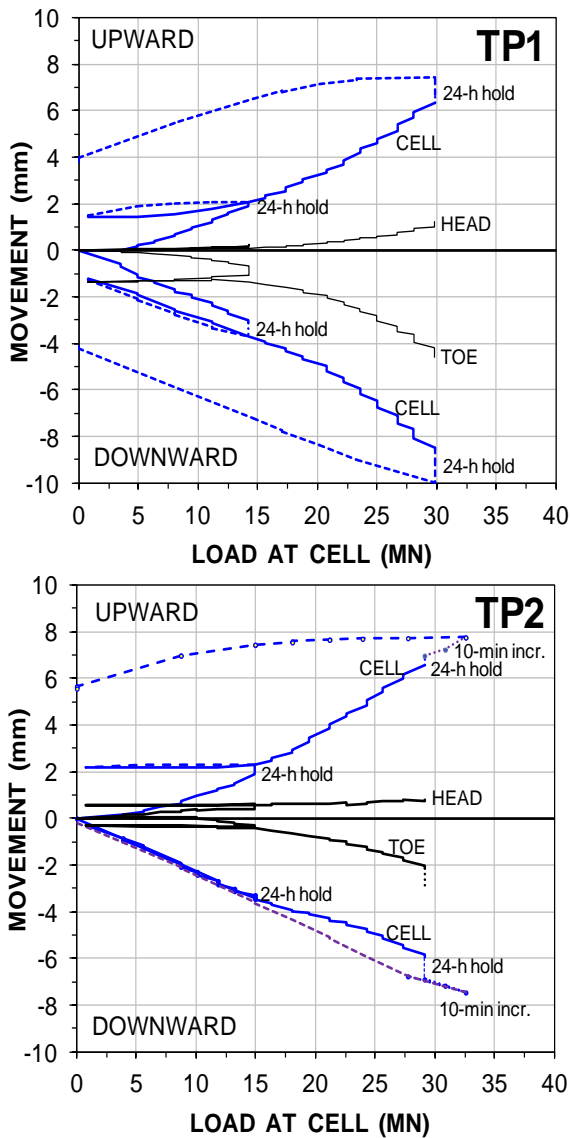
Figure 7 shows the measured upward and downward load-movement curves of the TP1 and TP2 bidirectional tests. Loads are those measured and are not adjusted for pile weight and water pressure at the cell level. At the end of the 60-minute hold for the maximum load, the Pile TP1 and TP2 Cycle 2 downward cell movements were 9.0 mm and 5.9 mm, the toe movements were 4.6 and 2.2 mm, the upward cell movements were 6.7 and 6.9 mm, and the pile head movements were 1.2 and 0.8 mm, respectively. For TP2, the change of the downward load-movement curve to becoming less steep after the unloading and reloading event is probably due to some disturbance to the dial gages. For both piles, the initially very small movements for increasing load were probably due to the piles being affected by some residual load.

Fig. 7. Measured load-movement curves

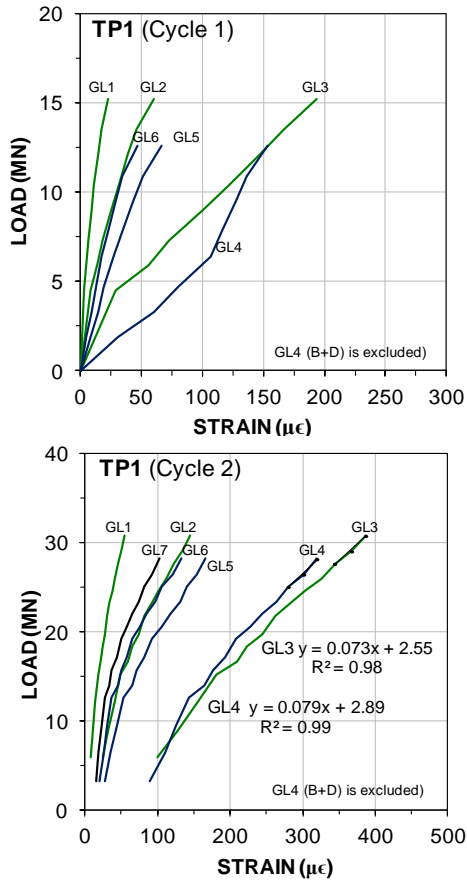
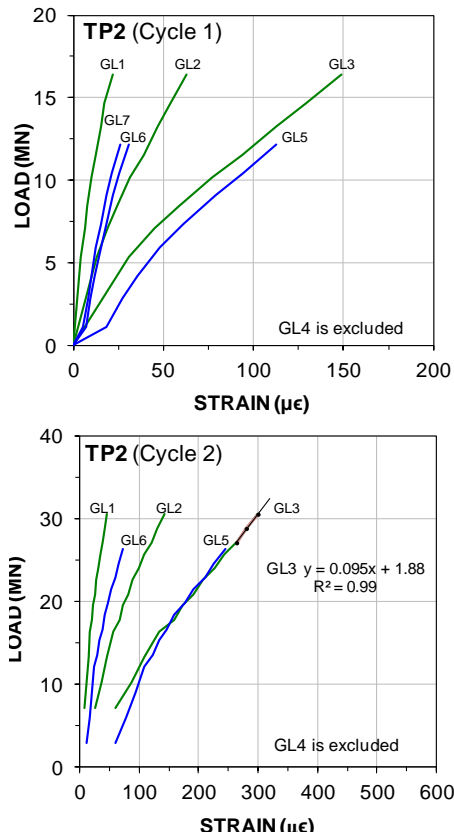
Figures 12 and 13 combine the average strains records for the two load cycles applied to TP1 and TP2, respectively. As is usually the case, the load-strain relations are slightly curved, which is due to the influence of shaft resistance and, but to a minor degree, to the fact that concrete modulus reduces with increasing strain. Short portions of the curves will always appear rather straight, however.

Fig. 12. Bidirectional cell load versus measured strain for TP1 Cycles 1 and 2

Fig. 13. Bidirectional cell load versus measured strain for TP2 Cycles 1 and 2

The average slope of the curve—once the relative movement between the pile and the soil at the gage level is large enough for the shaft resistance to become fully mobilized—will indicate, approximately, the stiffness of the pile (provided that the continued shear force development is neither strain-hardening nor strain-softening to any significant degree). Therefore, the slope of that portion of the curve will be the pile stiffness, EA, as a function of strain as determined by a linear regression analysis (Fellenius 2015).

Thus, at the movement magnitude at GL3 (TP1 and TP2) and GL4 (TP1) toward the end of Cycle 2, the slope of the end of the curves may represent the pile stiffness. The slopes were 73 and 79 GN for TP1 GL3 and TP1 GL4, respectively, and 95 GN for TP2 GL3. However, these stiffness values are larger than usually established in similar tests in the area (e.g., Nguyen and Fellenius 2015), as will be discussed below.

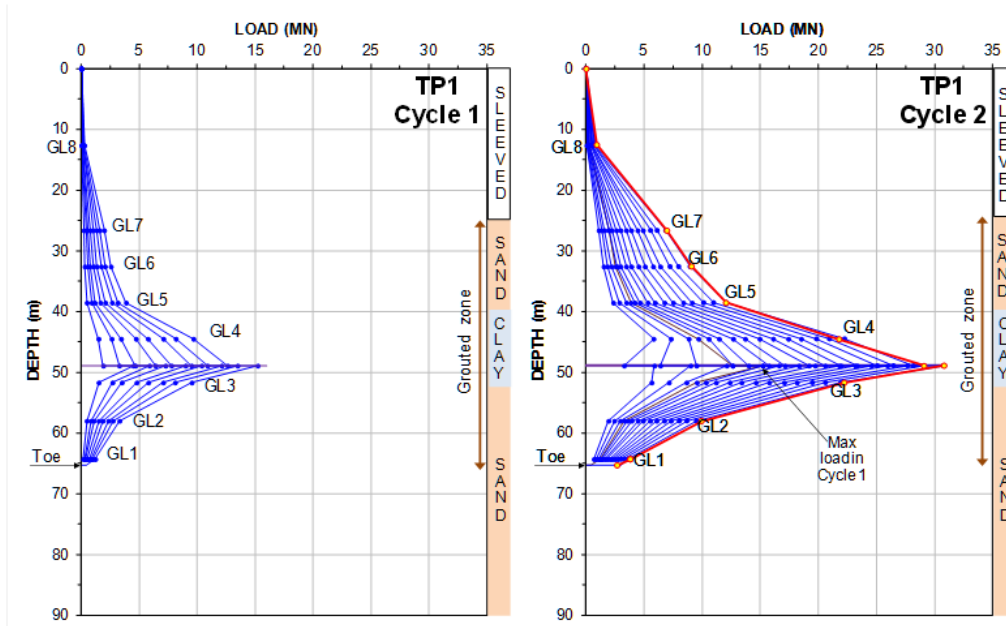
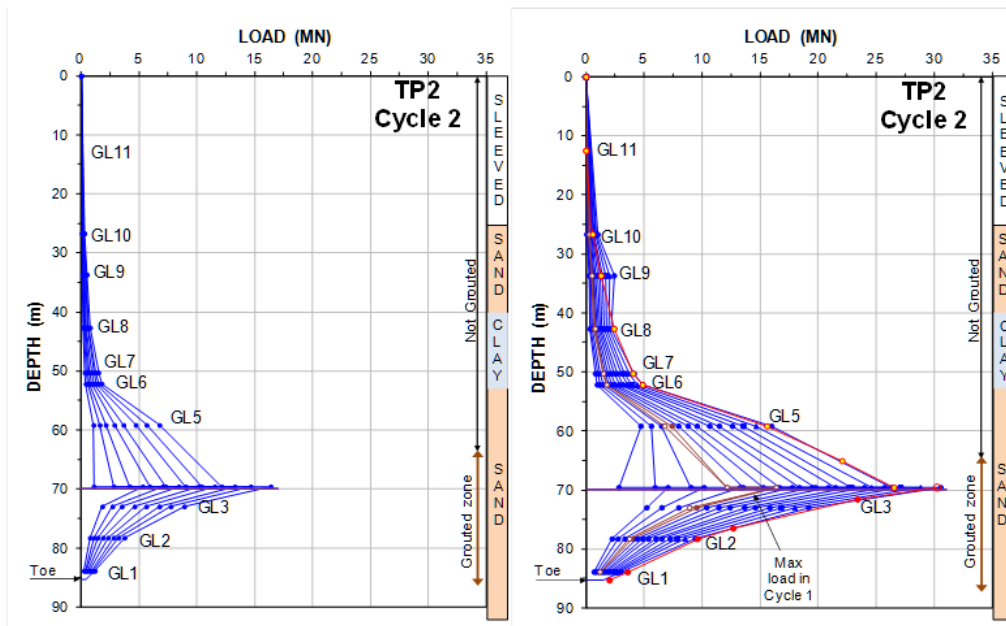
The derived 60-GN pile stiffness was used to convert the average of strain measured at each gage level for each applied load. The results for the two tests are shown in Figures 15 and 16, respectively. The lines of loads plotted above the cell level connect to the respective cell loads minus the buoyant pile weight above the cell level and the lines below connect to a respective cell loads plus the load resulting from the water pressure at the cell level. No consideration of residual load was included.

Fig. 15. TP1 Cycles 1 and 2 load distributions

Fig. 16. TP2 Cycles 1 and 2 load distributions

The even distributions indicated that the chosen 60-GN stiffness is a reasonable stiffness to use for the back-calculation of the load distribution. A larger stiffness would have resulted in load magnitudes at GL3 and GL4 (TP1) and GL3 and GL5 (TP2) too close to the applied cell loads, or even larger than the cell loads. This would only have been possible if the pile had micro-cracks before the start of the test, which is improbable. Micro-cracks may develop in rock sockets, where the shaft shear is able to prevent the concrete from reducing volume (height) during the cooling after the hydration process and, thus, develop cracks, but that does not apply here. Or, the pile could have been subjected to residual (locked-in) loads which then would have had to be caused by positive shaft shear above the cell level and negative shaft shear below. Presence of such locked-in loads is highly unlikely, indeed impossible, as it would have required the soils to have undergone swelling. Above the cell level, presence of residual load would have resulted in strain-gage evaluated loads that are smaller than the true loads.

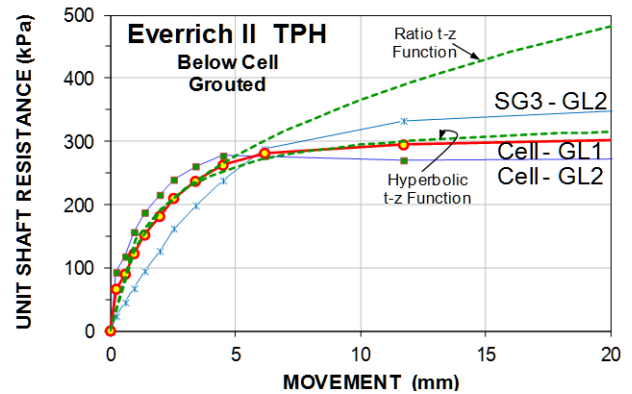
Usually, the Hyperbolic Function is more representative for the mobilization of shaft resistance as opposed to the Ratio Function. The results from the Everrich II tests, which was carried out to much larger movement, suggested that this was the case for the Everich II site. Figure 20 shows the unit shaft shear vs. movement for one of the Everich II test piles. Both the Ratio and Hyperbolic t-z Functions have been fitted to the Cell-GL1 shear force vs. movement curve. The functions provide a good fit to the initial part of the curve. However, for large movement, the Ratio Function overestimated the shear force, whereas the Hyperbolic Function keeps providing a good fit.

Fig. 20. Unit shaft resistances vs. movement determined for the Everrich II test. The TPH pile was a 2,000-mm diameter, 80 m long bored pile (data from Nguyen and Fellenius 2015).

When comparing values for grouted and non grouted lengths, only values for GL5 to GL3 in TP1 and the same depth range values GL8 to GL6 in TP2 apply. In TP1, the beta-coefficient ranges from 0.43 to 0.99; the average was 0.71. In TP2, the range was 0.11 to 0.40; the average was 0.21. This appears to indicate that the grouting did indeed result in an increased shaft resistance and, possibly, one as large as that found in the tests mentioned in the introduction, specifically at the Everrich II test (Figure 20).
